SLG4653x Errata

CE-GP-002

This document contains the known errata for SLG46533, SLG46534, SLG46535, SLG46536, SLG46537, SLG46538 and the recommended workarounds.

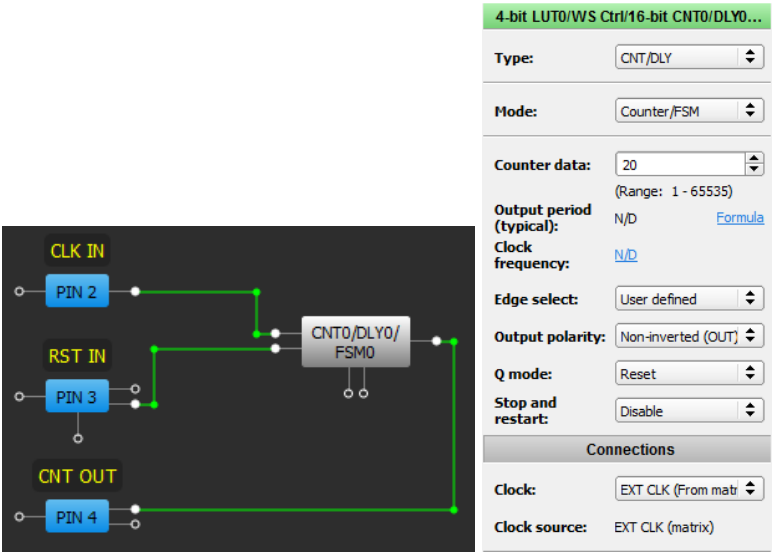
Figure 1

If the Counter Reset is asserted at the same time as a rising clock edge, it is possible that the Counter Data will be reset incorrectly and the counter output may appear faster than expected. This phenomenon appears more often as the clock frequency increases.

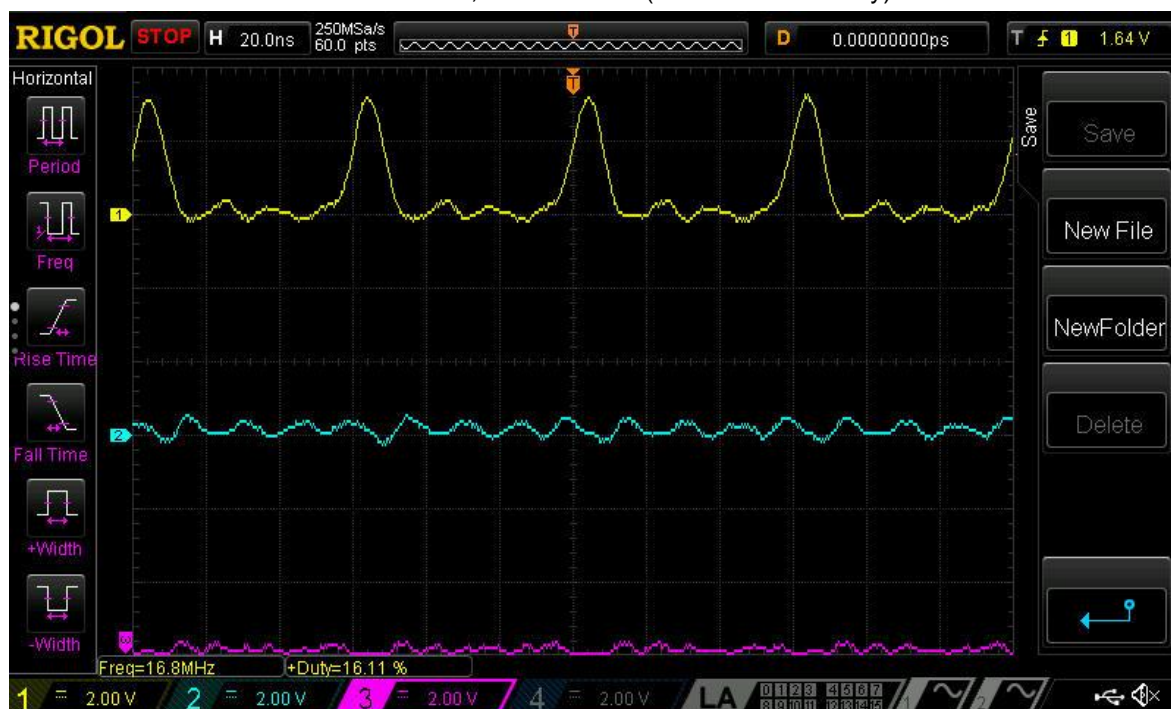
Figure 5

1. Period is 60 ns. Pulse width is 10 ns, DC = 16.7 % (correct functionality).

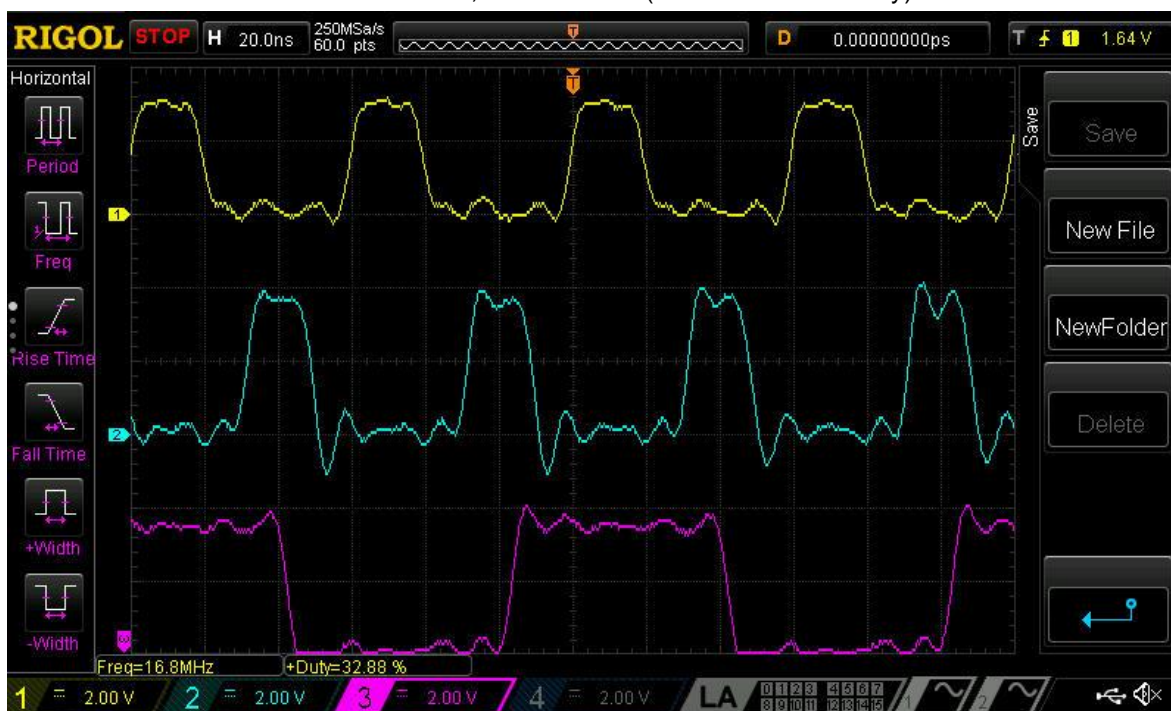
Figure 6

2. Period is 60 ns. Pulse width is 20 ns, DC = 33.3 % (incorrect functionality).

Currently there is no workaround for this issue. Filter block is good at filtering short spontaneous glitches. It is intended to be used in series connection before the delay cell to avoid its latching.

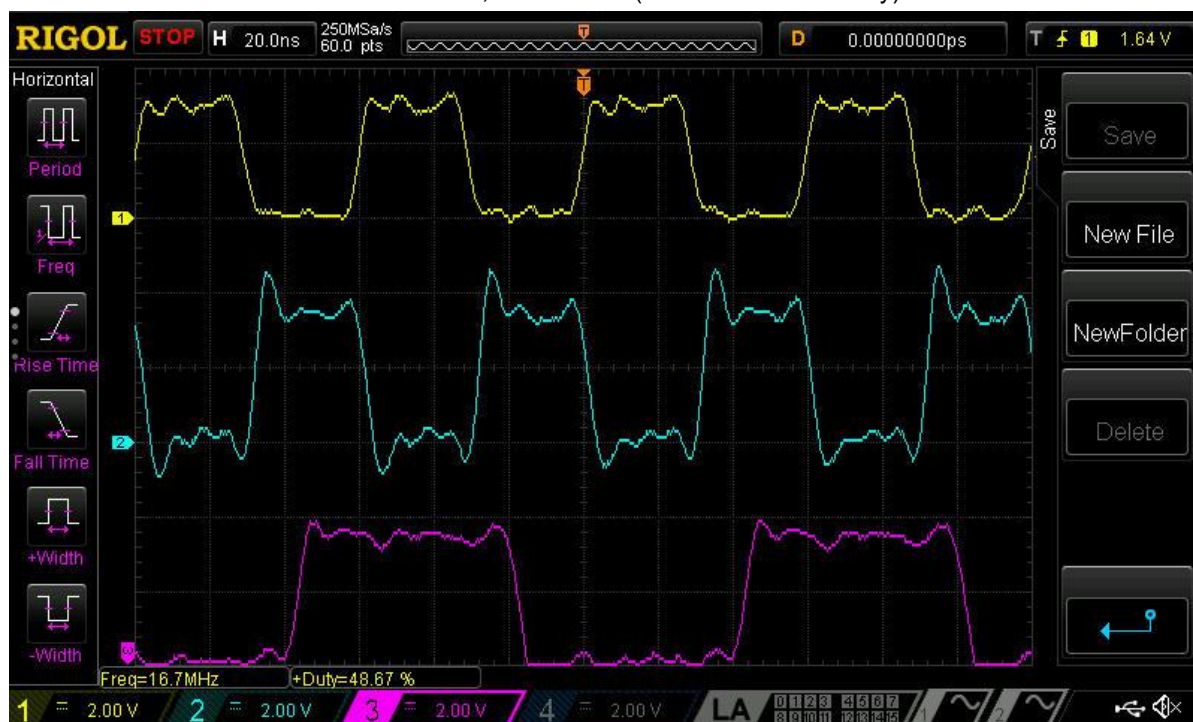
Figure 7

3. Period is 60 ns. Pulse width is 30 ns, DC = 50 % (incorrect functionality).

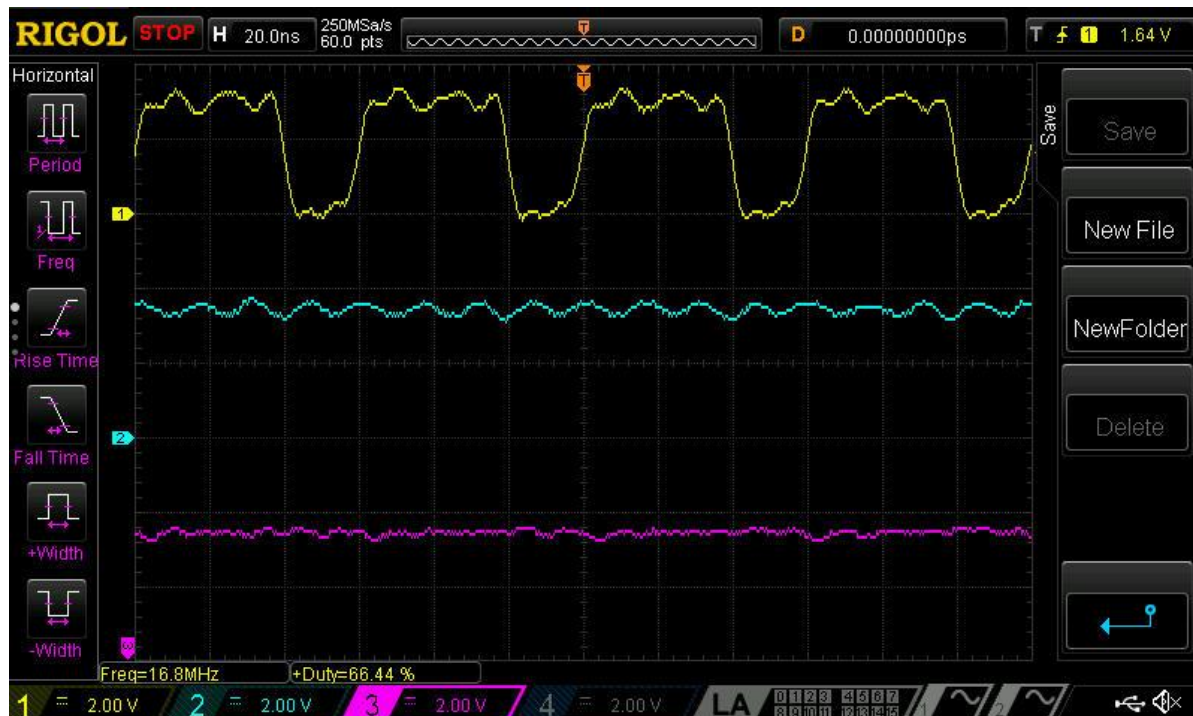
Figure 8

4. Period is 60 ns. Pulse width is 40 ns, DC = 66.67 % (correct functionality).

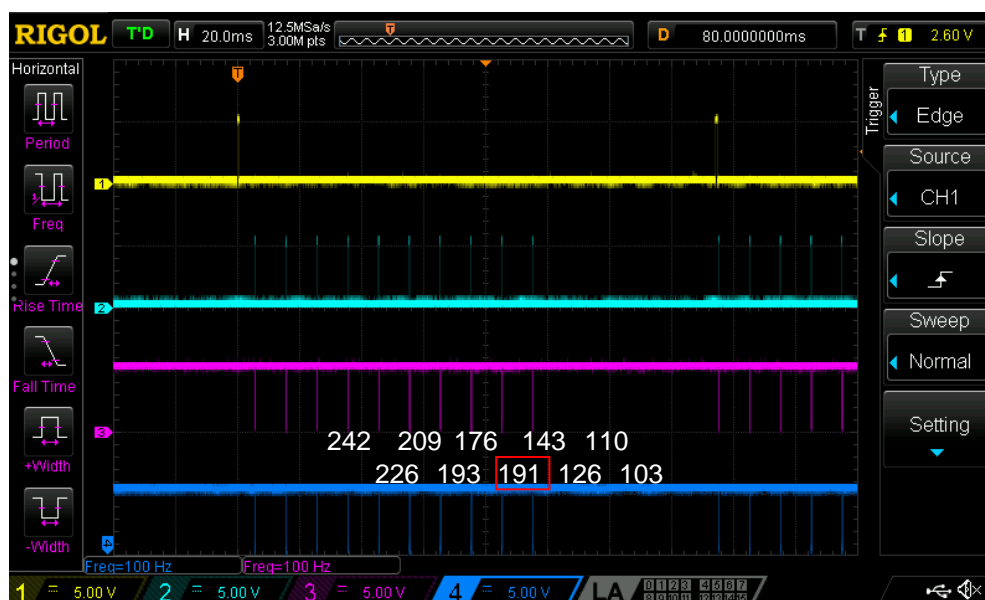
Figure 9

The example data capture below shows ten periodic I2C reads of CNT2/DLY2 configured to count down at about 16 clocks per read. The sixth read sample erroneously shows a value greater than that of the fifth. The seventh sample reads as if the previous I2C error never occurred - the difference from the fifth sample (176) to the seventh (143) is 33 clocks or 16 clocks + 17 clocks as expected.

If the possibility of incorrect I2C data reads can't be accommodated for by external software checks, one can guarantee proper operation by stopping the CNT/DLY block's clock during I2C reads through one of the following methods: by disabling the oscillator block, by reconfiguring the CNT/DLY block's clock source, or by gating an external clock using a LUT (Look-up Table) in the signal matrix. After disabling the CNT/DLY block's clock, the count registers can be read without error. Please note that this workaround will add the I2C read and processing time to the counter's overall clock period.

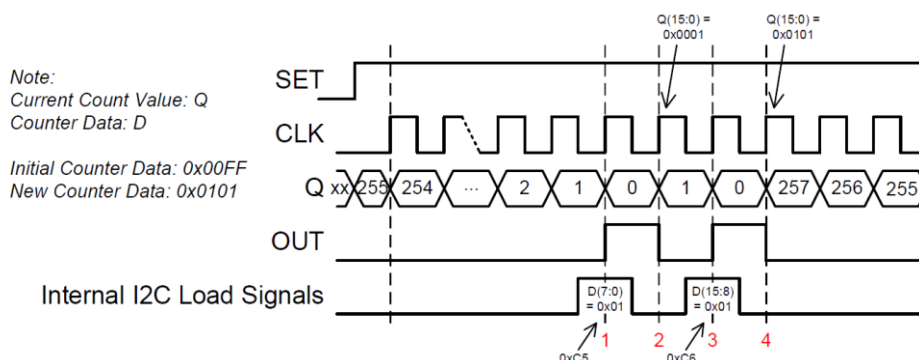
The timing diagram in [Figure 10](#) sets up a case where an improper output will be seen on the counter. In this example, the initial Counter Data value (D) is set up as 0x00FF. As you can see, the Current Count Value (Q) decrements from 255 down to 0 with rising edges on CLK. At time "1"

Figure 10: I2C Write of 16-Bit Counter Data Example

As previously mentioned, the 16-bit value is loaded from the I2C buffers to the Counter Data registers in 8-bit chunks. Right at time “1”, the LSB byte (0x01) is loaded into the Counter Data registers. This makes the Counter Data value temporarily equal to 0x0001. At time “2” between the internal I2C load signals, the counter receives a rising edge on its clock input. This causes the Current Count Value to underflow and to be loaded with the Counter Data value which is 0x0001. At time “3”, the MSB byte (0x01) is loaded into the Counter Data registers setting the Counter Data value to 0x0101. At time “4”, the Current Count Value underflows again and is set to the Counter Data value of 0x0101.

This behavior results in two output pulses on OUT when only one pulse is expected. Observing this behavior depends upon the asynchronous timing between the counter's clock and the I2C write command to the Counter Data registers. For some applications, the extra pulse on OUT can be ignored and the counter will self-correct after underflowing, overflowing, or being SET/RESET through the GreenPAK connection matrix.

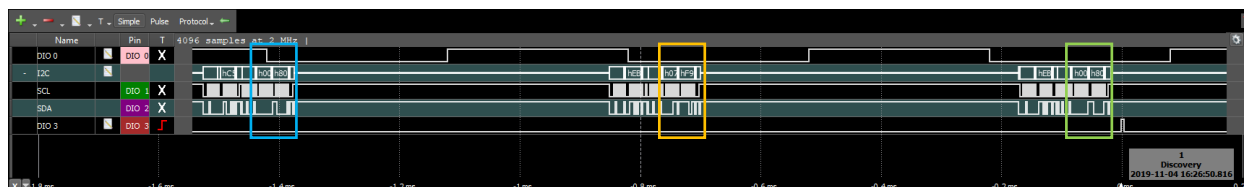
For the following condition, the Counter Data register contents are unexpectedly loaded into the counter's DFF chain. This behavior occurs when there is a falling edge on the counter block's clock input during the data return portion of an I2C read of the Counter Data registers. Figure 12 shows this falling edge boxed in light blue followed by two I2C reads of the Current Count Value registers.

Figure 12: Counter Behavior

As you can see by the MCU data log below, the Current Count Value gradually increases from 0xF904 to 0xF907 but is unexpectedly reset to 0x8000. Please note that the colored HEX values in the MCU Log correspond to the boxed I2C read commands shown in the waveform above. As previously described, this reset occurs because there is a falling edge on the counter's clock input while the GreenPAK device is responding to an I2C read request to 0xC5 and 0xC6. (Note that 0xC5/0xC6 are the Counter Data registers and 0xEB/0xEC are the Current Count Value registers for CNT0.)

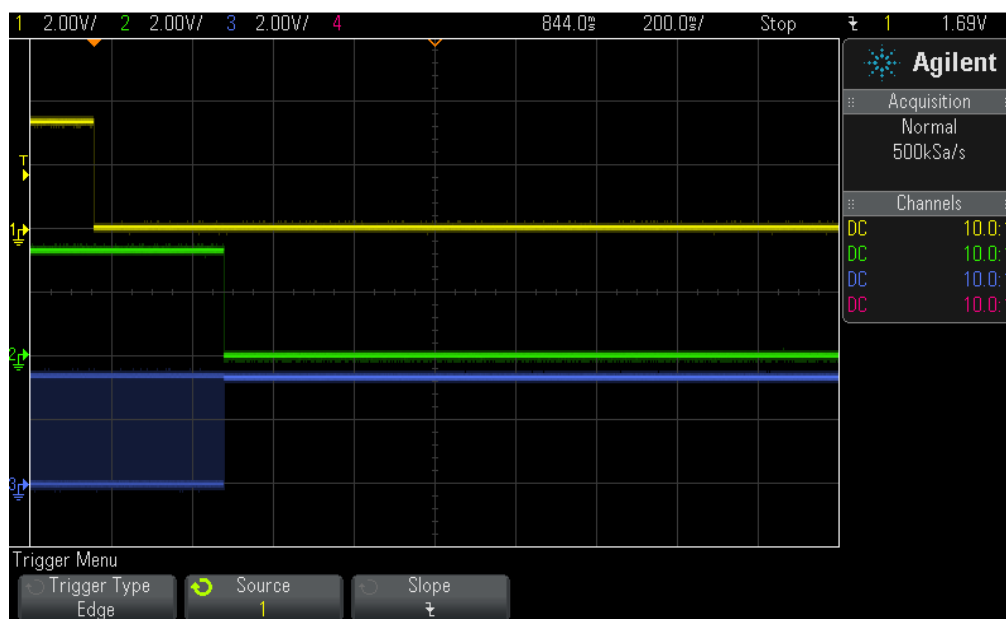
Figure 14

By toggling I2C\_SDA low and then I2C\_SCL low, the GreenPAK registers this as a start bit and latches all General Purpose Outputs such as PIN#17 (“OSC\_OUT0”). In the [Figure 14](#), notice that PIN#17 (OSC\_OUT0) stops toggling.

Disable IO Latching in programmed OTP. This register is I2C-write locked during normal operation and therefore should be disabled in configuration file.

Do not share I2C bus with other devices and make sure the I2C bus is not powered down while the GreenPAK is still powered through VDD.

If the above cannot be satisfied, then consider using the SLG4658x devices, where this errata has been fixed.

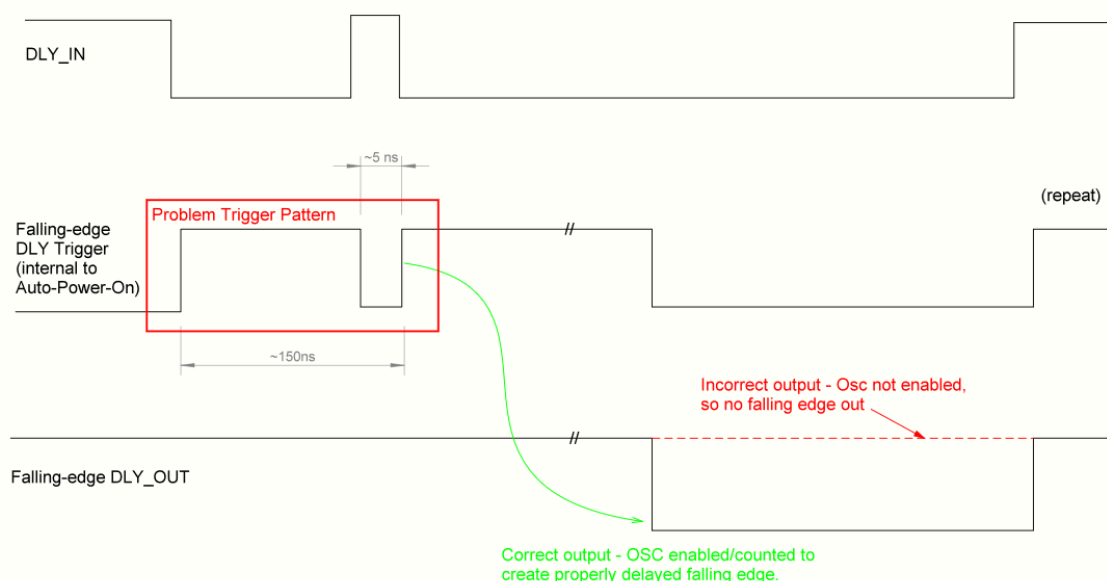
For this chip, the Auto Power On circuitry of the 25 kHz/2 MHz generators contains a circuit errata, which can potentially fail to power on the OSC for a specific pattern and timing of the OR of all related DLY trigger signals. The pattern is shown in [Figure 15](#) (boxed in red) and consists of a relatively longer pulse (~145 ns) followed by a shorter (~5 ns) glitch of opposite polarity.

**Figure 15: Problem Trigger Pattern**

1. Use signal conditioning circuits to prevent glitch on DLY inputs < 200 ns. Examples:
  - a. ACMP with Hysteresis
  - b. External RC in front of Digital Input with Schmitt Trigger
  - c. Filter cell.
2. Set OSC power mode to Force Power On mode instead of Auto Power On.
3. Use different oscillator, such as 25 MHz Ring OSC, which does not have Auto Power On issue.

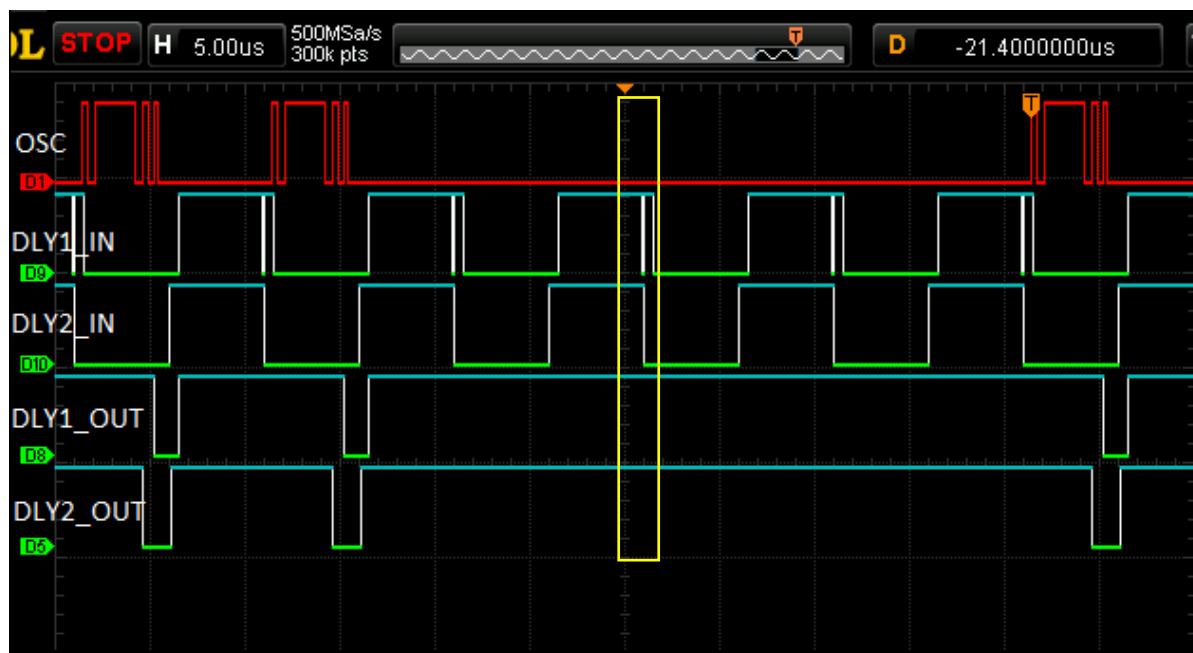
Figure 17 shows a series of DLY output events are missing, where the OSC is correspondingly not triggering when it was supposed to. Figure 18 is a zoom in of the boxed region from Figure 17. The total glitch/chatter time was measured in this case at 152 ns. By using the composite OR of the two delay channels, we can asynchronously strobe with tiny frequency variations, and so tune the timing to induce this errata. Note that the error is not persistent – the system is recovered when all DLYs are returned to inactive state, such as when input of falling edge DLY goes high, thus canceling delay, or after DLY out finishes.

Figure 17: Errata Capture (Zoom Out)

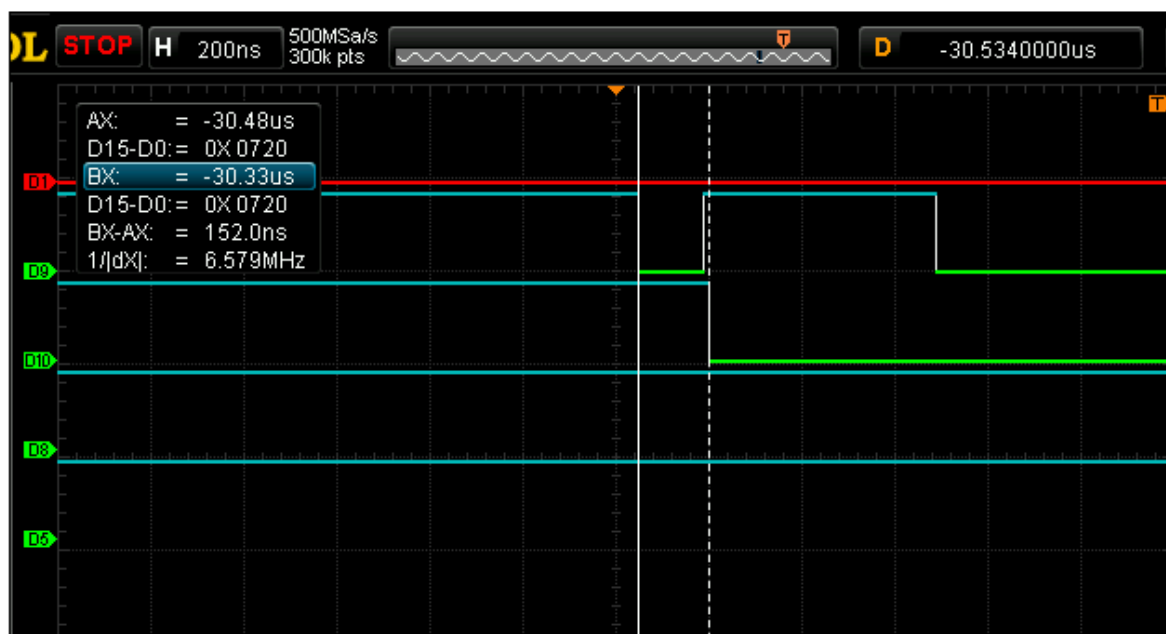
Figure 18: Errata Capture (Zoom In)

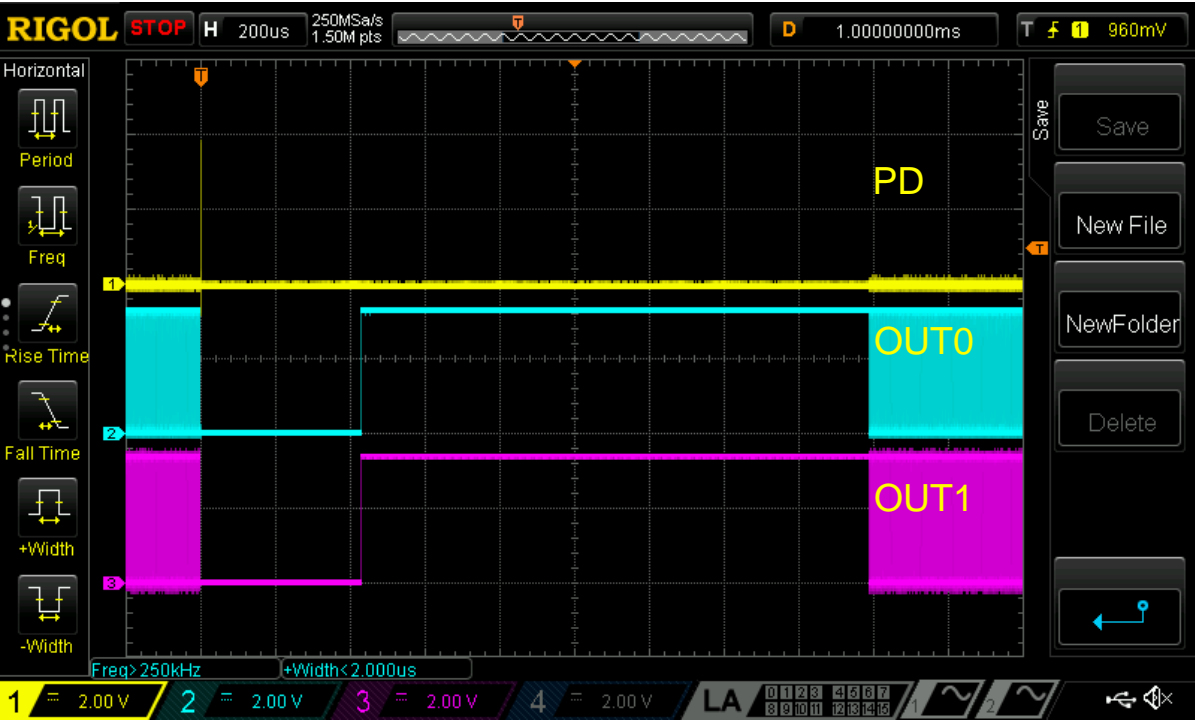
If a pulse with a duration of less than ~40 ns is applied to the PWR DOWN input of the oscillator, the oscillator outputs remain stuck for milliseconds, as shown in figures below. The issue is observed for all available oscillators.

Figure 21. 2 MHz OSC Long Start-Up

Change Fast start-up setting to Enable or omit applying glitches at PWR DOWN input in OSC.

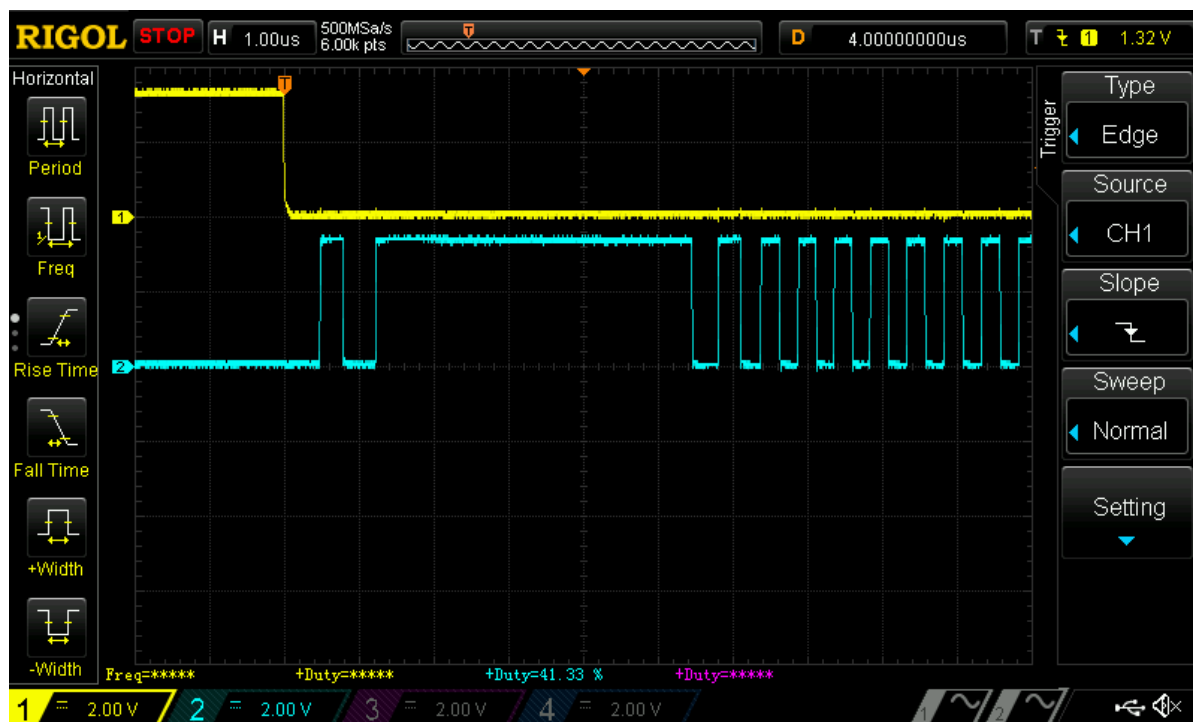
2 MHz OSC has an additional ~ 9 cycles settling period. Higher VDD shows longer settling time.

Figure 23. Channel 1 – OSC Power Down; Channel 2 –OSC output

Such behavior will lead to substantial error in period calculations if the delay time is relatively small.

Enable Fast Start-up option. Fast Start-up means forcing bias ready at the power-up instead of automatic enabling at OSC event. The standby current consumption difference between Fast start-up disabled and enabled is only an additional 300 nA.

Use the “Force power on” OSC power control option to make the OSC operate at all times. However, this will cause increased constant current consumption.
