SLG46583

ISSUE 1: Long 2 MHz OSC Settling Time Functional Blocks Affected: OSC, Counter, Delay

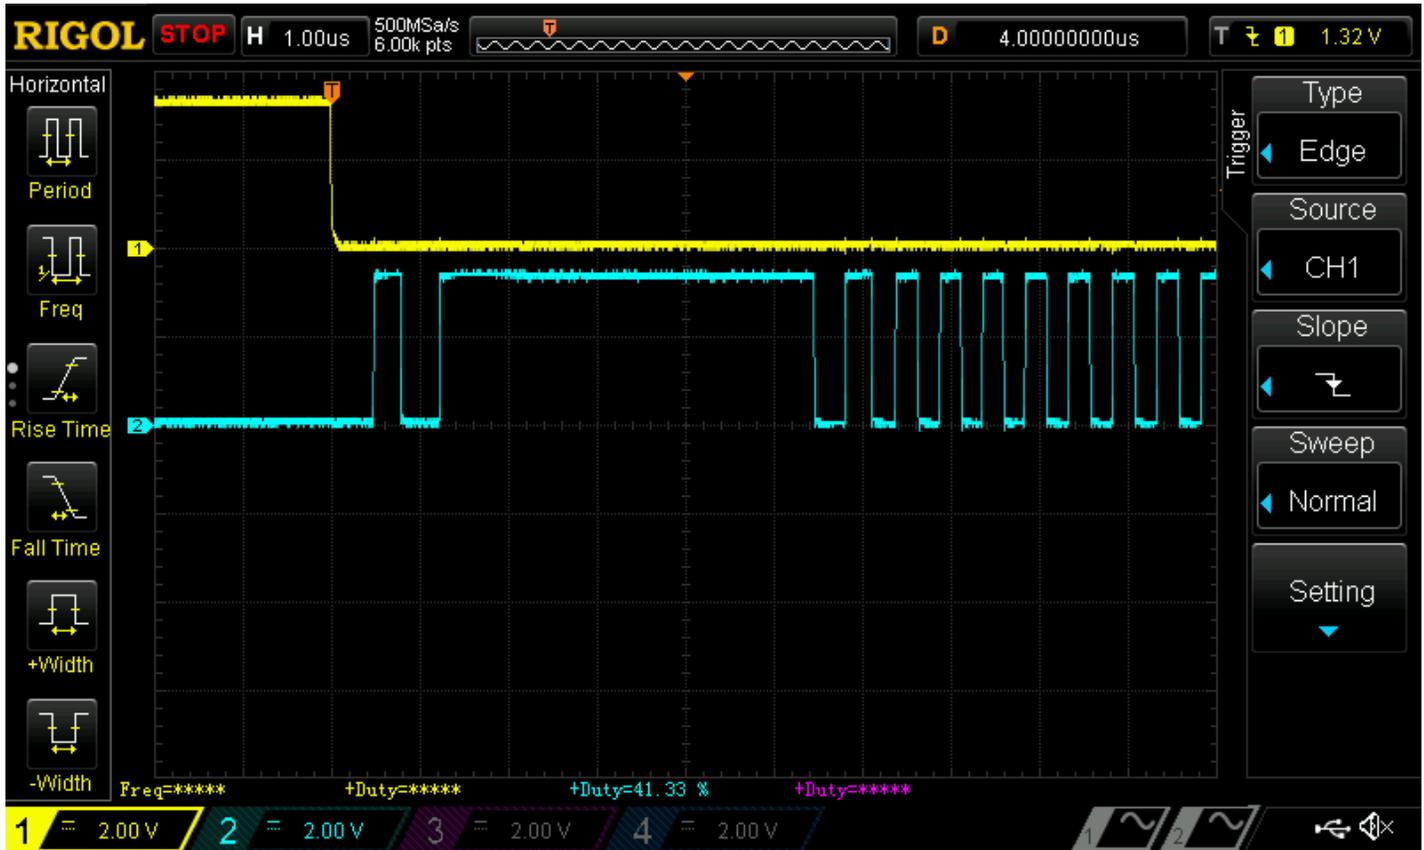
2 MHz OSC has an additional ~ 9 cycles settling period. Higher VDD shows longer settling time.

Channel 1 – OSC Power Down; Channel 2 –OSC output

Such behavior will lead to substantial error in period calculations if the delay time is relatively small.

- Enable Fast Start-up option. Fast Start-up means forcing bias ready at the power-up instead of automatic enabling at OSC event. The standby current consumption difference between Fast start-up disabled and enabled is only an additional 300 nA.
- Use the “Force power on” OSC power control option to make the OSC operate at all times. However, this will cause increased constant current consumption.

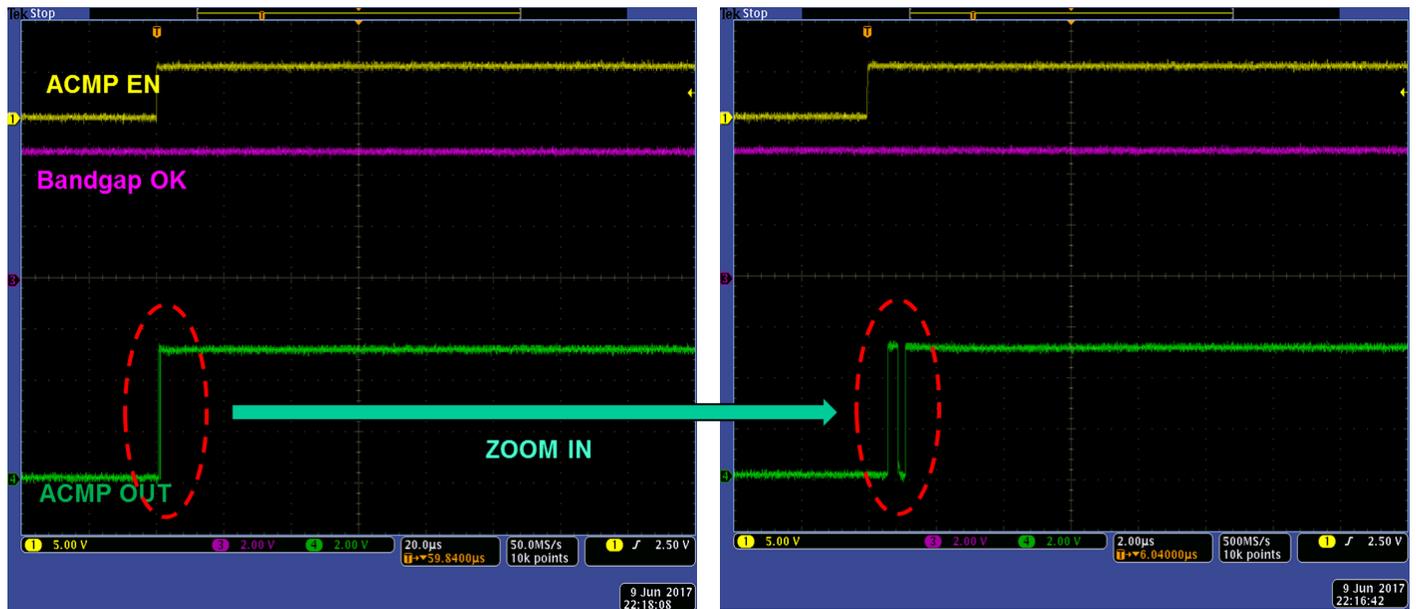
After power-up, if LDO is enabled earlier than ACMP, its output may generate a glitch.

VDD = 5.0 V, ACMP IN+ > IN-, one of LDOs enabled.

Because BG_OK is already released by LDO, there is no gating signal. Depending on the ACMP VREF condition & the positive input value, it is possible for the ACMP to have a glitch. Subsequently, the other ACMP will not have an issue unless the customer repeats LDO enable first and ACMP later during power stable.

- Use both edge delay on the output to filter out the glitch.

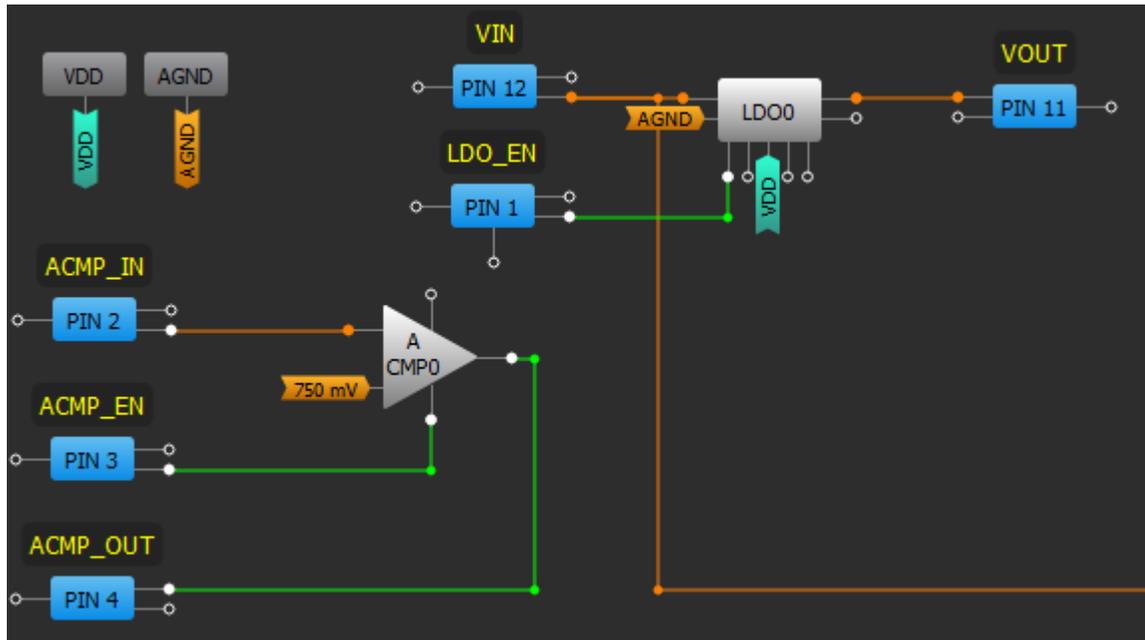
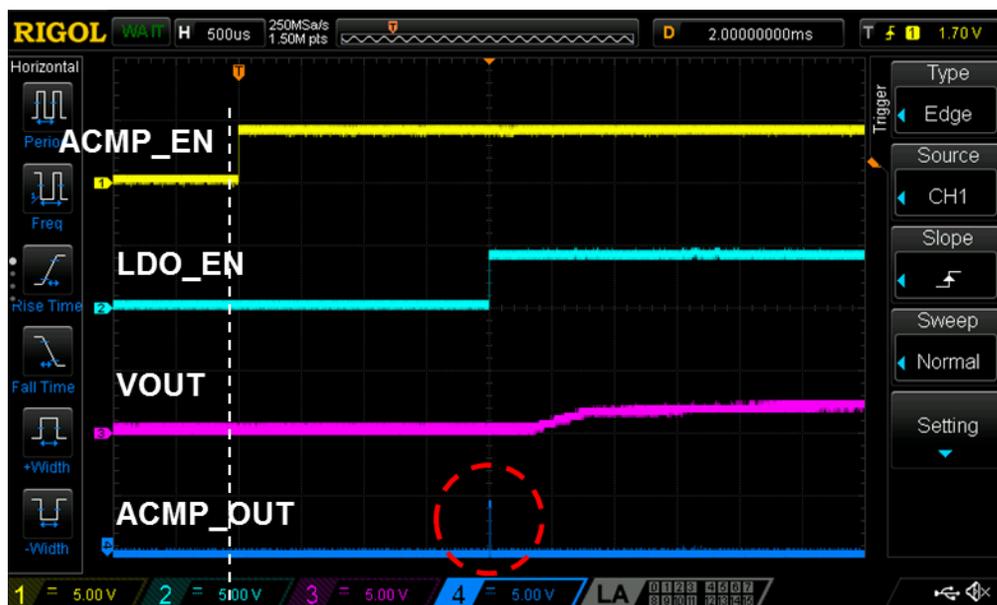
If an LDO's Low Power Mode is selected (for example tied to VDD) a glitch may appear on the ACMP's output after the first LDO is enabled. When the first LDO is turned on, the Low Power Mode switch causes a drop in the internal bandgap voltage that is used to derive the ACMP reference voltages.

- Use both edge delay on the output to filter out the glitch.
- Use some logic to avoid turning on Low Power Mode before enabling LDO and powering up the ACMP. Example is shown below.

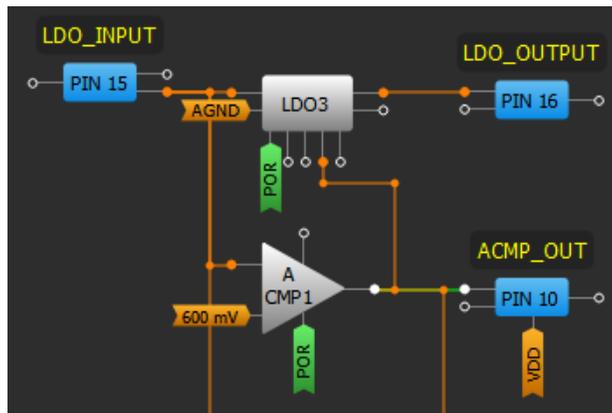
If an LDO’s VIN pin (LDO_INPUT) has an internal connection (depicted with an orange wire) to the ACMP’s IN+ port, the ACMP’s output may give an erroneous result with respect to the LDO’s input voltage. The switch between the LDO’s VIN pin and the ACMP’s IN+ port is implemented using an NMOS-only based transmission gate with its gate controlled by logic supplied from VDD. As a result, this switch is unable to pass LDO input voltages that are close to VDD. This can result in the ACMP’s IN+ port seeing a lower voltage than the actual voltage present at LDO_INPUT. This lower input voltage may cause the output of the ACMP to behave unexpectedly.

If the LDO’s UVLO feature is enabled, the ACMP’s output will cause unexpected LDO behavior that results from the previously described transmission gate voltage drop.

- If the GreenPAK's VDD is always powered up before the LDO's VIN input, you can externally short the LDO's VIN to another dedicated analog input pin for the desired ACMP.

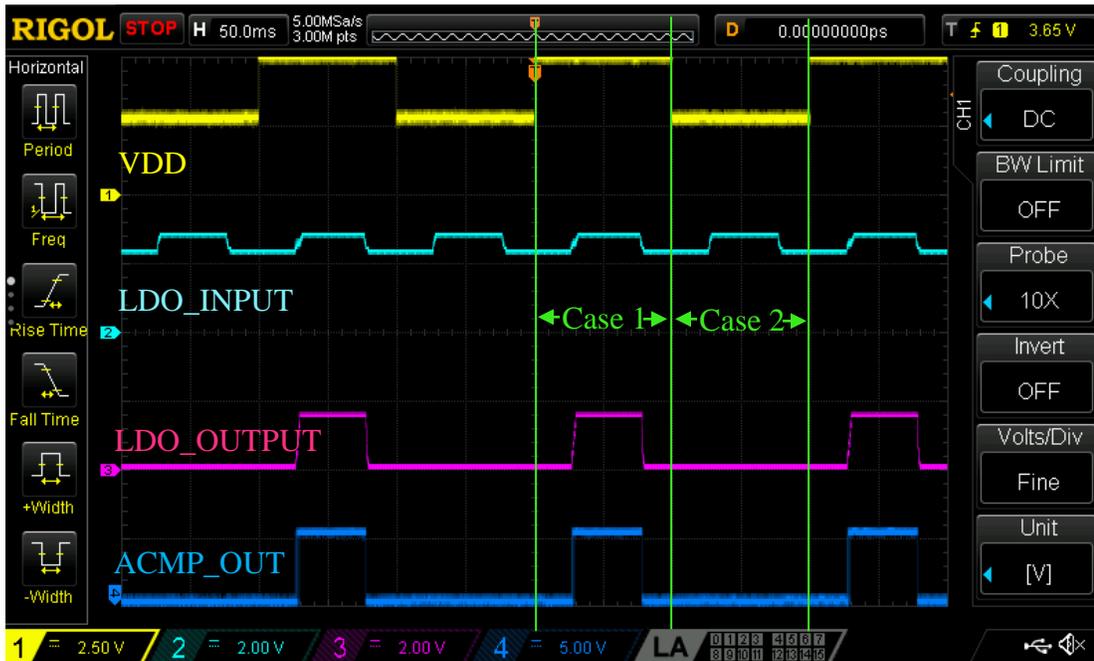
Case 1: proper behavior at VDD = 5 V.

With a 5 V VDD, the NMOS transmission gate passes the 2.25 and 2.75 V LDO_INPUT pin voltages to the ACMP's IN+ port. When the input voltage exceeds the 2.4 V IN- threshold of the ACMP, the LDO is enabled.

Case 2: erroneous behavior at VDD = 2.75 V.

When the VDD is reduced to 2.75 V, the NMOS transmission gate is unable to pass LDO_INPUT's full magnitude to the ACMP's IN+ port. Since the IN+ port of the ACMP doesn't exceed the 2.4 V IN- threshold, the ACMP's output stays low and keeps the LDO disabled.

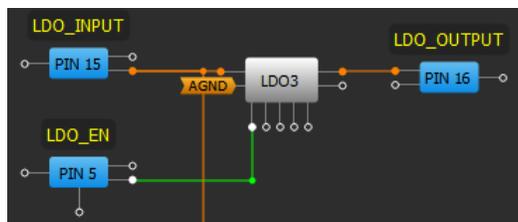
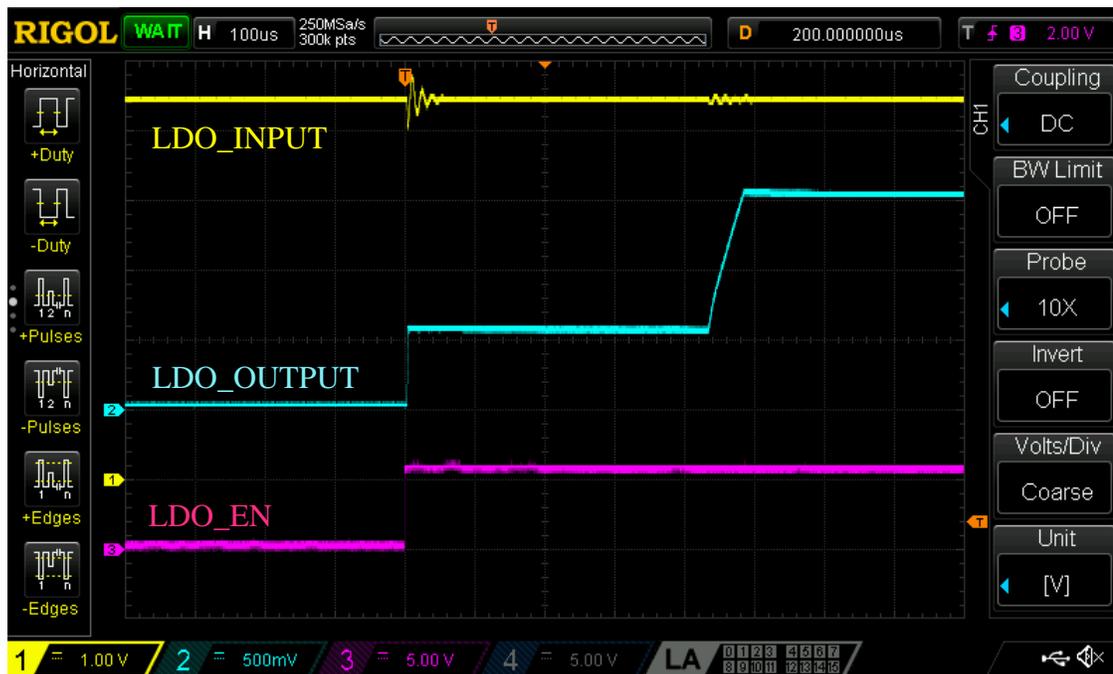
When a GreenPAK's first LDO is enabled, the LDO's VOUT will step to a non-zero voltage during its 500 μ s wait time. The magnitude of this step is directly proportional to the LDO's VIN and the GreenPAK's VDD. With a large LDO input voltage and VDD, this step can exceed 500 mV.

VDD = 5.5 V, LDO_INPUT = 5.5 V, all other LDOs disabled.

- If your GreenPAK design has an unused LDO, you can reduce the magnitude of this voltage step by keeping an unused LDO enabled in high power mode.

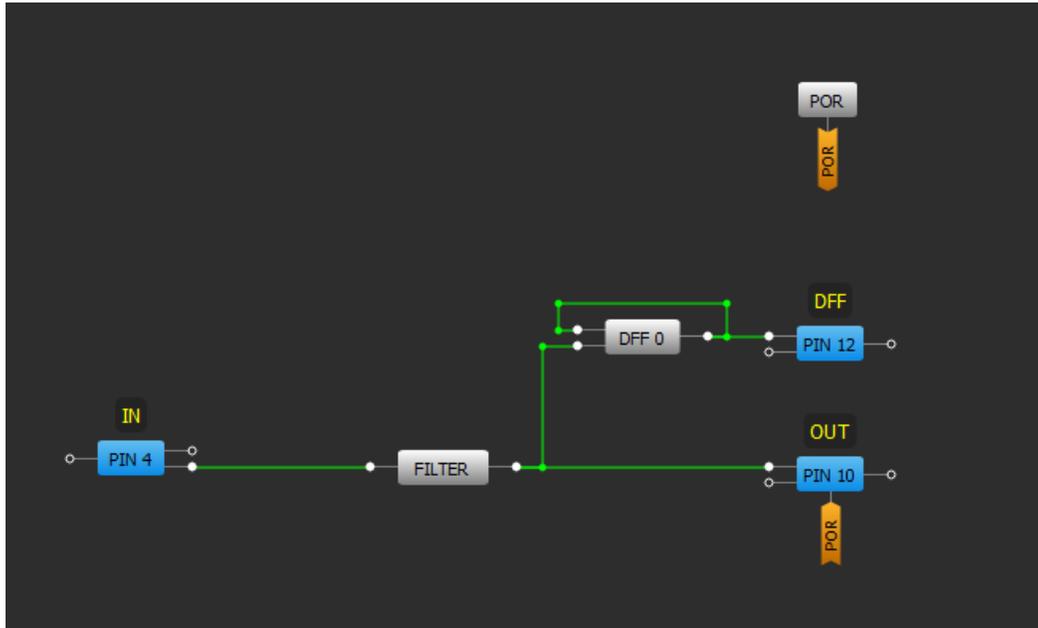
If the FILTER cell's input signal contains multiple consecutive pulses within short time intervals, the FILTER cell may not filter the input pulses as expected. The errant behavior applies only to repeated input pulses and depends on both their frequency and duty cycle.

Channel 1 (yellow/top line) – PIN#4 (IN).
 Channel 2 (light blue/2nd line) – PIN#10 (OUT).
 Channel 3 (magenta /3rd line) – PIN#12 (DFF).

Currently, there is no workaround for this issue. The FILTER block correctly filters isolated glitches, but it shouldn't be used to filter repetitive, high frequency input signals.

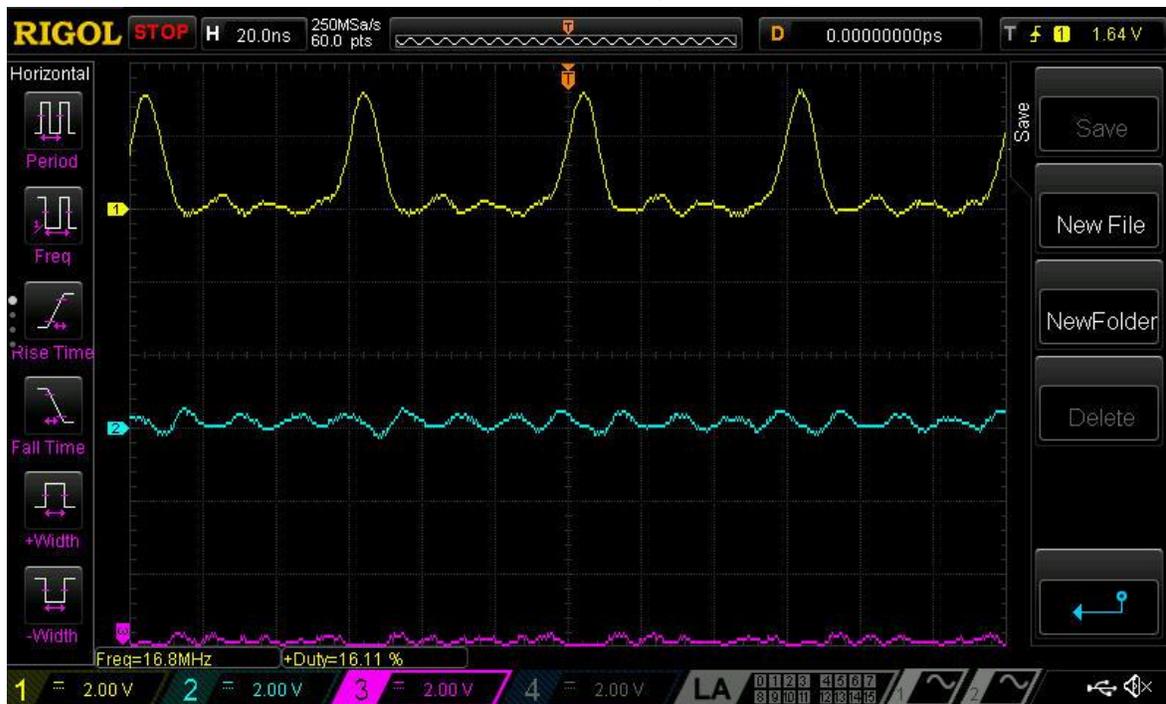
1. Period is 60 ns. Pulse width is 10 ns, DC = 16.7 % (correct functionality).

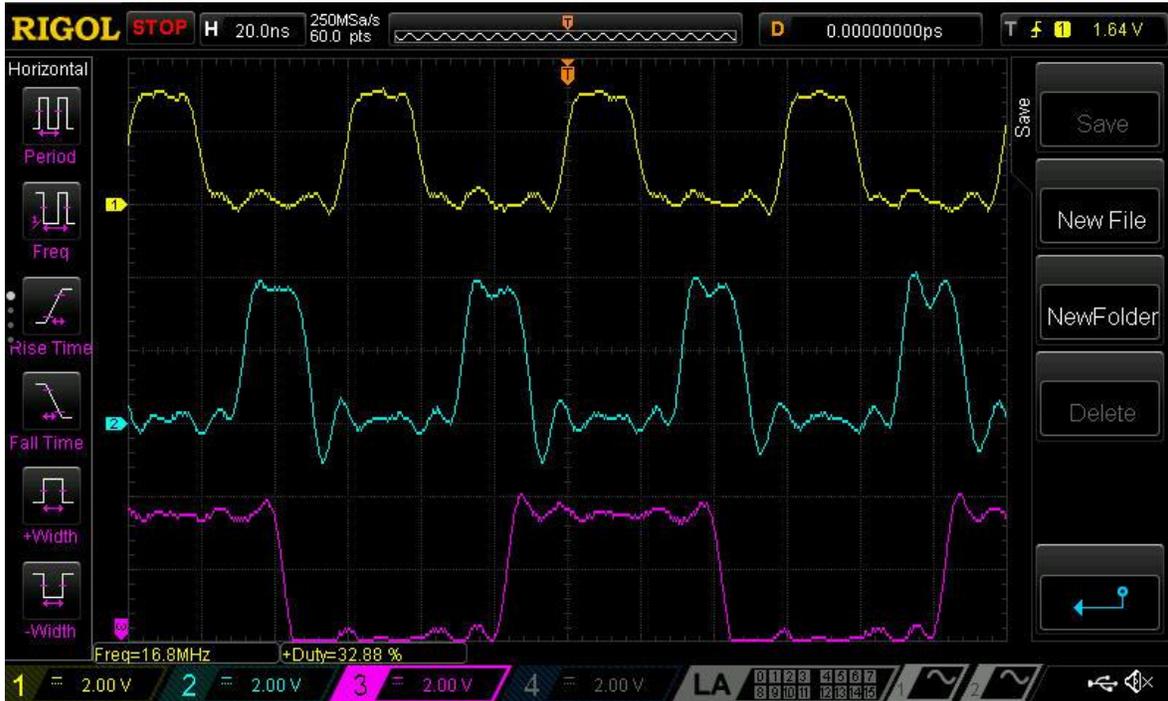
- Period is 60 ns. Pulse width is 20 ns, DC = 33.3 % (incorrect functionality).

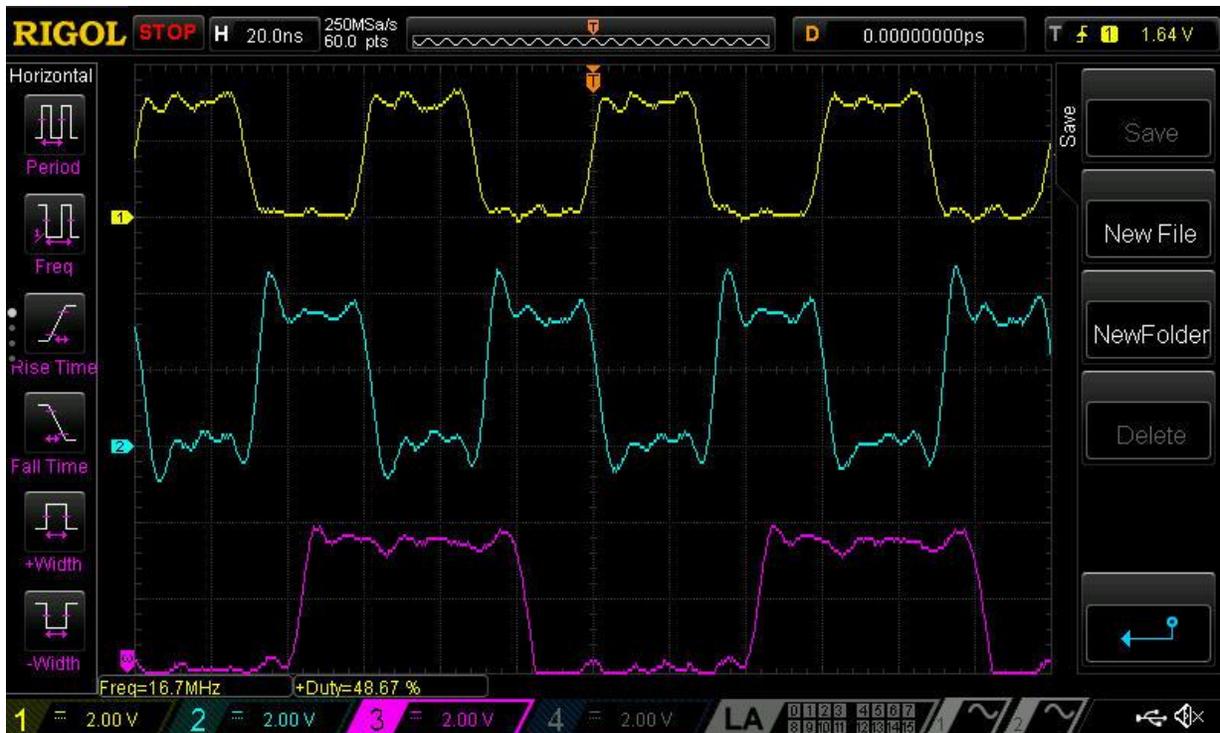
- Period is 60 ns. Pulse width is 30 ns, DC = 50 % (incorrect functionality).

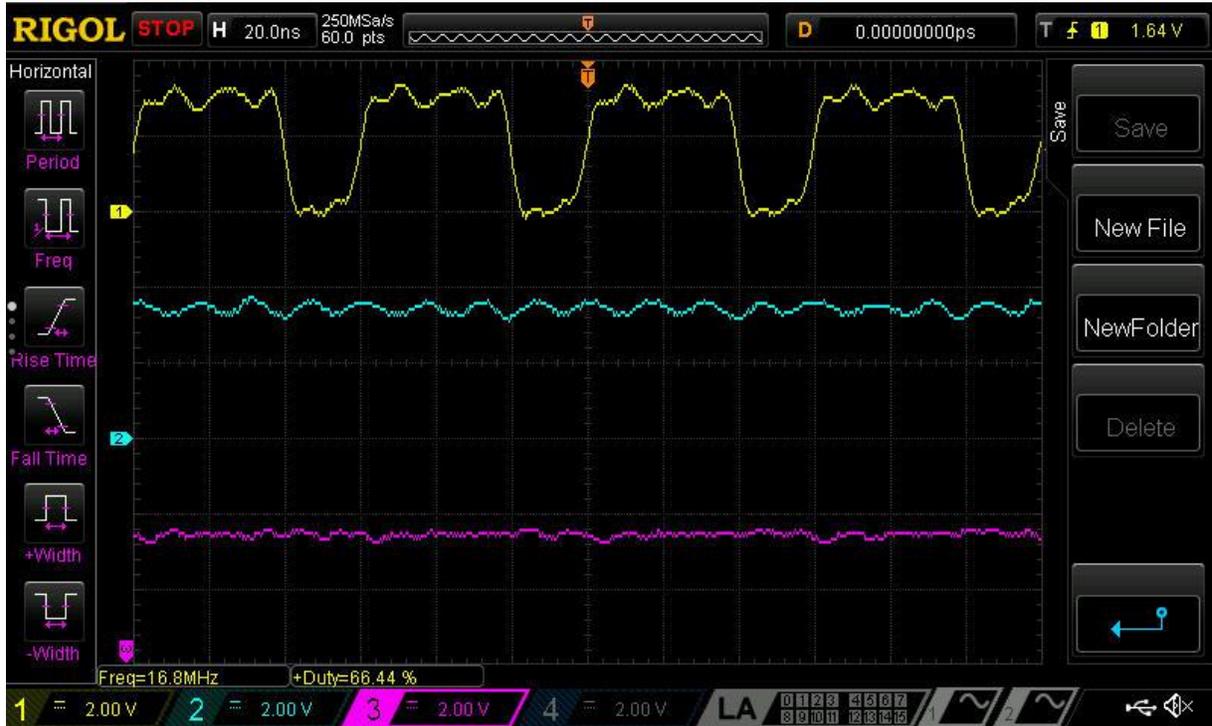
4. Period is 60 ns. Pulse width is 40 ns, DC = 66.67 % (correct functionality).

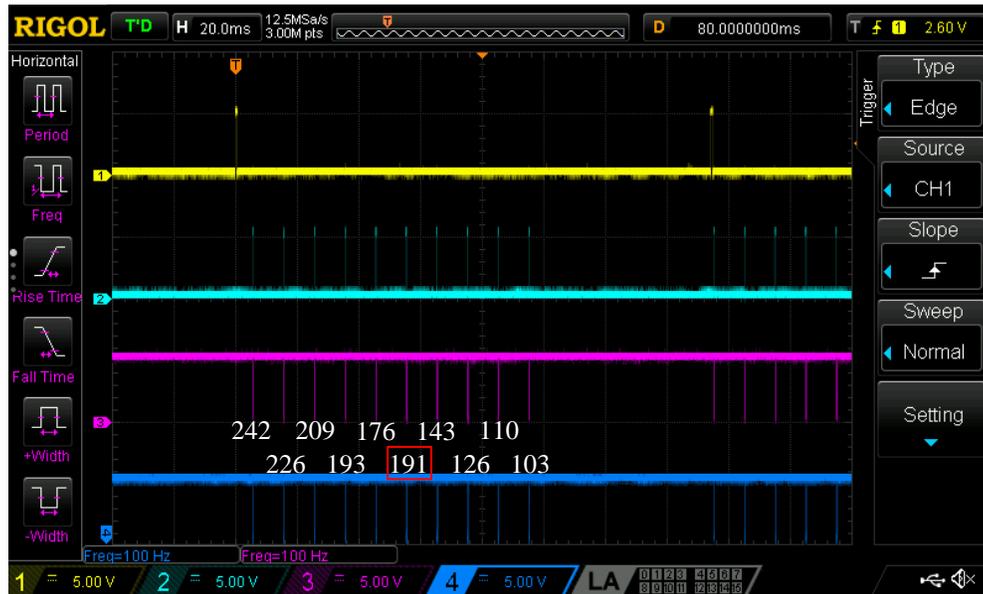
Asynchronous interaction between the CNT/DLY clock input and the I²C latch signal (generated by an I²C read command of the CNT/DLY block's count value) can result in an incorrect I²C data read. The CNT/DLY block will count accurately, but the count value transferred into the block's I²C read register might be loaded incompletely if the I²C latch signal and the clock input occur at about the same time.

The example data capture below shows ten periodic I²C reads of CNT2/DLY2 configured to count down at about 16 clocks per read. The sixth read sample erroneously shows a value greater than that of the fifth. The seventh sample reads as if the previous I²C error never occurred - the difference from the fifth sample (176) to the seventh (143) is 33 clocks or 16 clocks + 17 clocks as expected.

- Channel 1 (yellow/top line) – PIN#2 (CNT2/DLY2 Out).
- Channel 2 (light blue/2nd line) – PIN#1 (I²C Read Triggers).
- Channel 3 (magenta /3rd line) – PIN#8 (I²C SCL).
- Channel 3 (dark blue /4th line) – PIN#9 (I²C SDA).

If the possibility of incorrect I²C data reads can't be accommodated for by external software checks, one can guarantee proper operation by stopping the CNT/DLY block's clock during I²C reads through one of the following methods: by disabling the oscillator block, by reconfiguring the CNT/DLY block's clock source, or by gating an external clock using a LUT (Look-up Table) in the signal matrix. After disabling the CNT/DLY block's clock, the count registers can be read without error. Please note that this workaround will add the I²C read and processing time to the counter's overall clock period.

The best workaround depends on the resource constraints of the application. If the oscillator block doesn't clock other logic elements within the design, a matrix output can be used to manually power down the oscillators for the I²C read. When the CNT/DLY block's clock source is routed internally from the oscillator block, I²C commands can temporarily reconfigure the CNT/DLY block's clock source registers to select "Ext. CLK. (From Matrix)." This action will disable the clock by connecting it to ground. If the CNT/DLY block is clocked from the signal matrix, a LUT can be used to gate the clock during an I²C read.

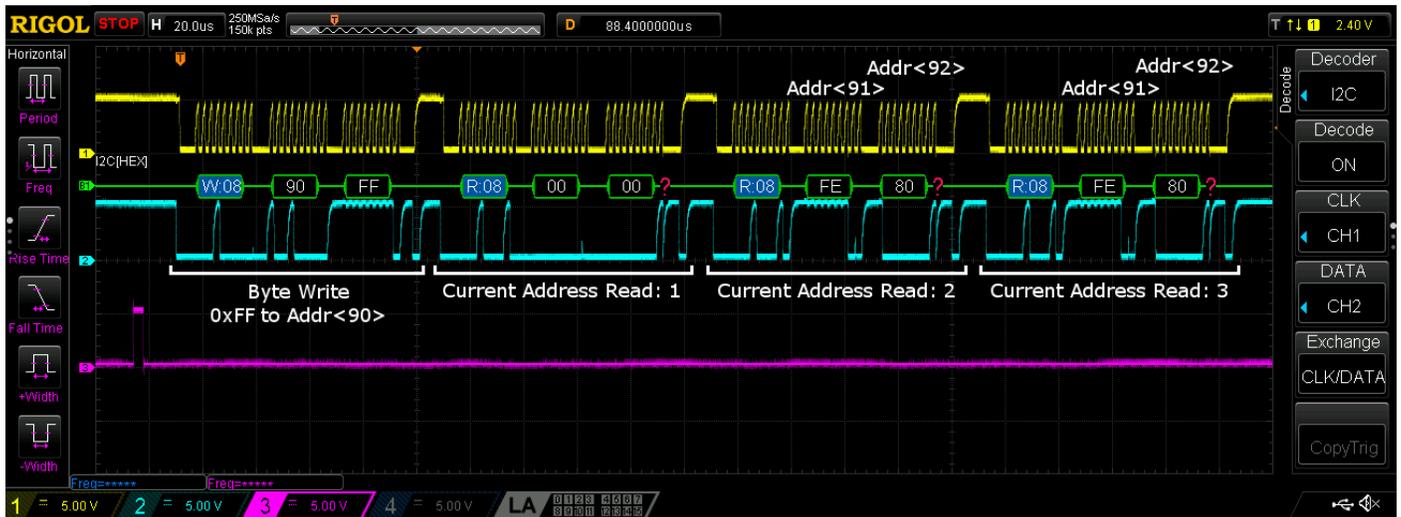
The first “Current Address Read” or “Sequential Read” command following an I²C “Byte Write” or a “Sequential Write” command will produce incorrect data. Additional read commands will return the expected data. See the waveform below for more information.

Channel 1 (yellow/top line) – PIN#8 (SCL).

Channel 2 (light blue/2nd line) – PIN#9 (SDA).

Channel 3 (magenta/3rd line) – I²C Software Trigger.

Note: In the GreenPAK test design, Addr<91> and Addr<92> expect FE and 80 respectively.

If possible, use the “Random Read” command as described in the datasheet for SLG46583. This command will output the correct data.

If you expect consecutive reads of the same register, we recommend sending a “Random Read” command to the register preceding the register of interest. After the “Random Read” command finishes, the chip’s register pointer will increment to the desired register and the following “Current Address Read” or “Sequential Read” commands will produce the correct data. Note that the “Current Address Read” and “Sequential Read” commands don’t increment the GreenPAK’s register pointer.

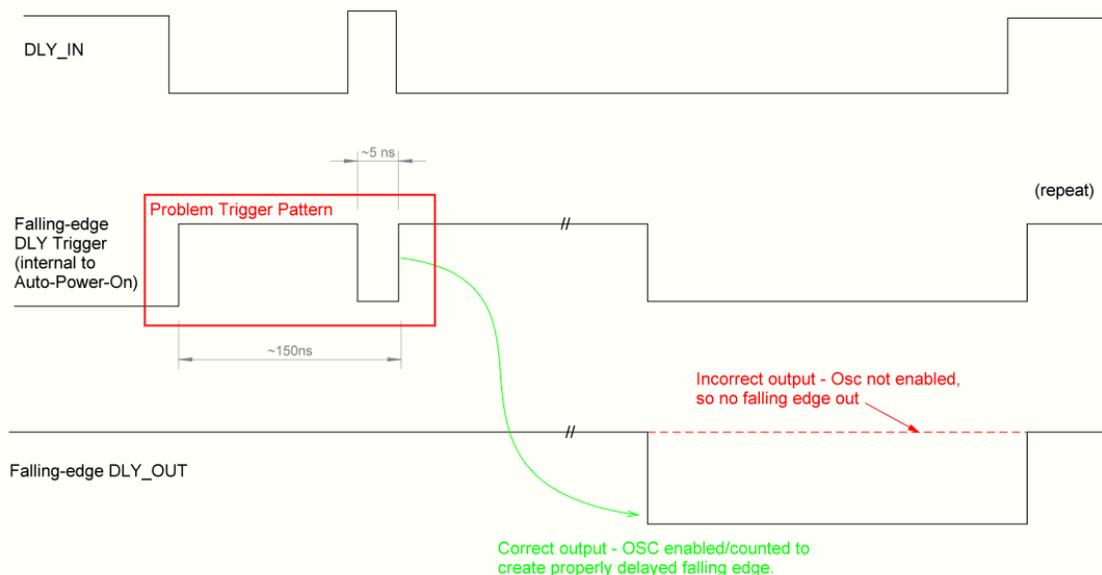
Figure 1: Problem Trigger Pattern

For this chip, the Auto Power On circuitry of the 25 kHz/2 MHz generators contains a circuit errata, which can potentially fail to power on the OSC for a specific pattern and timing of the OR of all related DLY trigger signals. The pattern is shown in [Figure 1](#) (boxed in red) and consists of a relatively longer pulse (~145 ns) followed by a shorter (~5 ns) glitch of opposite polarity.

1. Use signal conditioning circuits to prevent glitch on DLY inputs < 200 ns. Examples:
 - a. ACMP with Hysteresis
 - b. External RC in front of Digital Input with Schmitt Trigger
 - c. Filter cell.
2. Set OSC power mode to Force Power On mode instead of Auto Power On.

3. Use different oscillator, such as 25 MHz Ring OSC, which does not have Auto Power On issue.

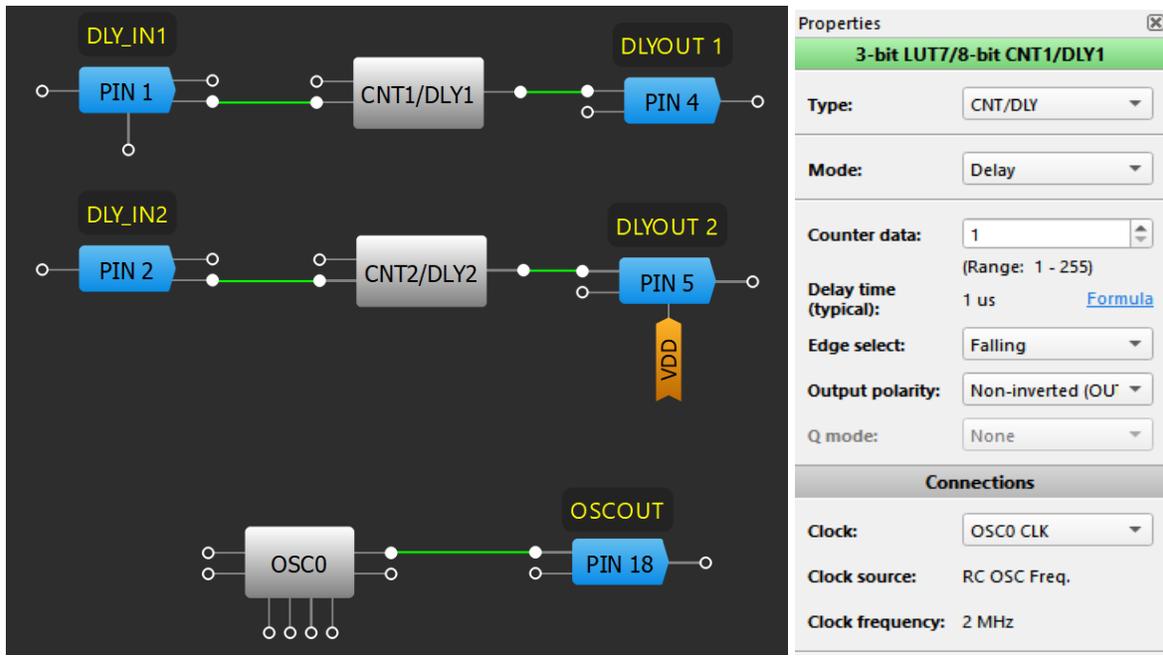
Figure 2: Test Circuit

The error is difficult to capture as the timing must be exact within ns, and short (ns) pulses are difficult to generate glitch precise enough to induce the problem. GPIO naturally filter out ns pulses, so for purposes of errata capture, two simultaneous falling-edge DLY circuits (as shown in Figure 2) were used. By lining up two delays precisely at a particular timing relationship, we can use the internal Auto Power On (OR logic) to generate the glitch pattern necessary to cause the error.

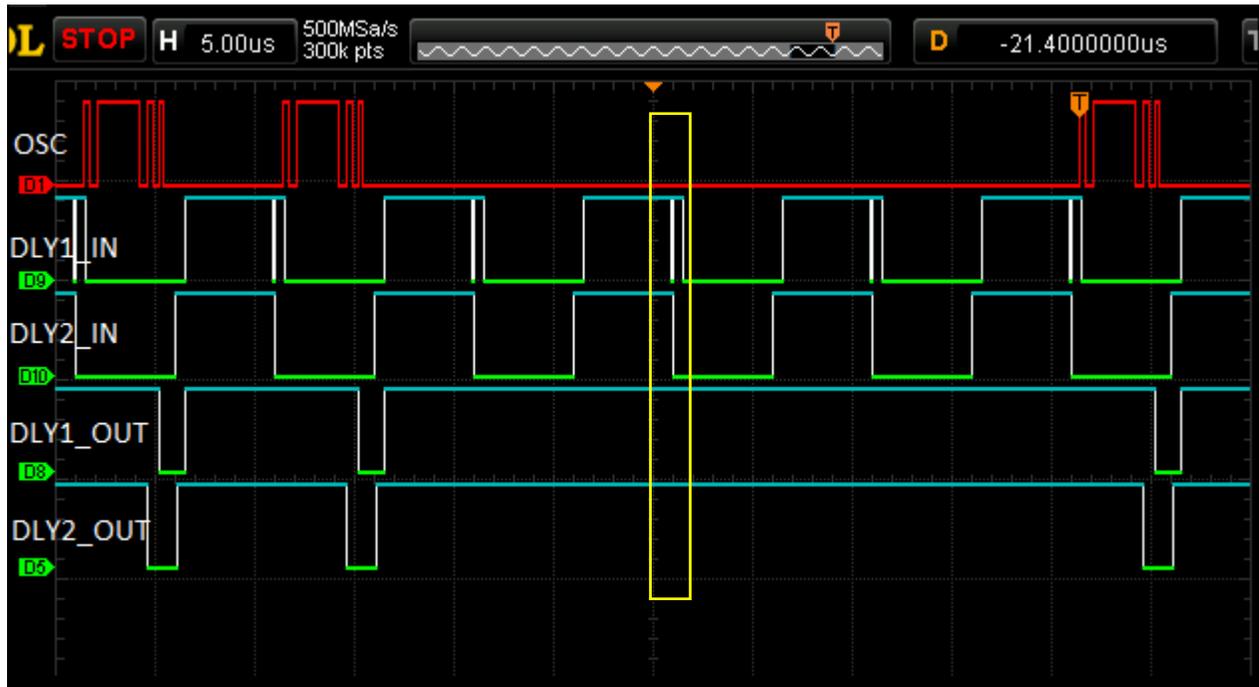
Figure 3: Errata Capture (Zoom Out)

Figure 3 shows a series of DLY output events are missing, where the OSC is correspondingly not triggering when it was supposed to. Figure 4 is a zoom in of the boxed region from Figure 3. The total glitch/chatter time was measured in this case at 152 ns. By using the composite OR of the two delay channels, we can asynchronously strobe with tiny frequency variations, and so tune the timing to induce this errata. Note that the error is not persistent – the system is recovered when all DLYs are returned to inactive state, such as when input of falling edge DLY goes high, thus canceling delay, or after DLY out finishes.
