## Product Change Notice (PCN)

**Subject:** RA2E2 group I3C function revision

**Publication Date:** 2/24/2022

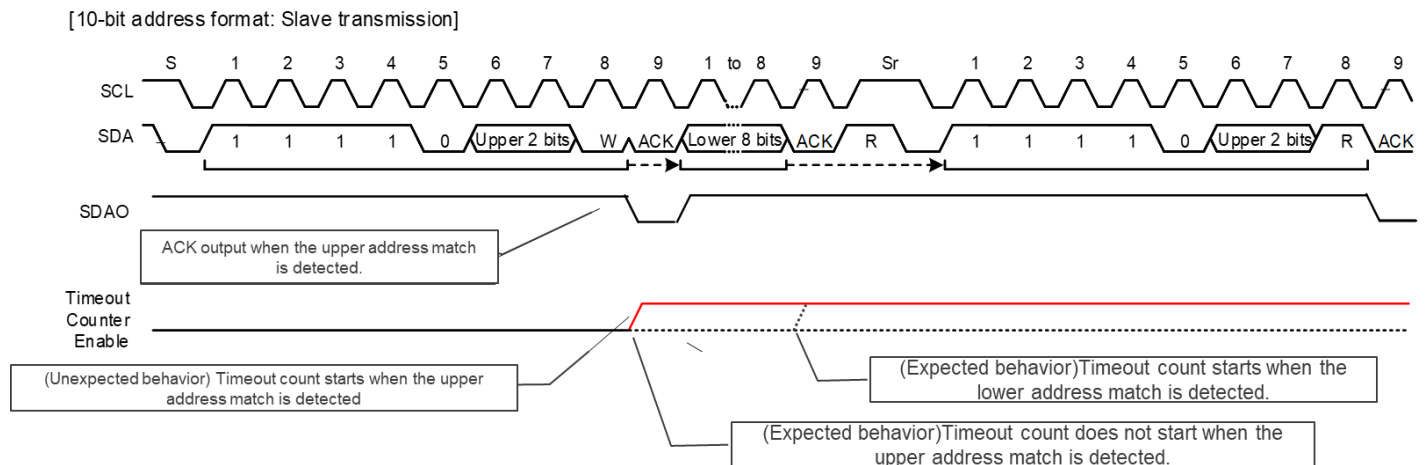
## #2 : I<sup>2</sup>C slave; Timeout count operation when 10-bit address communication and the upper address match is detected

In MCU Ver.1, the timeout count starts when 10-bit address communication and the upper address match is detected.

MCU Ver.2 is revised the circuit so that the timeout count does not start until the lower address match is detected after the upper address match is detected.

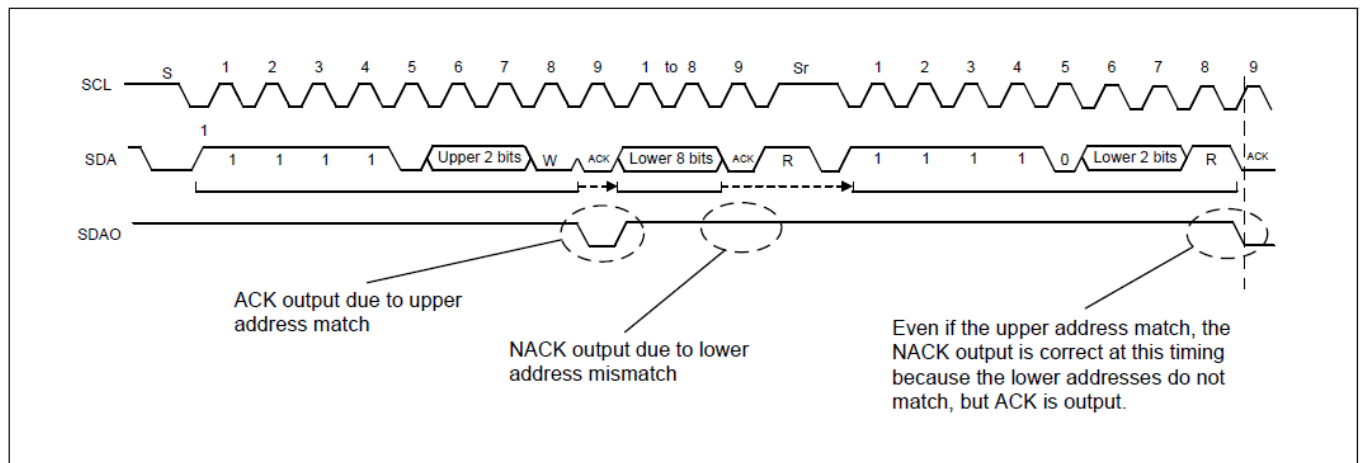
### #3 : I<sup>2</sup>C slave; ACK output operation when 10-bit address communication and the lower address mismatch is detected

MCU Ver.1 has the following restrictions and workarounds when using 10-bit address communication. The restrictions and workarounds are not required for MCU Ver.2

When multiple I<sup>2</sup>C slaves are connected to the I<sup>2</sup>C bus and there is a possibility that an I<sup>2</sup>C Slave other than this module will NACK for the upper address / R after Repeated START, there are the following restrictions and workarounds.

- Work around : Set the upper 2 bits of the 10-bit address assigned to this module to a value different from other Slave. If the address is exhausted and cannot be set to a different value, use restriction (1).
- Restriction (1) : 10-bit address not available.
- Restriction (2) : After the ACK response in the red circle in the above figure, none of the slaves respond to data, so the SDA keeps the high level and the I<sup>2</sup>C Master receives the 0xFF data. In the case of a system that can handle 0xFF as abnormal data, 0xFF is read and discarded on the I<sup>2</sup>C Master side. If 0xFF is valid data, use restriction (1).

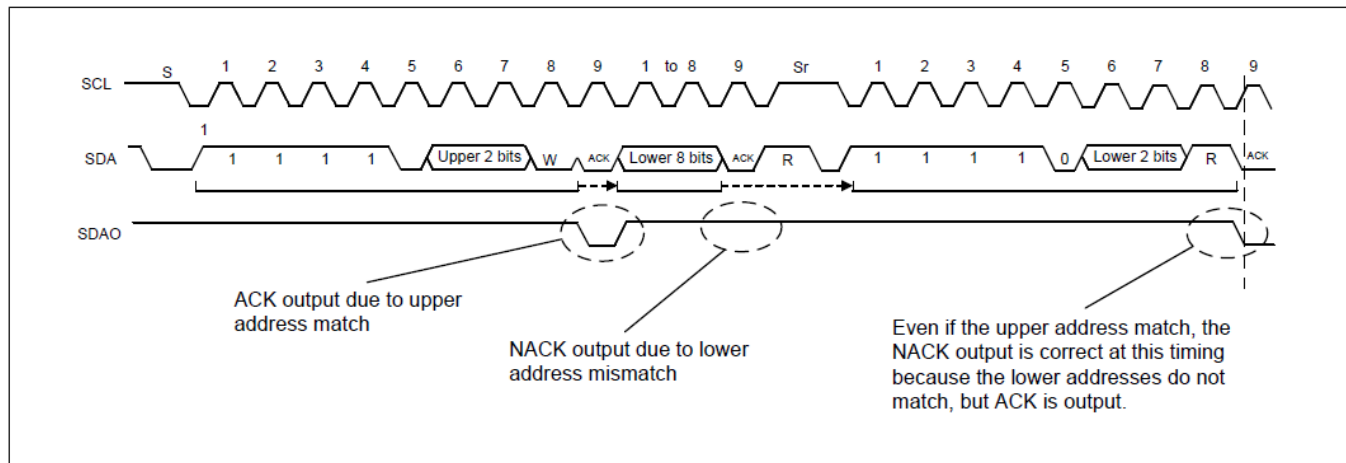
MCU Ver.1 has the following restrictions and workarounds. The restrictions and workarounds are not required for MCU Ver. 2.

When multiple I<sup>2</sup>C slaves are connected to the I<sup>2</sup>C bus and there is a possibility that an I<sup>2</sup>C Slave other than this module will NACK for the upper address / R after Repeated START, there are the following restrictions and workarounds.

- Work around : Set the upper 2 bits of the 10-bit address assigned to this module to a value different from other Slave. If the address is exhausted and cannot be set to a different value, use restriction (1).
- Restriction (1) : 10-bit address not available.
- Restriction (2) : After the ACK response in the red circle in the above figure, none of the slaves respond to data, so the SDA keeps the high level and the I<sup>2</sup>C Master receives the 0xFF data. In the case of a system that can handle 0xFF as abnormal data, 0xFF is read and discarded on the I<sup>2</sup>C Master side. If 0xFF is valid data, use restriction (1).

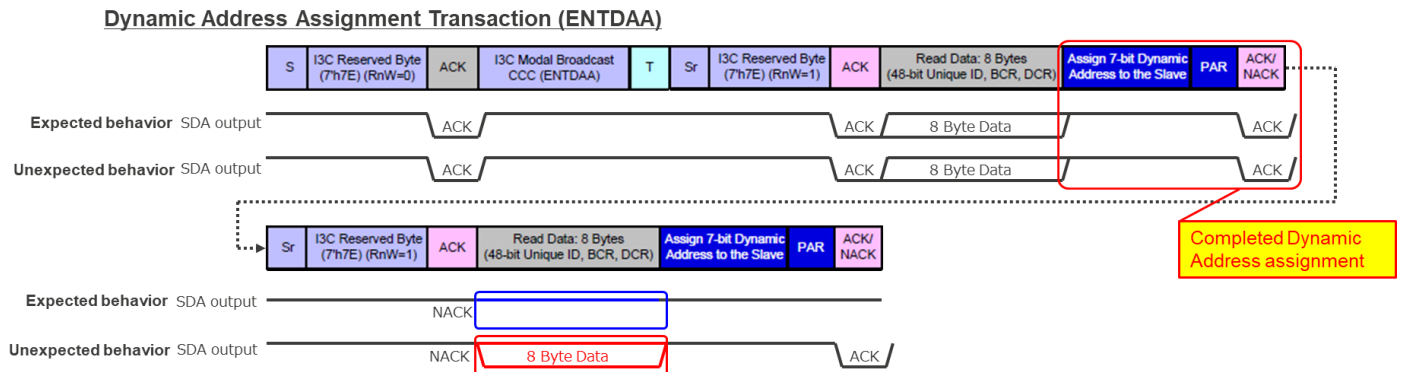
#### # 4 : I3C slave; Arbitration operation when Dynamic Address is assigned by the ENTDAAC command

In MCU Ver.1, if a dynamic address is assigned by the ENTDAAC command in I3C slave mode, I3C will participate in dynamic address arbitration in response to the ACK response of other slaves even after the dynamic address assignment.

MCU Ver.1 requires the restrictions and workarounds when assigning dynamic address, but the restrictions and workarounds are not required for MCU Ver.2.

Note: When multiple I3C (I3C Slave) are connected on the I3C Bus assign Dynamic Addresses in the following order.

1. Set the SDCTPIDH and SDCTPIDL registers (6 Bytes) of the I3C (I3C Slave) to a value (All 1 etc.) that has a lower priority than other Slave Devices by Dynamic Address Arbitration.
2. After setting the Static Address in the I3C (I3C Slave), assign the Dynamic Address using the SETDASA / SETAASA command.
3. Assign a Dynamic Address to an I3C Slave Device other than the I3C (I3C Slave) using the ENTDAAC command.

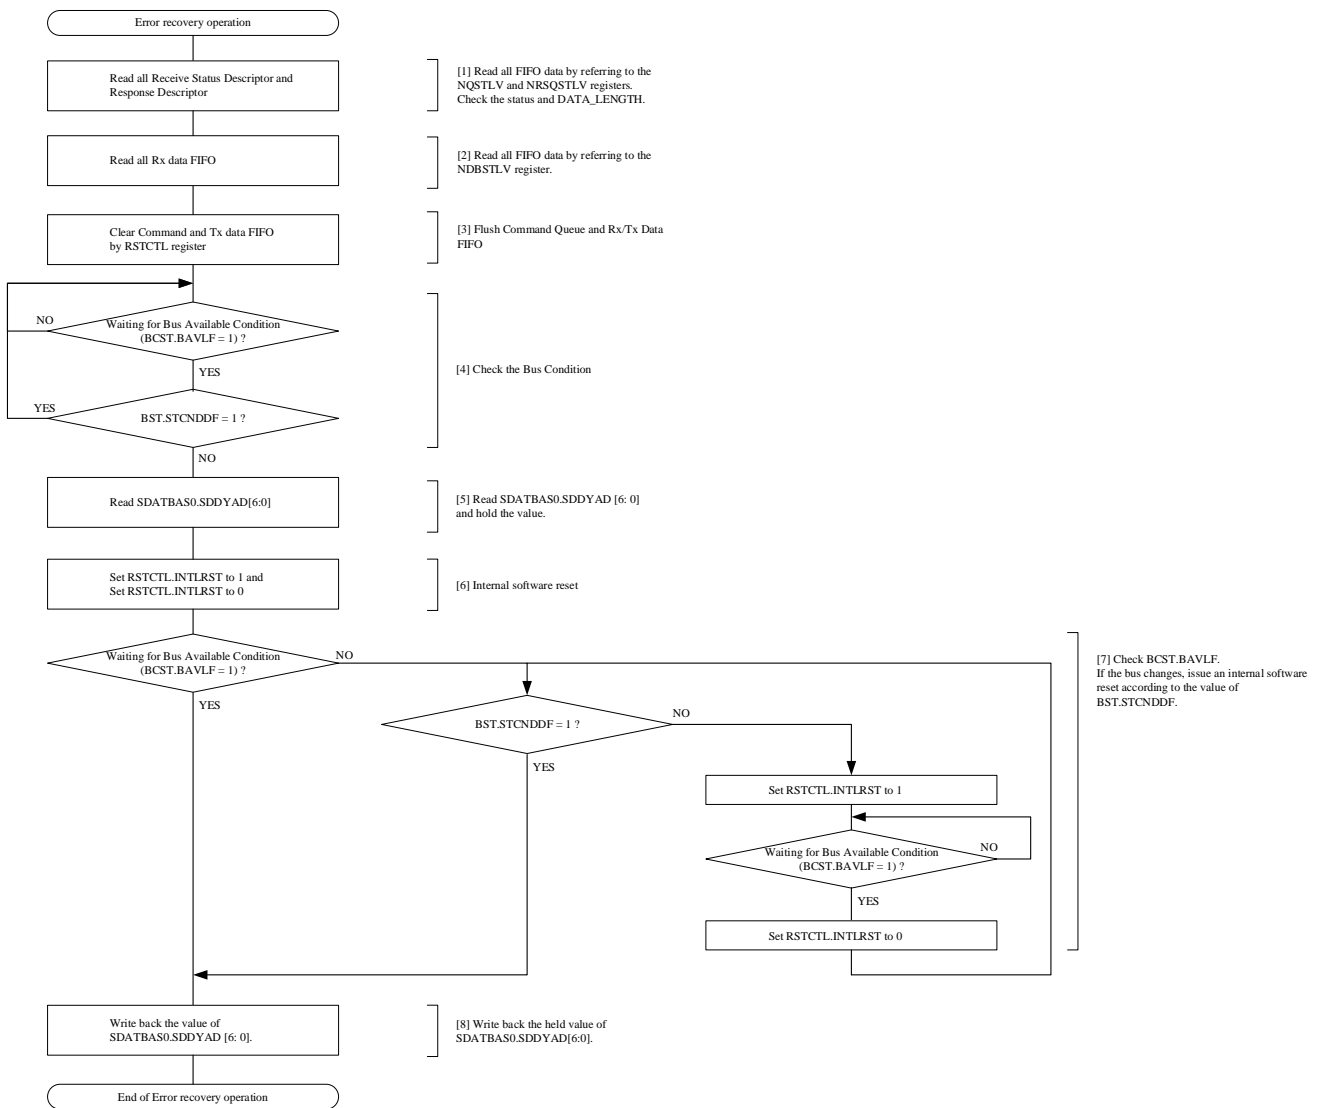
Figure 25.97 Example of error recovery operation flowchart for I3C slave

The I3C master must perform an error recovery flow according to the following case:

- When TEF is detected.

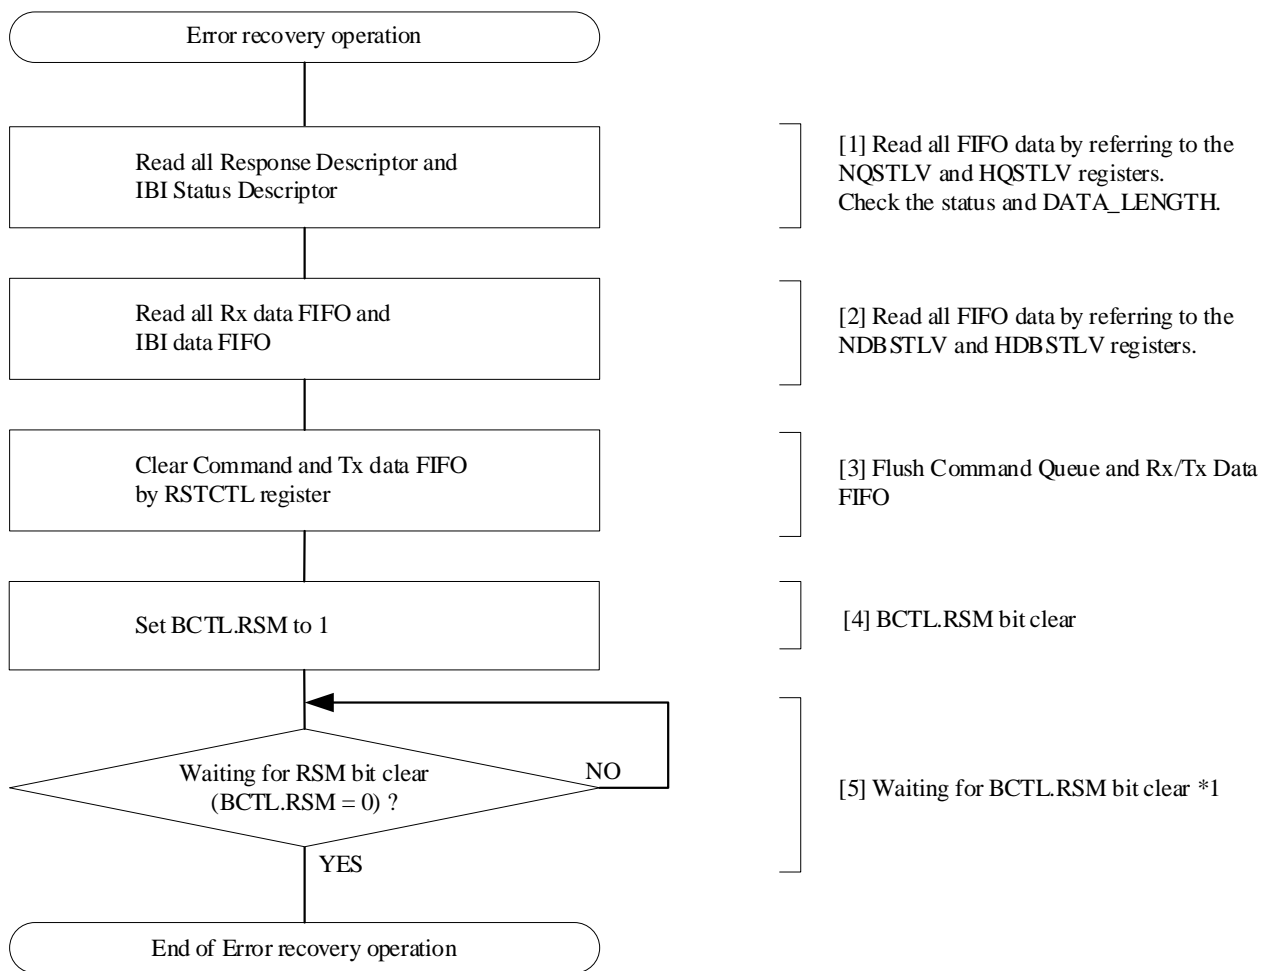
**Figure 25.96-2 Example of error recovery operation flowchart for I3C Master**

**Note:** For MCU Ver.2, apply the following error recovery flow.

If an error occurs, I3C will be suspended. (BCTL.RSM becomes 1.) After I3C is suspended, the application must write the value 1 to the BCTL.RSM bit to resume I3C operation and recover from the suspended state.

Note 1. It is possible to set the Command Descriptor while waiting for the RSM bit to be cleared.
