Errata

SLG46170

CE-GP-021

This document contains the known errata for SLG46170 and the recommended workarounds.

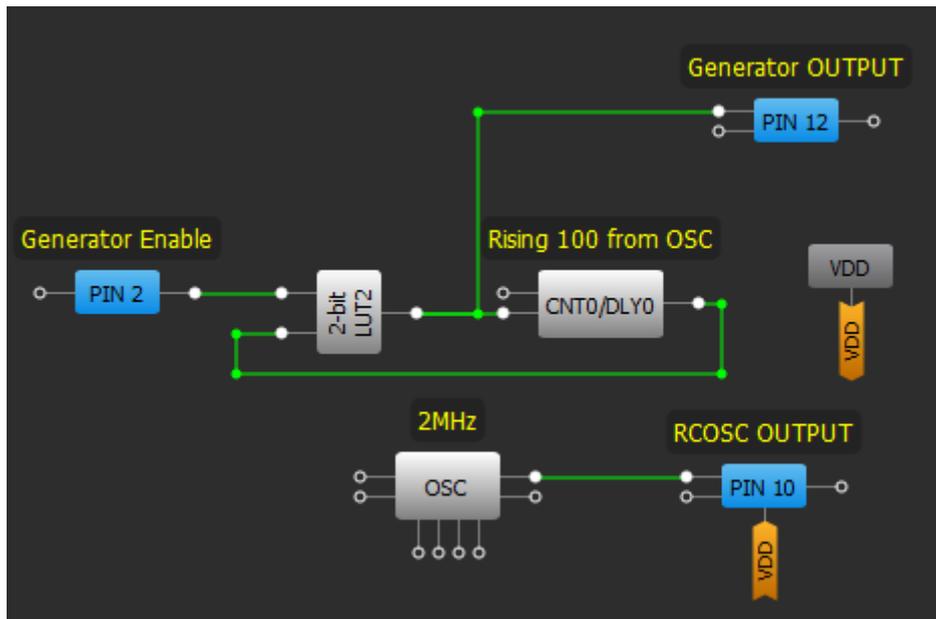
An example of such issue is in the following configuration:

The RC OSC has a longer settling time when configured as 2 MHz with Auto Power On in the designs that have very short RC OSC disable time.

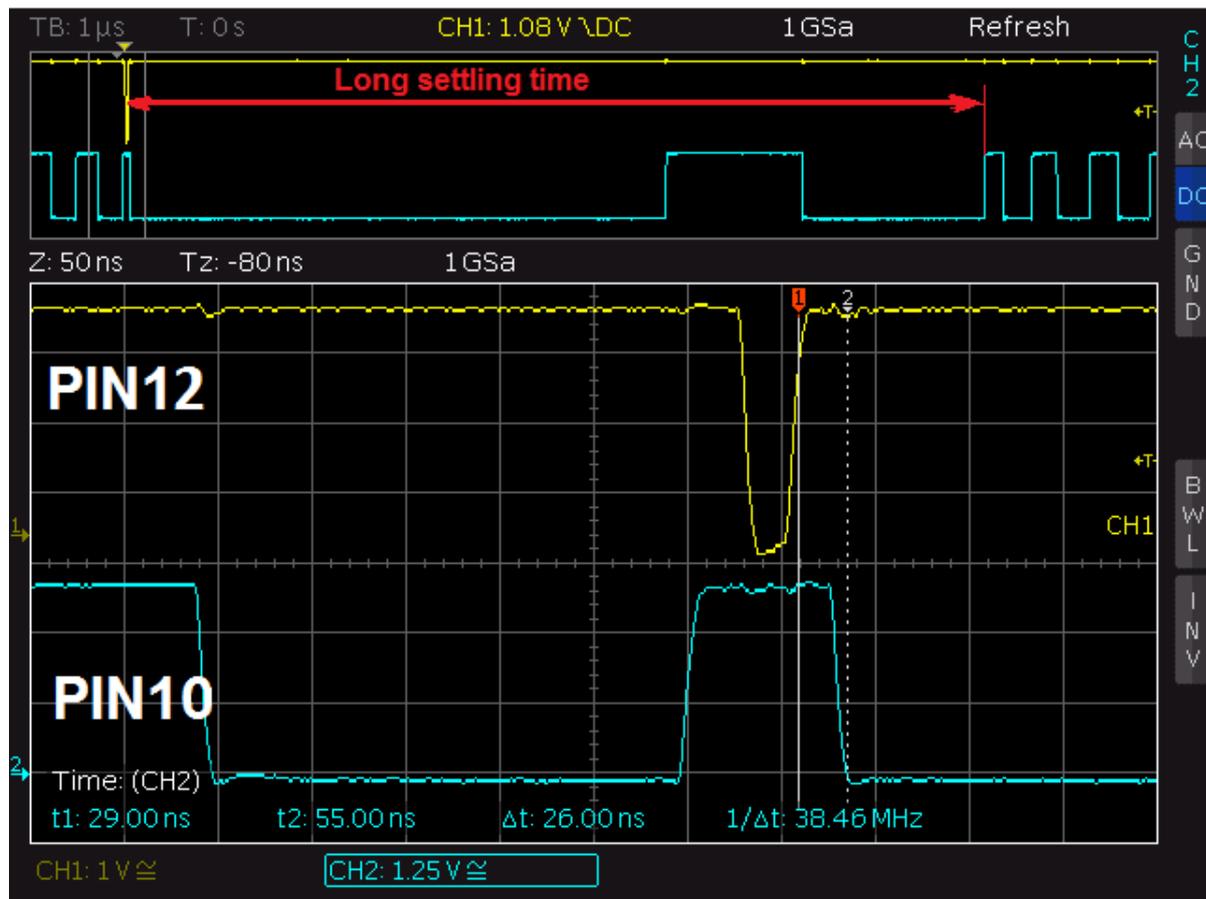
Channel 1 – 2-bit LUT0 output; Channel 2 – RC OSC output

The configuration shown above generates a periodical signal with a frequency defined by the Delay cell and started by a HIGH signal on PIN2. The issue becomes apparent in a longer settling time when the scheme generates short pulses (Delay is configured as a rising edge delay only). See waveform below.

Such behavior will lead to substantial error in period calculations if the delay time is relatively small.

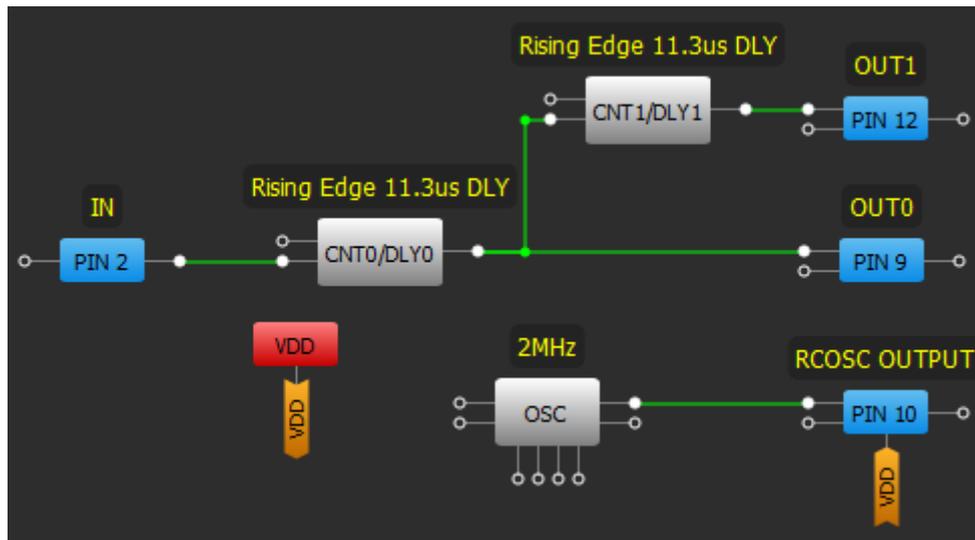
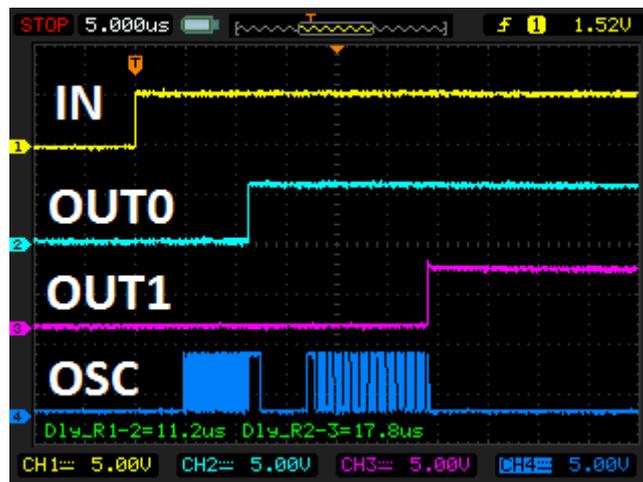
The same situation occurs while using two connected delays (all edge detect types except for a pair “Rising edge DLY – Falling edge DLY”).

In the following example, Delay0 and Delay1 are configured in the same way. However, Delay1 time is 17.8 us instead of expected 11.3 us (Delay0 time).

- using two delays in series (except for a pair “Rising edge DLY – Falling edge DLY”) use one Filter cell or P DLY between delay blocks. Using LUTs won’t help in this case.

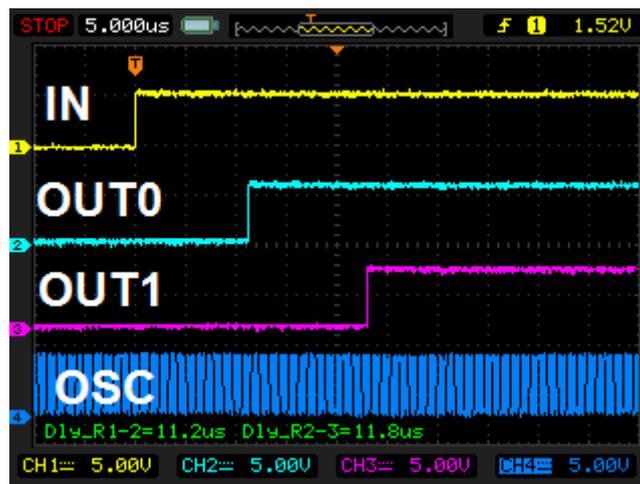
If there are some inner blocks which use RC OSC at the moment or RC OSC is forced power on when such error appears, RC OSC will be operational and delay value will be proper.

- use the “Force power on” RC OSC power control option to make the RC OSC operate at all times.

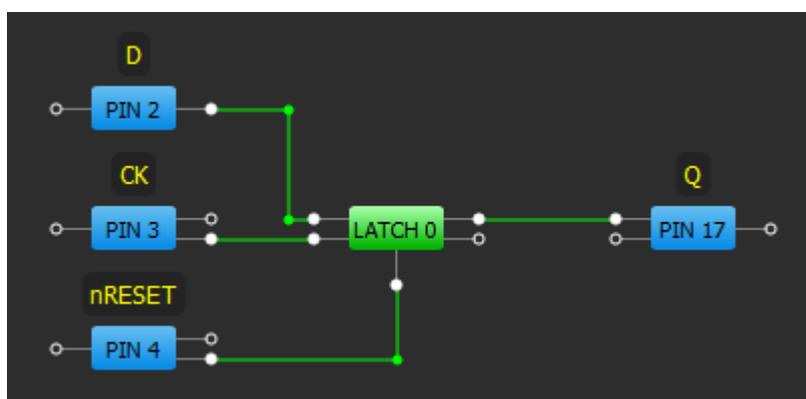
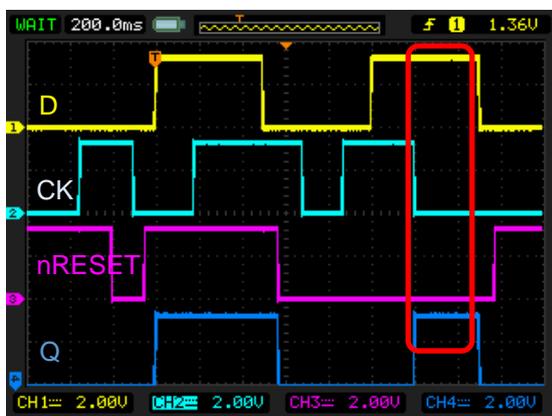
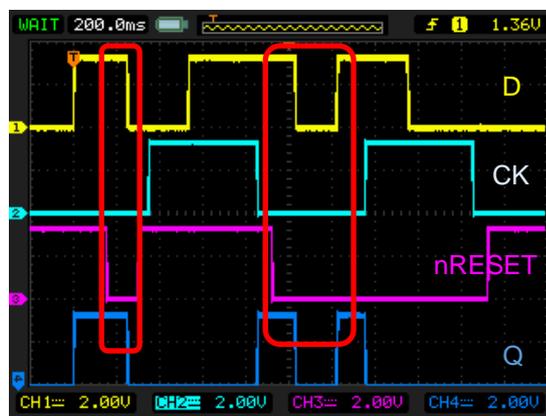
The reset function in LATCH blocks does not operate correctly. This can be described as function failure when nRESET input is set LOW.

The scope shots shown above show the incorrect nRESET function operation marked with red rectangles. From these waveforms can be seen that the reset function operates only when the CK signal is HIGH, in all other cases it is inoperational.

- Avoid using nRESET function in LATCH blocks in SLG46721/722 devices, if possible, use SLG46110/120 devices, where this function operates correctly.
- Use nSET configuration, initial state HIGH, add inverter on D input and use nQ (inverted) output of the LATCH block:

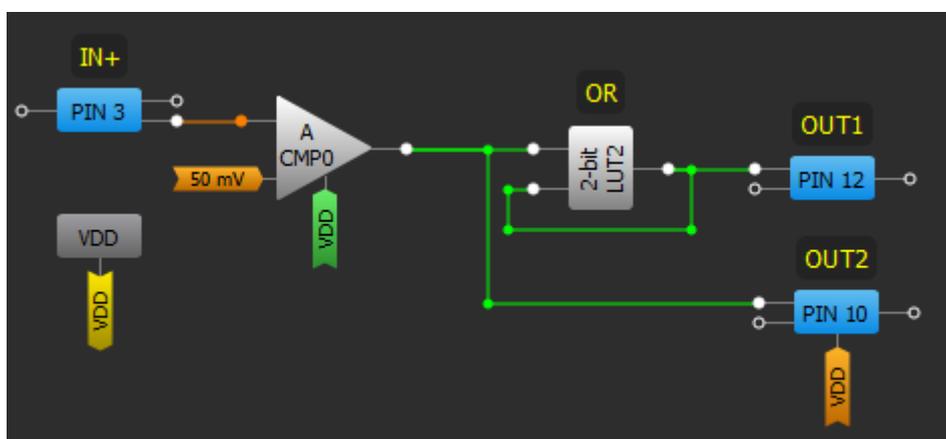
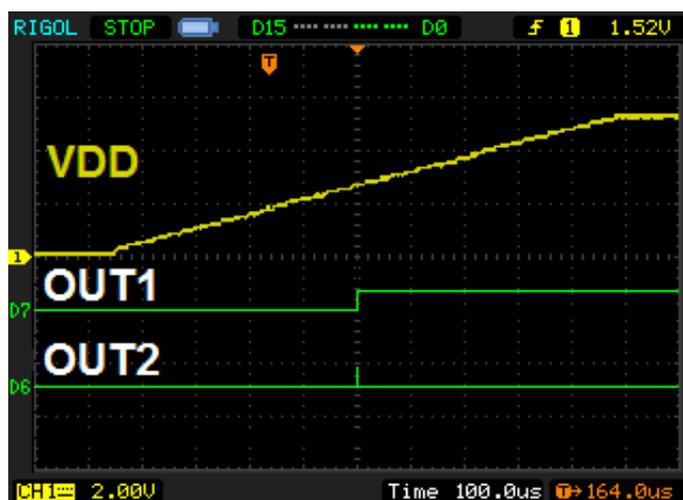
In some cases, ACMP may have short high-level glitches on its output (even if IN+ voltage is less than IN- voltage) after GreenPAK chip being powered up. Such cases may appear when using ACMP with Low Bandwidth mode enabled and Power-Up is connected directly to the V_{DD}.

In order to detect such glitches, scheme with additional LUT was used. This LUT detects high level on ACMP output and stays high until chip powers down.

ACMP IN+ is connected to the Ground.

Use POR block, connected to the ACMP's Power-Up pin. However, in this case ACMP will start working with low level output and will be able to go high only after POR goes high + ACMP power on time.

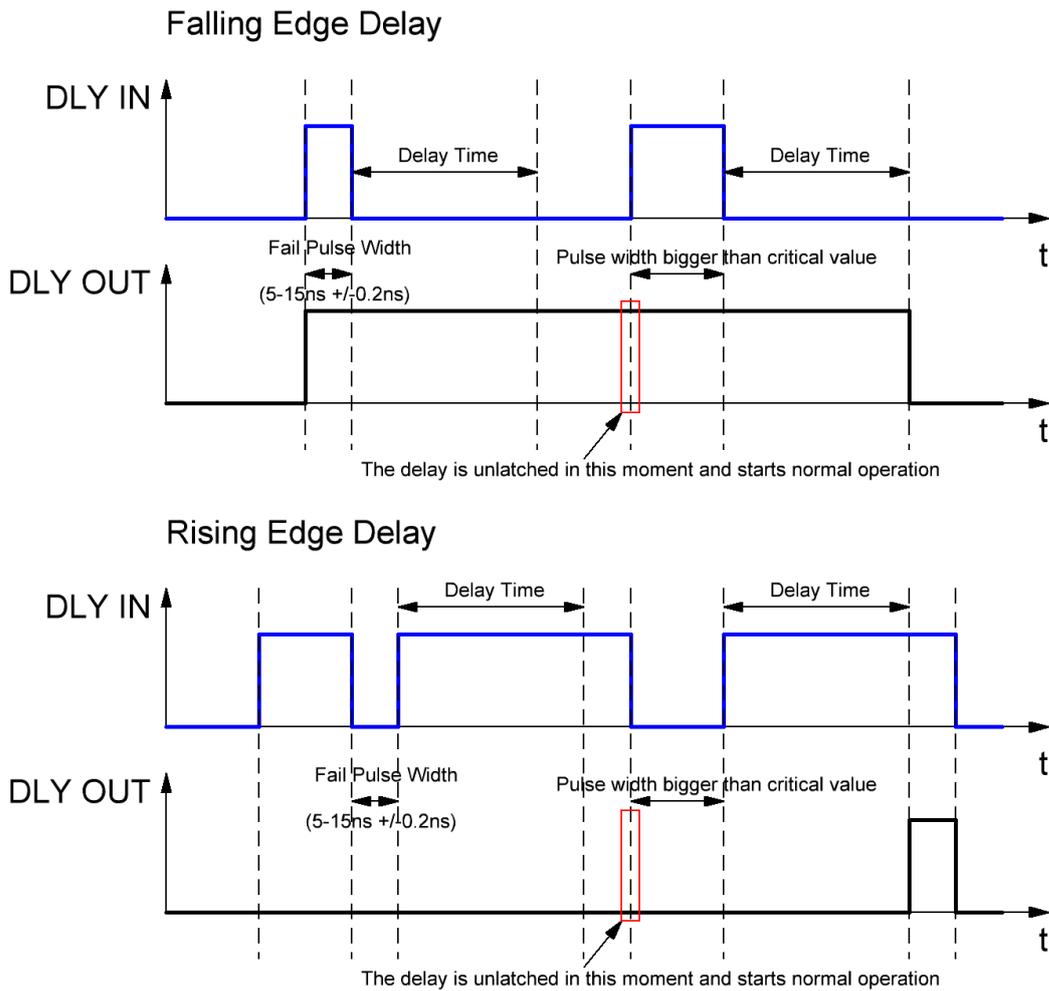
The delay output could be latched despite the input change when a short pulse is input. For example, if the delay cell is configured as a falling edge delay, the short pulse (see NOTE) appears on its input the delay cell output will switch from LOW to HIGH but may not switch from HIGH to LOW even after the delay time has passed.

NOTE: The pulse width varies from chip to chip and with different V_{DD} voltage. It is in range of 5-15 ns and in the window ± 0.2 ns, so it should be very precise for issue happen.

Use P DLY/FILTER block configured as a both edge delay or FILTER.

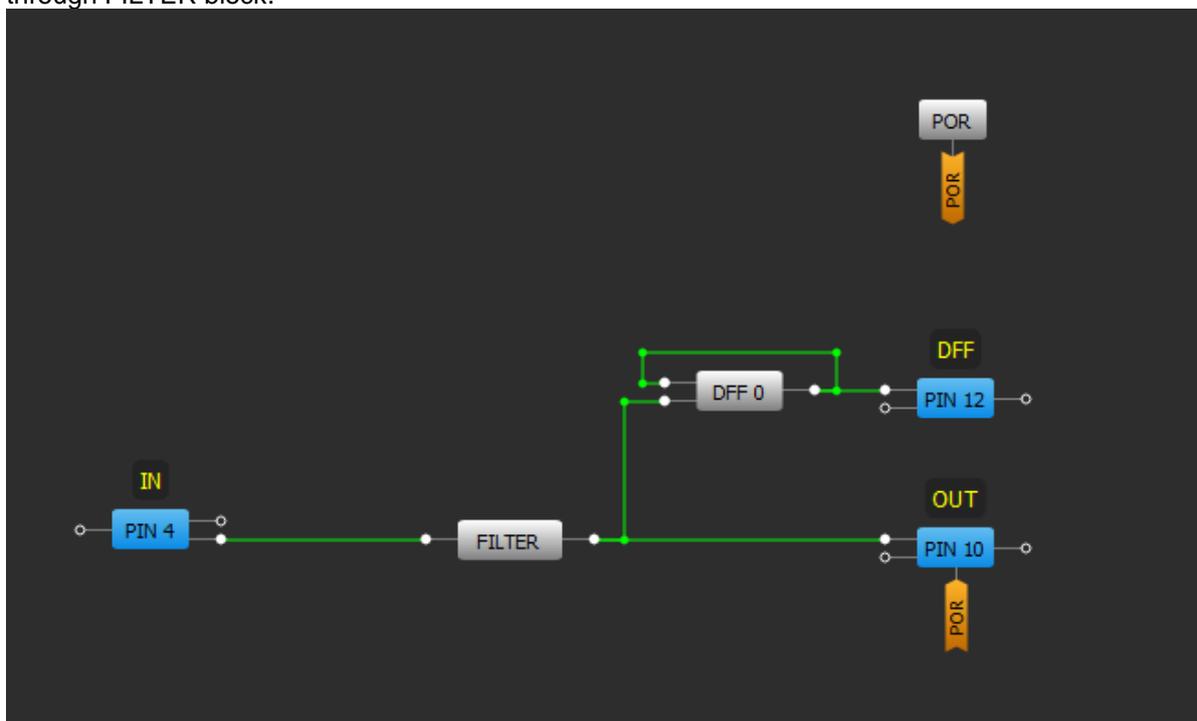
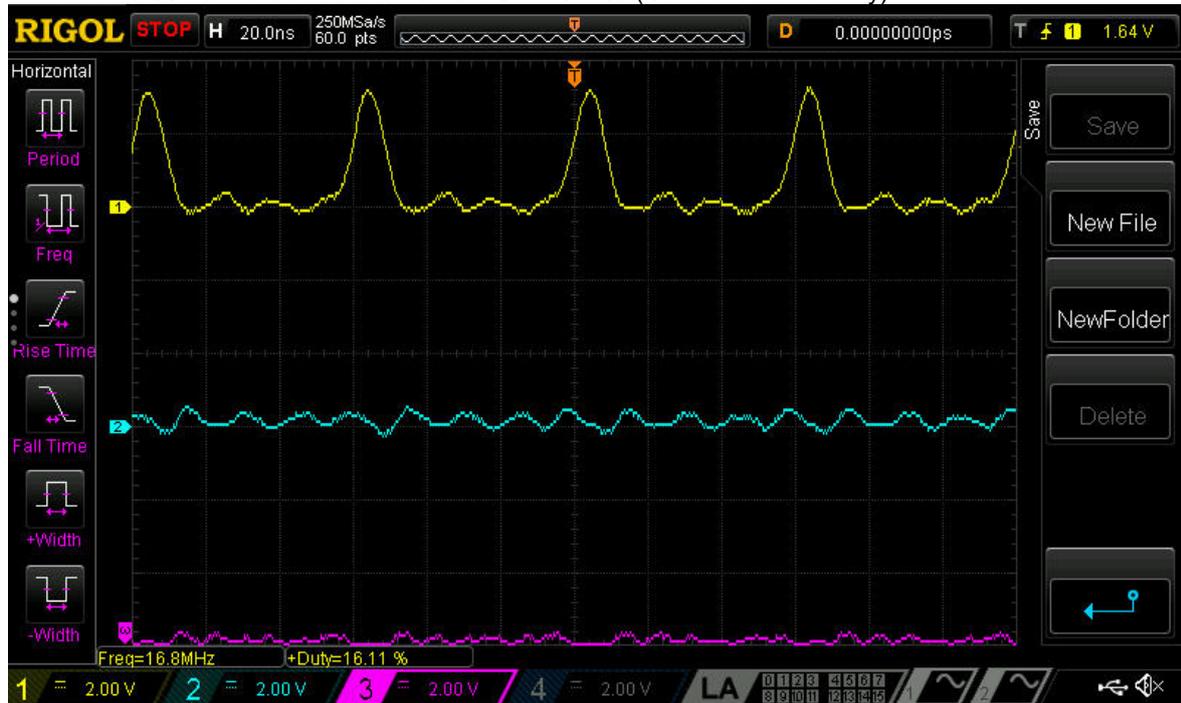
Channel 1 (yellow/top line) – PIN#4 (IN)
 Channel 2 (light blue/2nd line) – PIN#10 (OUT)
 Channel 3 (magenta /3rd line) – PIN#12 (DFF)

1. Period is 60 ns. Pulse width is 10 ns DC = 16.7 % (Correct functionality)

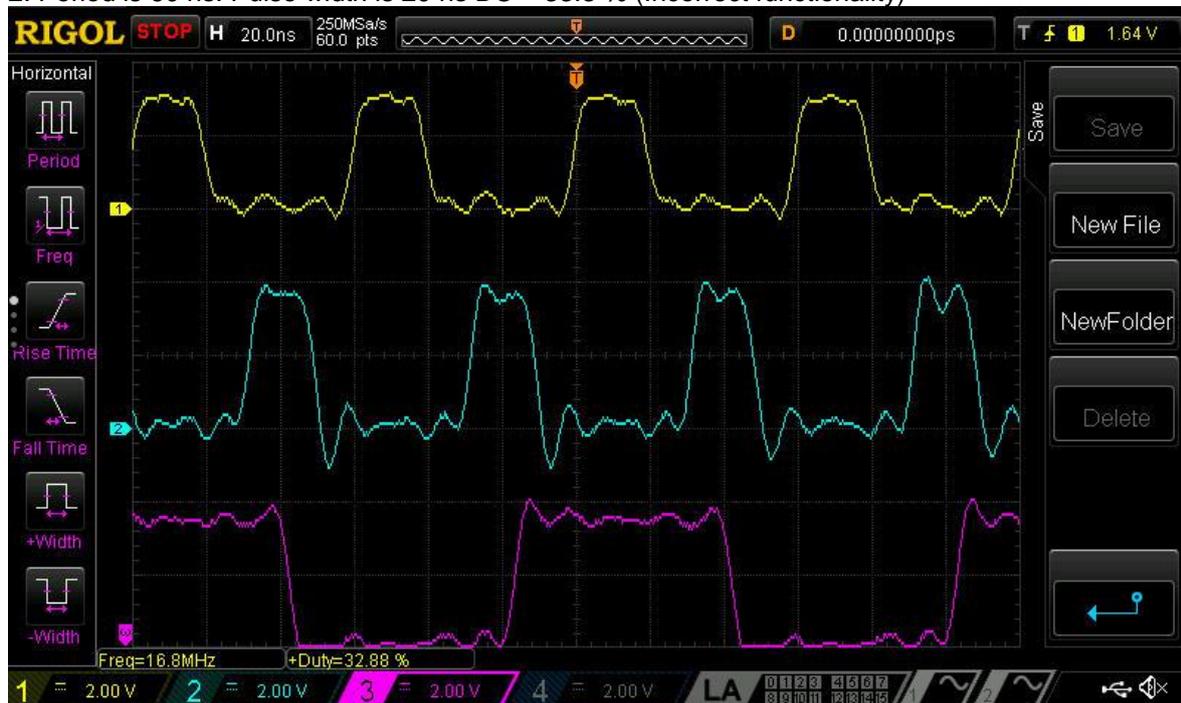
If clock type high frequency input comes in, the FILTER cell may not filter out it. There are several factors like input frequency, duty cycle and LOW duration in such signal that may lead to its passing through FILTER block.

2. Period is 60 ns. Pulse width is 20 ns DC = 33.3 % (Incorrect functionality)

Currently there is no workaround for this issue. Filter block is good at filtering short spontaneous glitches. It is intended to be used in series connection before the delay cell to avoid its latching (see issue #5).

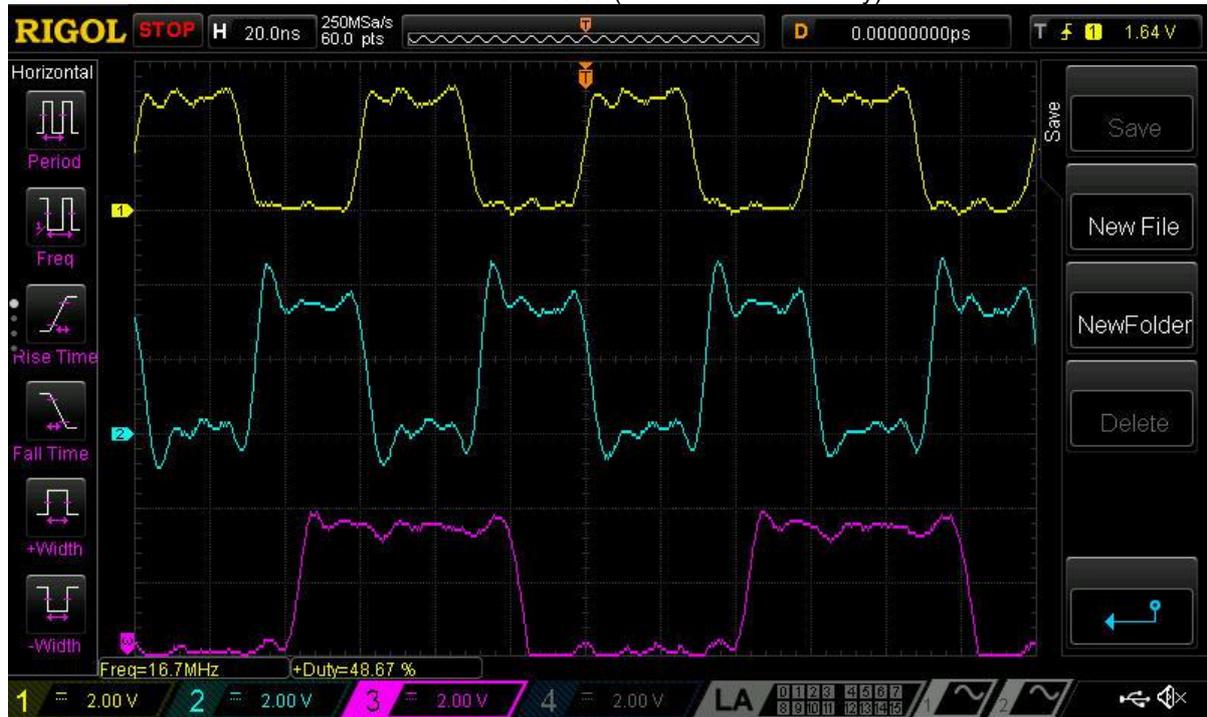
3. Period is 60 ns. Pulse width is 30 ns DC = 50 % (Incorrect functionality)

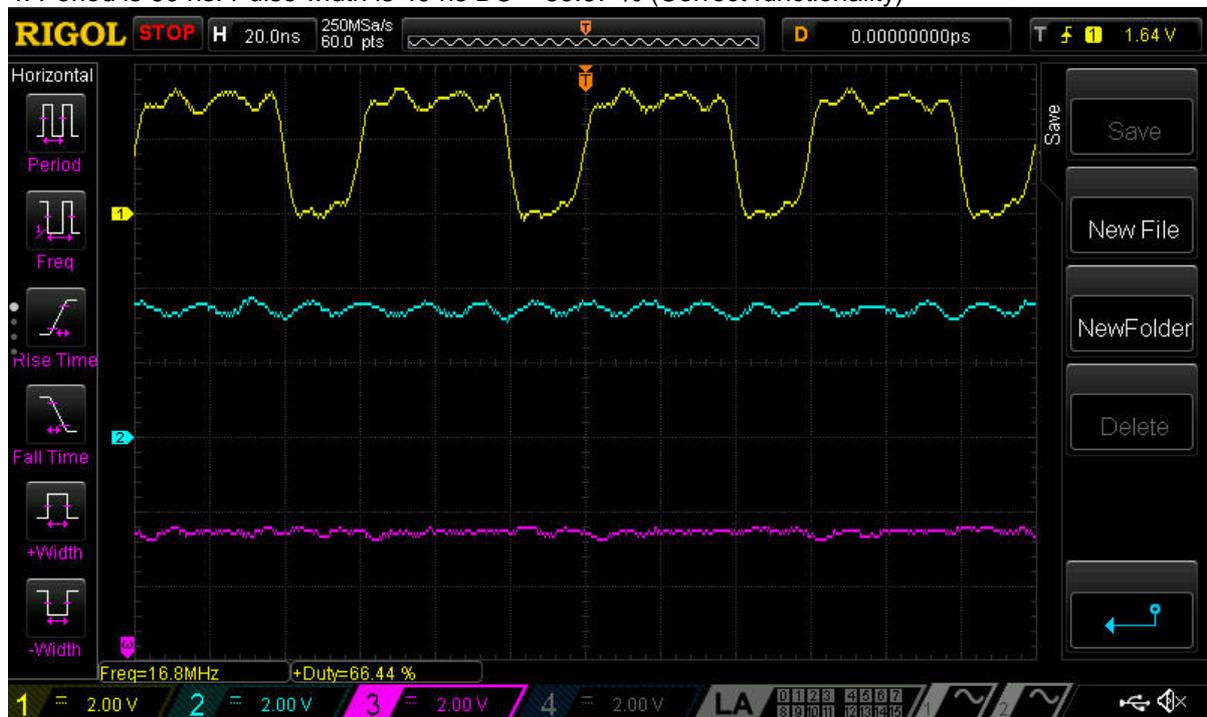
4. Period is 60 ns. Pulse width is 40 ns DC = 66.67 % (Correct functionality)

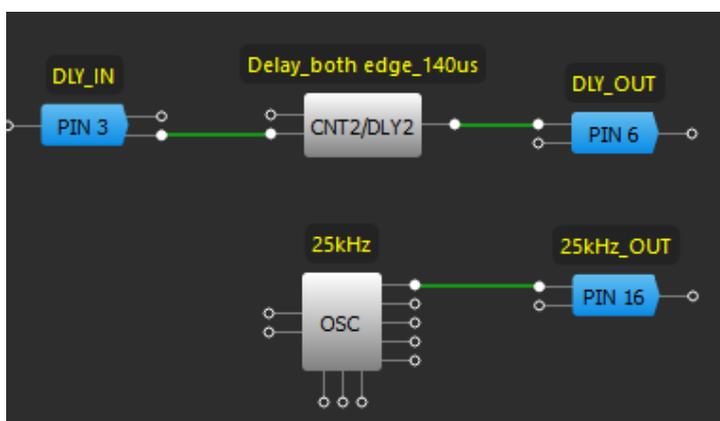
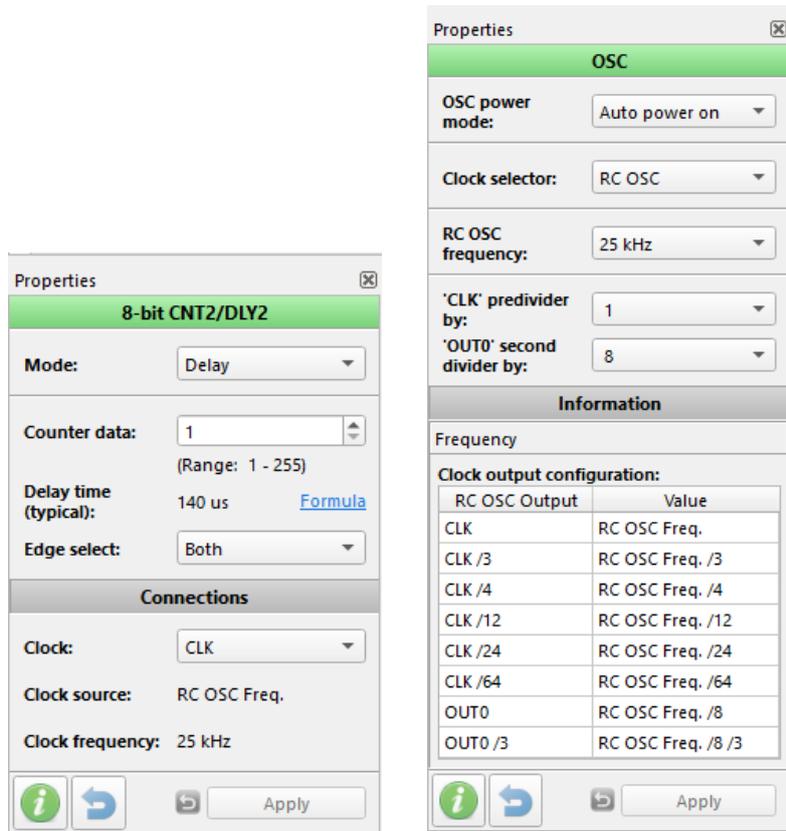
The first period of the RC OSC can be very short when OSC configured as 25 kHz with Auto Power On in the designs. This can occur when V_{DD} is above 4.0 V. Critical for CNT/DLY with a low counter data (less than 10) or if it is necessary to use the frequency of the OSC to clock external elements.

An example of such issue is in the following configuration:

- Avoid V_{DD} higher than 4 V
- Force ON OSC

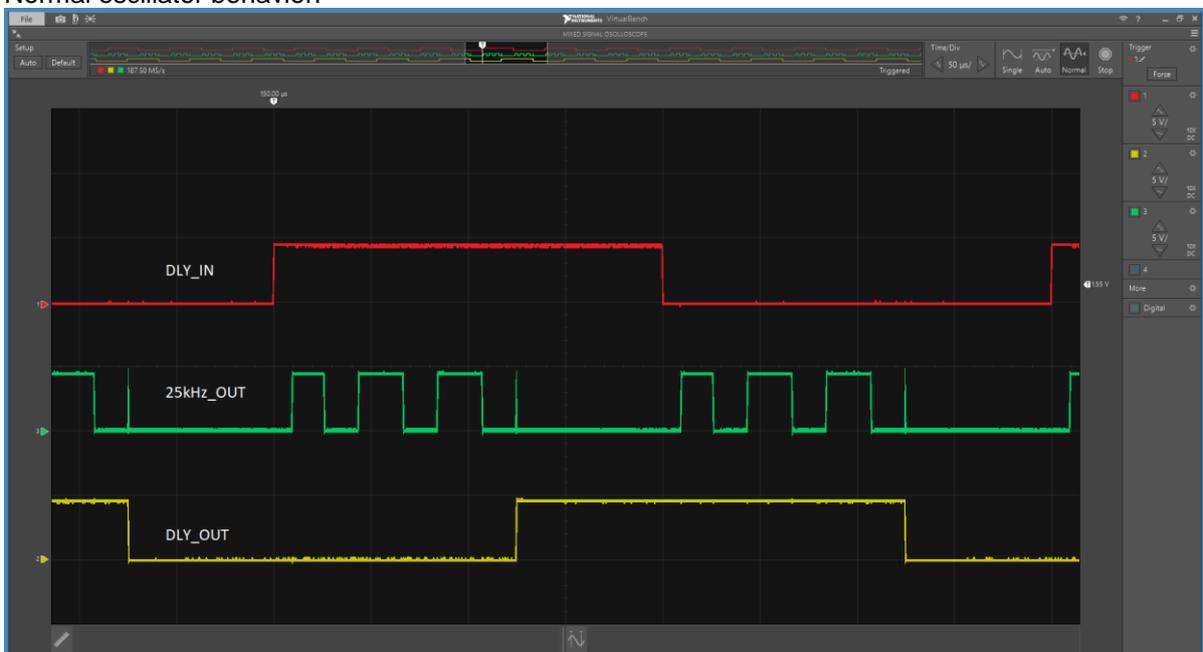
Normal oscillator behavior.

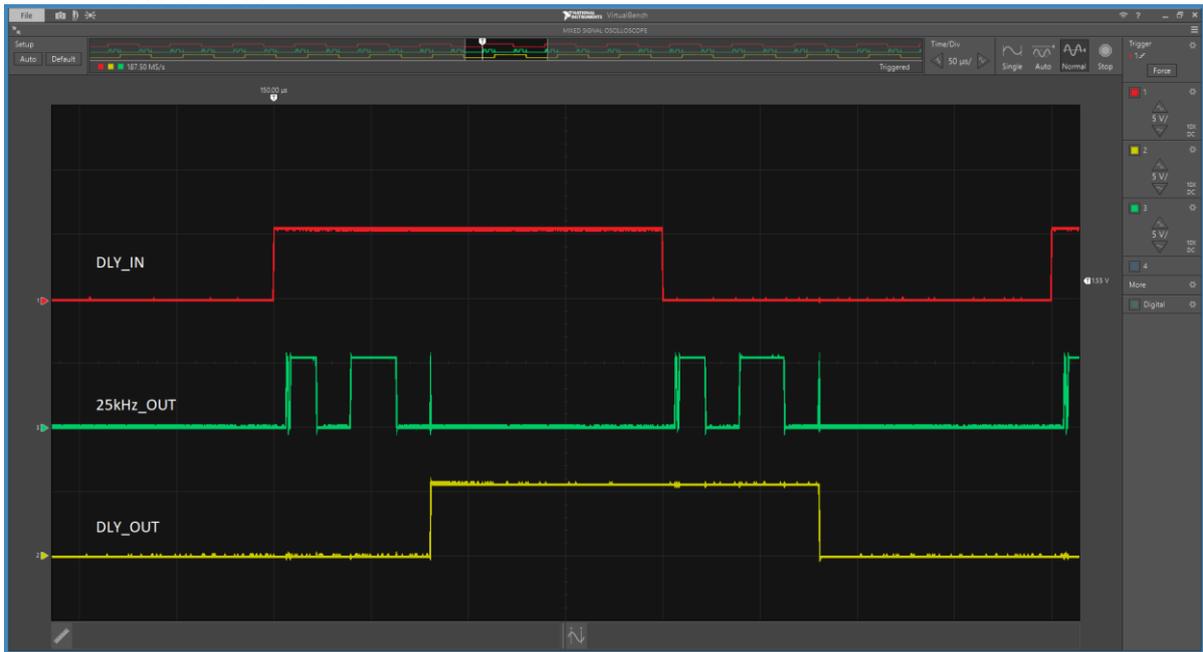
Abnormal oscillator behavior.
