SLG4653x Errata

CE-GP-002

This document contains the known errata for SLG46533, SLG46534, SLG46535, SLG46536, SLG46537, SLG46538 and the recommended workarounds.

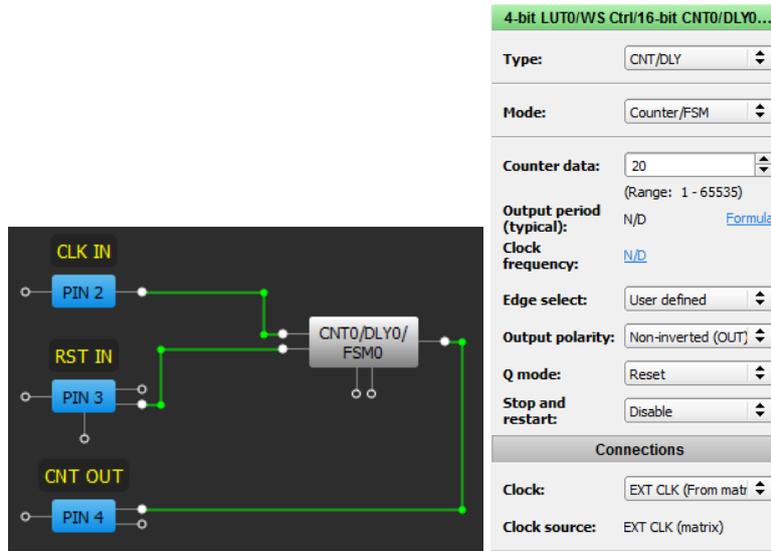
Figure 1

If the Counter Reset is asserted at the same time as a rising clock edge, it is possible that the Counter Data will be reset incorrectly and the counter output may appear faster than expected. This phenomenon appears more often as the clock frequency increases.

Synchronize RESET input of the Counter with its CLK using 2 DFF cells as shown on Figure 3.

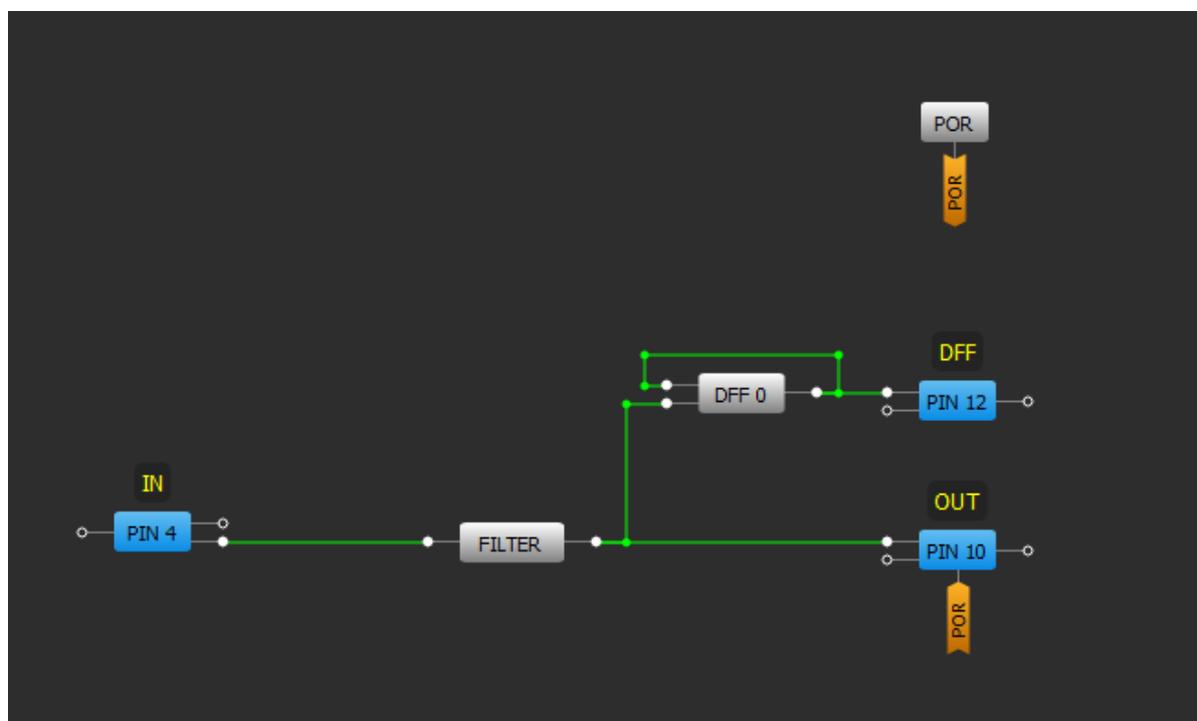
Figure 4

If clock type high frequency input comes in, the FILTER cell may not filter out it. There are several factors like input frequency, duty cycle, and LOW duration in such signal that may lead to its passing through FILTER block.

Currently there is no workaround for this issue. Filter block is good at filtering short spontaneous glitches. It is intended to be used in series connection before the delay cell to avoid its latching.

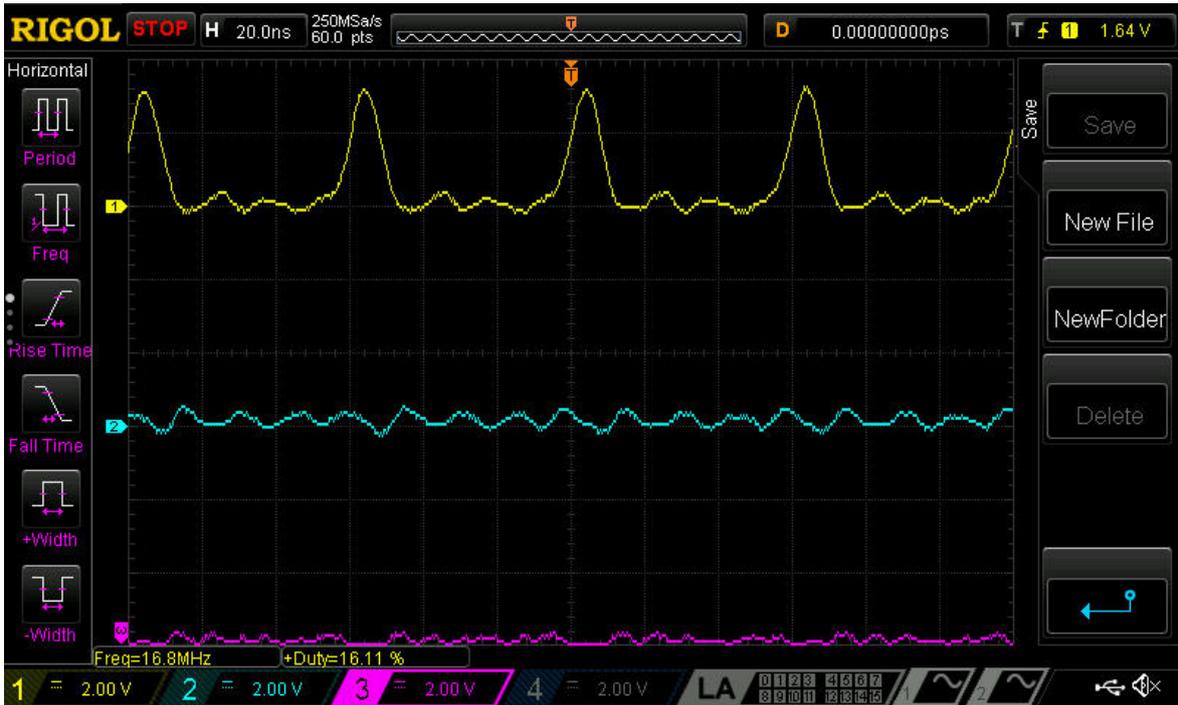
Figure 5

- 1. Period is 60 ns. Pulse width is 10 ns, DC = 16.7 % (correct functionality).

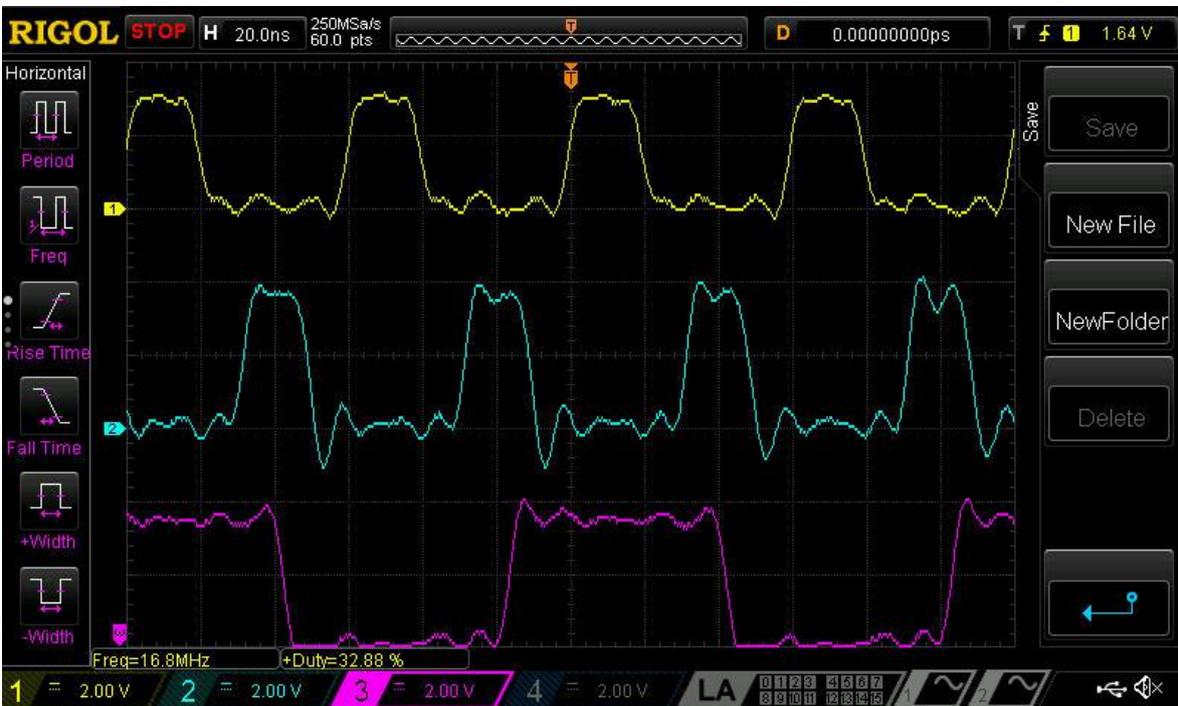
Figure 6

- 2. Period is 60 ns. Pulse width is 20 ns, DC = 33.3 % (incorrect functionality).

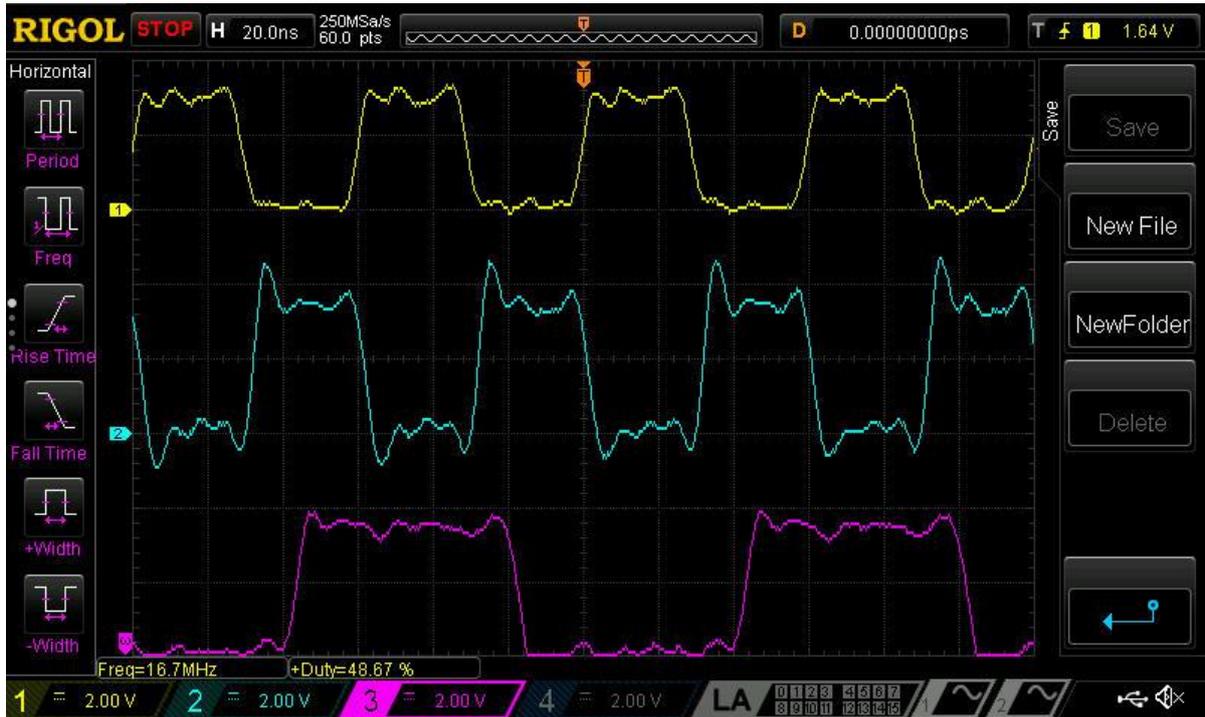
Figure 7

3. Period is 60 ns. Pulse width is 30 ns, DC = 50 % (incorrect functionality).

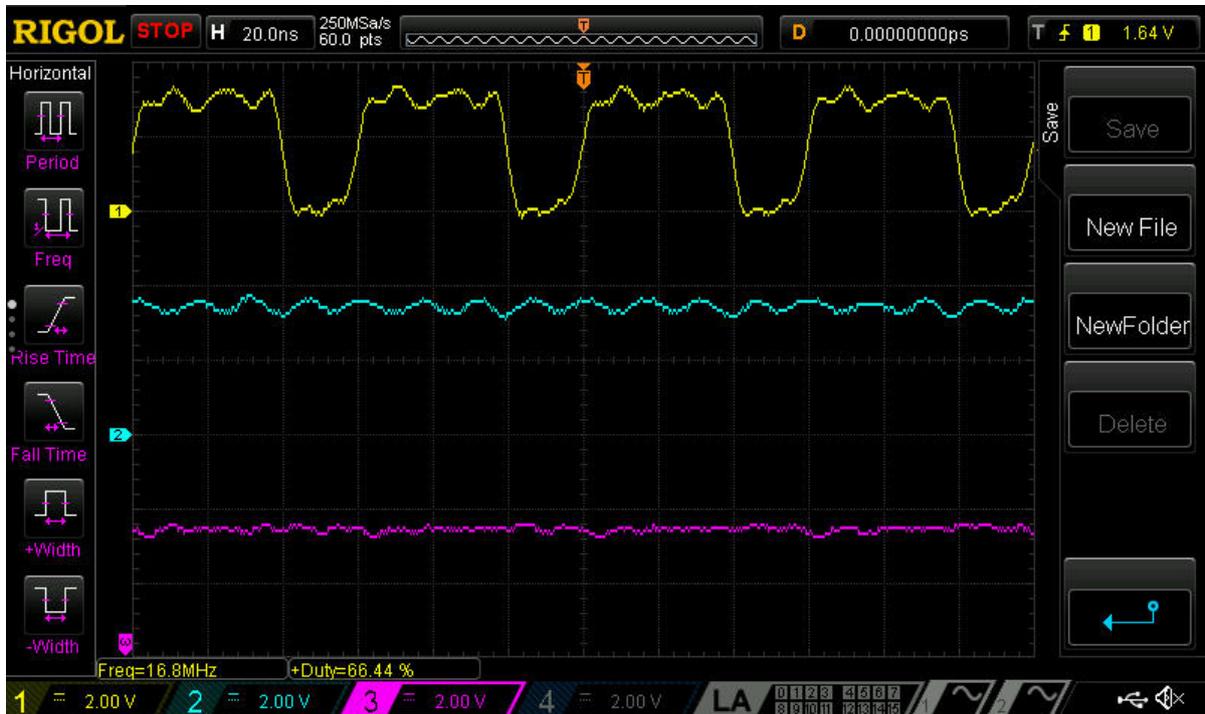
Figure 8

4. Period is 60 ns. Pulse width is 40 ns, DC = 66.67 % (correct functionality).

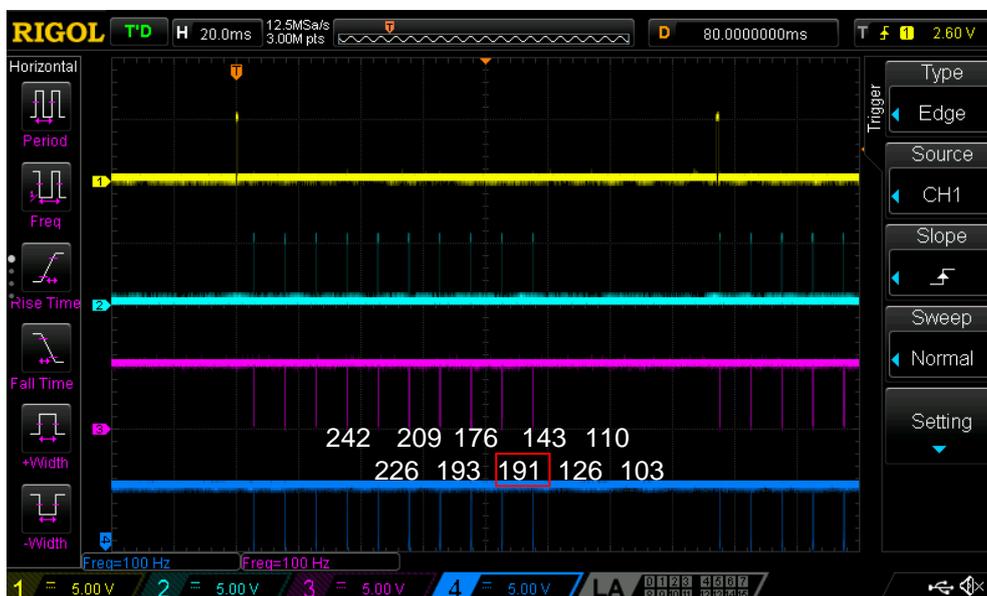
Figure 9

Asynchronous interaction between the CNT/DLY clock input and the I2C latch signal (generated by an I2C read command of the CNT/DLY block's count value) can result in an incorrect I2C data read. The CNT/DLY block will count accurately, but the count value transferred into the block's I2C read register might be loaded incompletely if the I2C latch signal and the clock input occur at about the same time.

The example data capture below shows ten periodic I2C reads of CNT2/DLY2 configured to count down at about 16 clocks per read. The sixth read sample erroneously shows a value greater than that of the fifth. The seventh sample reads as if the previous I2C error never occurred - the difference from the fifth sample (176) to the seventh (143) is 33 clocks or 16 clocks + 17 clocks as expected.

If the possibility of incorrect I2C data reads can't be accommodated for by external software checks, one can guarantee proper operation by stopping the CNT/DLY block's clock during I2C reads through one of the following methods: by disabling the oscillator block, by reconfiguring the CNT/DLY block's clock source, or by gating an external clock using a LUT (Look-up Table) in the signal matrix. After disabling the CNT/DLY block's clock, the count registers can be read without error. Please note that this workaround will add the I2C read and processing time to the counter's overall clock period.

The best workaround depends on the resource constraints of the application. If the oscillator block doesn't clock other logic elements within the design, a matrix output can be used to manually power down the oscillators for the I2C read. When the CNT/DLY block's clock source is routed internally from the oscillator block, I2C commands can temporarily reconfigure the CNT/DLY block's clock source registers to select "Ext. CLK. (From Matrix)." This action will disable the clock by connecting it to ground. If the CNT/DLY block is clocked from the signal matrix, a LUT can be used to gate the clock during an I2C read.

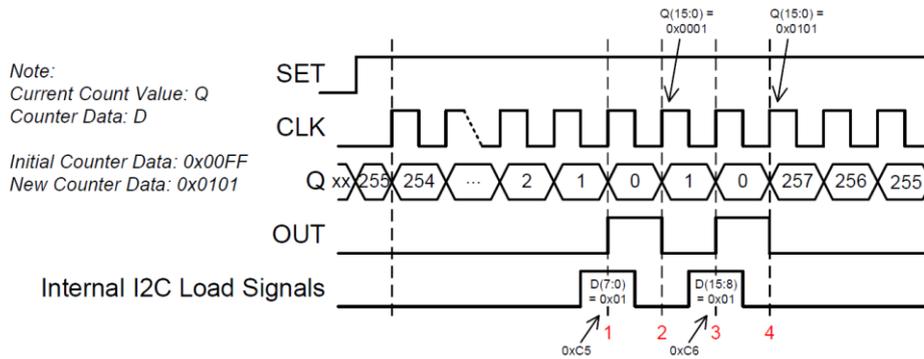
Figure 10: I2C Write of 16-Bit Counter Data Example

The timing diagram in [Figure 10](#) sets up a case where an improper output will be seen on the counter. In this example, the initial Counter Data value (D) is set up as 0x00FF. As you can see, the Current Count Value (Q) decrements from 255 down to 0 with rising edges on CLK. At time "1" denoted by a red number 1, an I2C command (not shown) has just been sent to the GreenPAK device to reconfigure the Counter Data value to 0x0101.

As previously mentioned, the 16-bit value is loaded from the I2C buffers to the Counter Data registers in 8-bit chunks. Right at time “1”, the LSB byte (0x01) is loaded into the Counter Data registers. This makes the Counter Data value temporarily equal to 0x0001. At time “2” between the internal I2C load signals, the counter receives a rising edge on its clock input. This causes the Current Count Value to underflow and to be loaded with the Counter Data value which is 0x0001. At time “3”, the MSB byte (0x01) is loaded into the Counter Data registers setting the Counter Data value to 0x0101. At time “4”, the Current Count Value underflows again and is set to the Counter Data value of 0x0101.

This behavior results in two output pulses on OUT when only one pulse is expected. Observing this behavior depends upon the asynchronous timing between the counter’s clock and the I2C write command to the Counter Data registers. For some applications, the extra pulse on OUT can be ignored and the counter will self-correct after underflowing, overflowing, or being SET/RESET through the GreenPAK connection matrix.

For applications where the application processor needs to read the Current Count Value while the counter is clocking, disable the "Stop and Restart Bit." When this bit is disabled, the counter's clock will not be gated internally which avoids the loss of count values during Tstop. In order to guarantee the current count value after an I2C write to the Counter Data registers, the clock should be manually stopped for the I2C write or a SET/RESET command should be generated after the I2C write. (Case 1)

I2C Write of Counter Data: Accommodate for the double pulse described in Case 1.

Disable the counter's clock during the I2C write.

Manually SET/RESET the counter after the I2C write is complete.

Disregard the first set of pulses on the counter output after an I2C write by waiting for one counter cycle to complete. This allows the counter's DFF chain to be loaded with the new Counter Data value after the counter overflows/underflows.

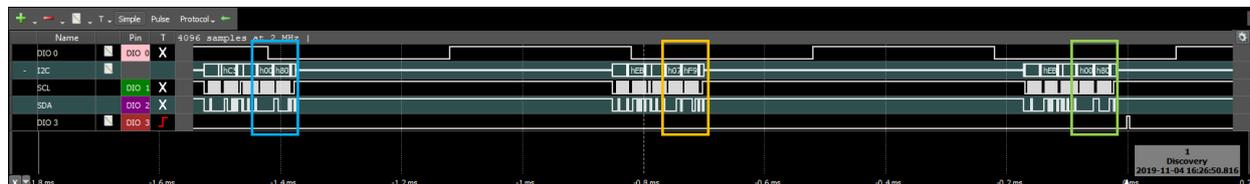
Figure 12: Counter Behavior

For the following condition, the Counter Data register contents are unexpectedly loaded into the counter's DFF chain. This behavior occurs when there is a falling edge on the counter block's clock input during the data return portion of an I2C read of the Counter Data registers. Figure 12 shows this falling edge boxed in light blue followed by two I2C reads of the Current Count Value registers.

As you can see by the MCU data log below, the Current Count Value gradually increases from 0xF904 to 0xF907 but is unexpectedly reset to 0x8000. Please note that the colored HEX values in the MCU Log correspond to the boxed I2C read commands shown in the waveform above. As previously described, this reset occurs because there is a falling edge on the counter's clock input while the GreenPAK device is responding to an I2C read request to 0xC5 and 0xC6. (Note that 0xC5/0xC6 are the Counter Data registers and 0xEB/0xEC are the Current Count Value registers for CNT0.)

The reason that the counter isn't set to 0x8000 on the I2C read immediately following the Counter Data query is because the counter requires two rising edges on its clock input to load the data from the Counter Data registers into the DFF chain. Note that all rising edges during Tstop will be gated internally by the "Stop and Restart" feature.

I2C Read of Counter Data: Avoid reading Counter Data via I2C while the counter is being clocked.

Within the MCU, we recommend saving the Counter Data register configuration as a software variable so that the Counter Data register does not need to be read during counter operation.

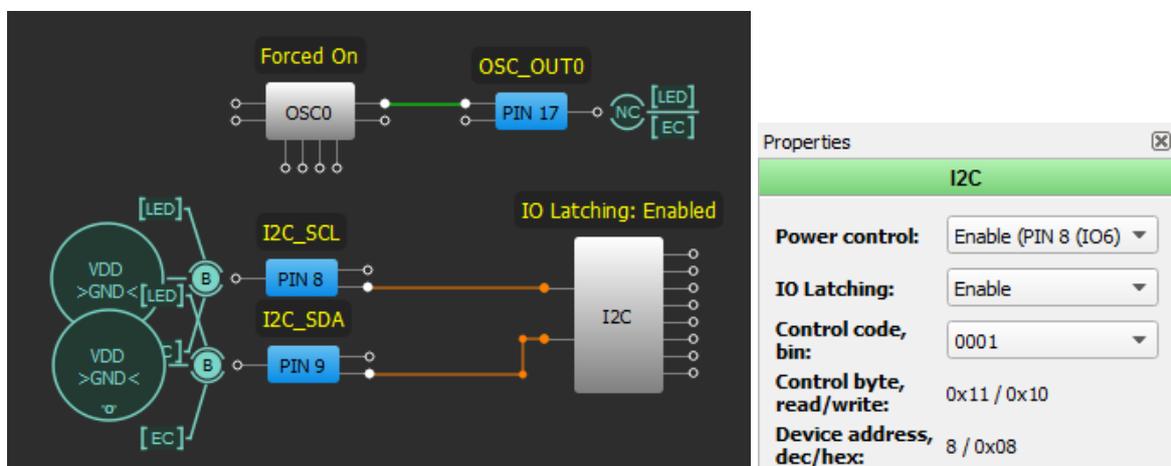
Figure 13

The GreenPAK device does not check for a matching I2C Slave address condition before triggering 'IO Latching'. A Start bit on the I2C bus will trigger IO Latching. A Start bit is when I2C_SDA goes low first followed by I2C_SCL going low after.

In the example below, we will be monitoring the OSC output, which is measured by a scope on Channel 3 via PIN17 ("OSC_OUT0"). The I2C bus will be forced low to create a START bit.

Disable IO Latching in programmed OTP. This register is I2C-write locked during normal operation and therefore should be disabled in configuration file.

Do not share I2C bus with other devices and make sure the I2C bus is not powered down while the GreenPAK is still powered through VDD.

If the above cannot be satisfied, then consider using the SLG4658x devices, where this errata has been fixed.

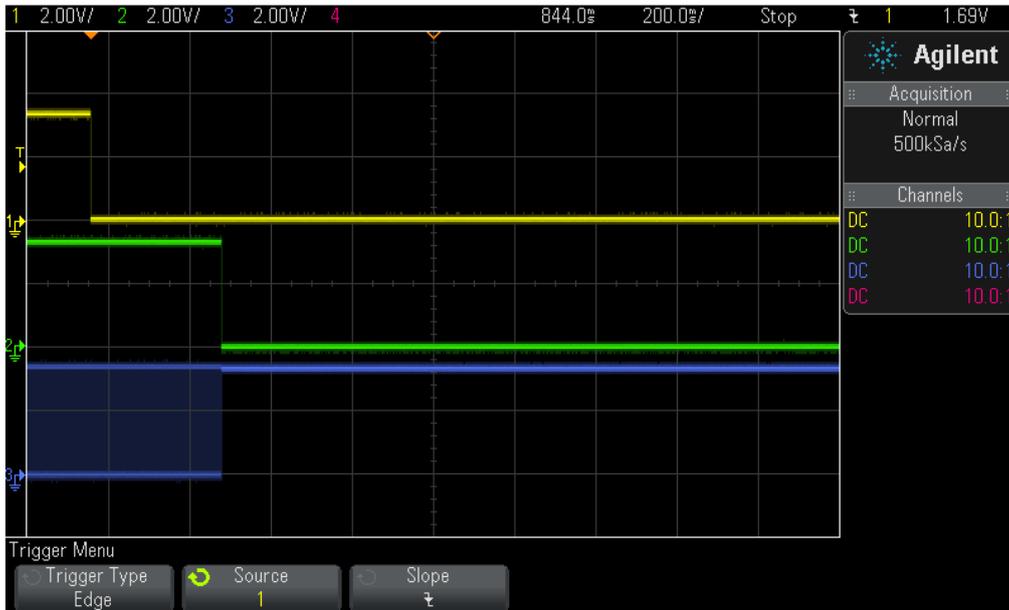
Figure 14

By toggling I2C_SDA low and then I2C_SCL low, the GreenPAK registers this as a start bit and latches all General Purpose Outputs such as PIN#17 (“OSC_OUT0”). In the [Figure 14](#), notice that PIN#17 (OSC_OUT0) stops toggling.

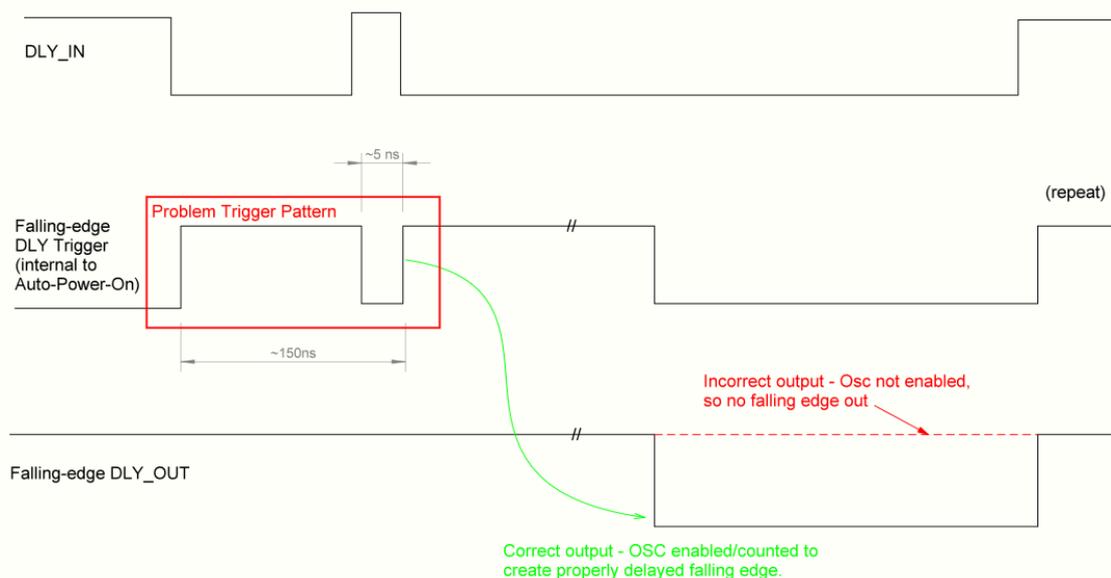
Figure 15: Problem Trigger Pattern

For this chip, the Auto Power On circuitry of the 25 kHz/2 MHz generators contains a circuit errata, which can potentially fail to power on the OSC for a specific pattern and timing of the OR of all related DLY trigger signals. The pattern is shown in [Figure 15](#) (boxed in red) and consists of a relatively longer pulse (~145 ns) followed by a shorter (~5 ns) glitch of opposite polarity.

1. Use signal conditioning circuits to prevent glitch on DLY inputs < 200 ns. Examples:
 - a. ACMP with Hysteresis
 - b. External RC in front of Digital Input with Schmitt Trigger
 - c. Filter cell.
2. Set OSC power mode to Force Power On mode instead of Auto Power On.
3. Use different oscillator, such as 25 MHz Ring OSC, which does not have Auto Power On issue.

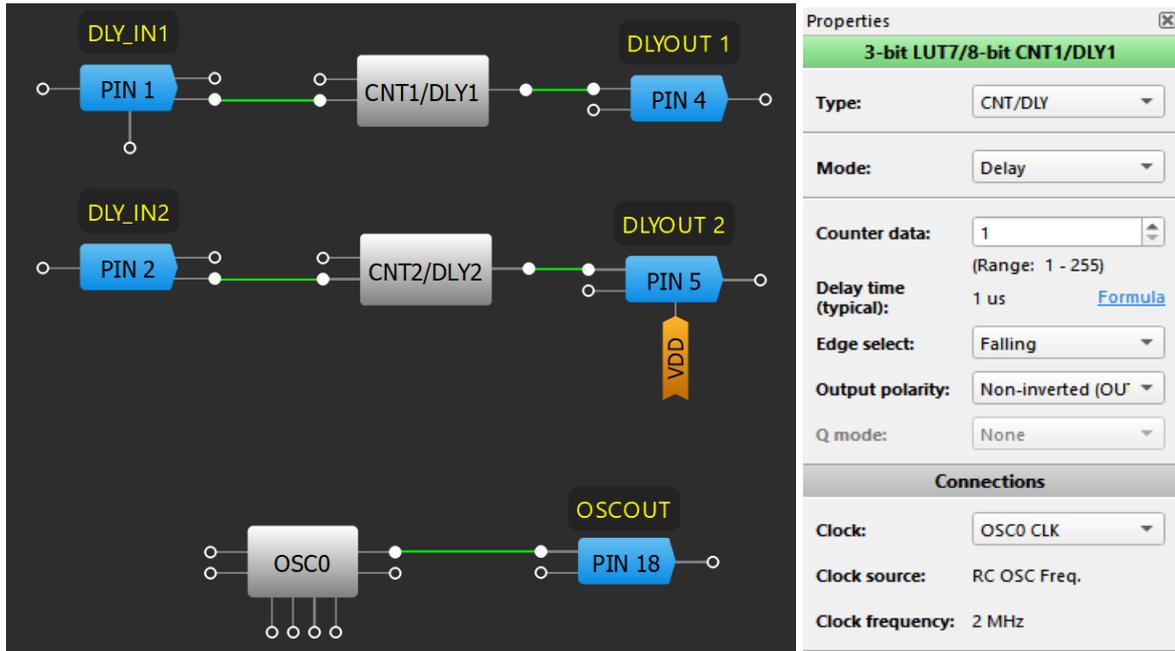
Figure 16: Test Circuit

The error is difficult to capture as the timing must be exact within ns, and short (ns) pulses are difficult to generate glitch precise enough to induce the problem. GPIO naturally filter out ns pulses, so for purposes of errata capture, two simultaneous falling-edge DLY circuits (as shown in [Figure 16](#)) were used. By lining up two delays precisely at a particular timing relationship, we can use the internal Auto Power On (OR logic) to generate the glitch pattern necessary to cause the error.

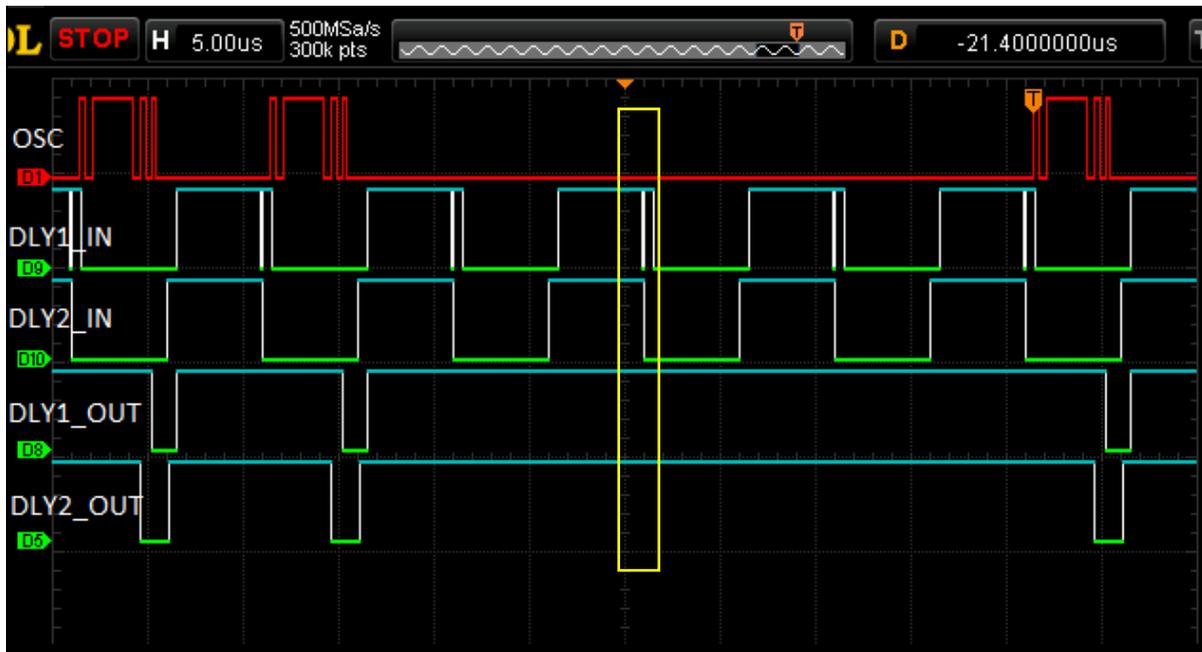
Figure 17: Errata Capture (Zoom Out)

Figure 17 shows a series of DLY output events are missing, where the OSC is correspondingly not triggering when it was supposed to. Figure 18 is a zoom in of the boxed region from Figure 17. The total glitch/chatter time was measured in this case at 152 ns. By using the composite OR of the two delay channels, we can asynchronously strobe with tiny frequency variations, and so tune the timing to induce this errata. Note that the error is not persistent – the system is recovered when all DLYs are returned to inactive state, such as when input of falling edge DLY goes high, thus canceling delay, or after DLY out finishes.
