[Notes] RX Smart Configurator for FreeRTOS and Azure RTOS on e² studio (build error with custom user board)

R20TS0779ES0100 Rev.1.00 Dec. 01, 2021

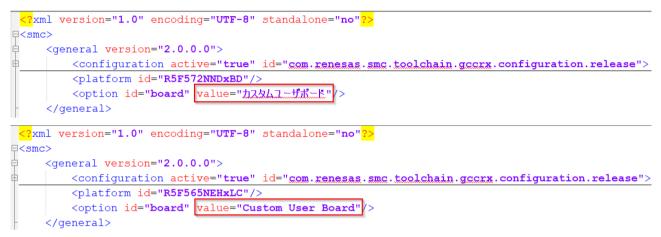
Figure 3. scfg content with board information

How to know the imported project is created by e² studio in English or Japanese?

- Open .scfg file inside the imported project with any text editor tool
- Search for id="board" and check the "value"
 - If value="カスタムユーザボード", it is created by e² studio in Japanese
 - o If value="Custom User Board", it is created by e² studio in English

- Close SC editor if it is open
- Open scfg file in the project folder with any text editor tool
- Delete the line <option id="board" value="..."/> and save the change
- Reopen SC editor (by double-clicking the scfg file)
