## Abstract

The design of a daisy chain battery system, while fairly straightforward, has a number of design elements that can become obstacles to implementation. This case study provides a glimpse into the questions and responses in the development of one daisy chain system.

## Introduction

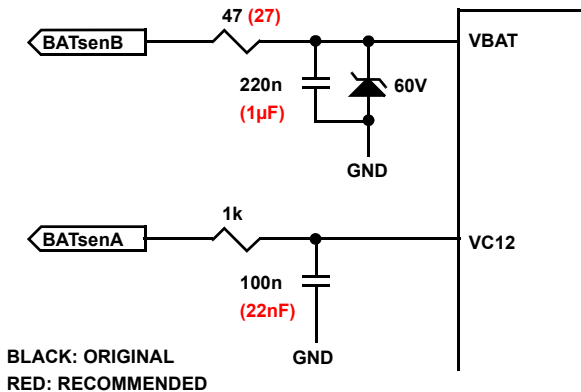
FIGURE 1. INITIAL VBAT CONNECTION

The VBAT input resistor was not damaged. Attached is a schematic of the VBAT connection.

Normally, we recommend a 27Ω resistor. While a 47Ω resistor may be OK, what happens is that the voltage at the VBAT pin drops when there is higher current, like during SPI or daisy chain communications. If the voltage drops too much, then there is not enough headroom on the front end analog circuits and there can be measurement errors. So, if the input resistor is not damaged then try a 27Ω resistor to see if this makes a difference.

If a smaller resistor value does not make a difference, then check that there is no large voltage differential across the VBAT series resistor. There should be a small drop in voltage (up to

about 80mV), however, if there is more than this, check the diode. If the diode is OK and there is still a voltage drop across the resistor, then the part may be damaged.

The schematic shows two connections to the top of the stack, one for VBAT and one for VC12. This is OK, however, check to see if there is a fault condition. If the BATsenB wire is broken, it could affect the measurement accuracy, however, this would also show up as an open VBAT fault.

Another recommendation we make on the input filters is that the time constants on all inputs be the same (or about the same). In this case, the cell input time constant is about 16 times the VBAT time constant. If there are high voltage transients on the pack voltage, the differential time constants will result in high voltage differentials on the IC input pins. To minimize this, we recommend different filter values, as shown in RED in [Figure 1 on page 2](#).

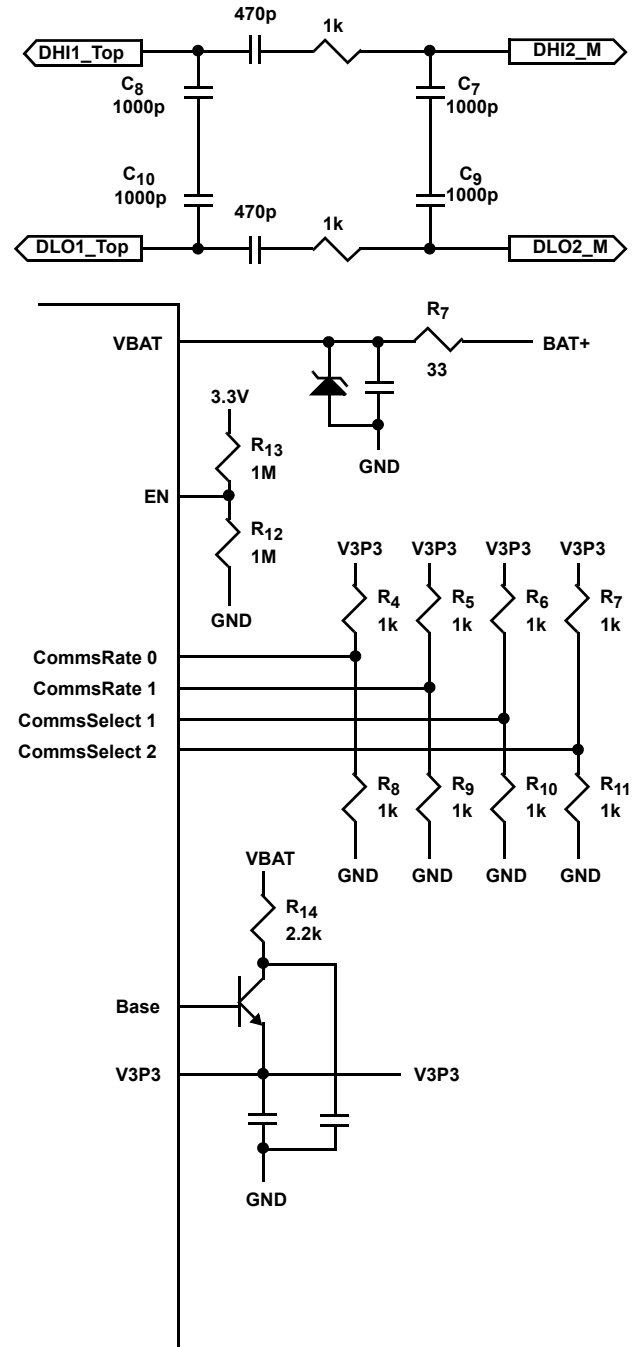
FIGURE 6. CUSTOMER ORIGINAL DAISY CHAIN CONTROL CONNECTIONS

Below (Figure 6) is a schematic of the ISL78600 daisy chain and control circuits in my battery management system.

Resistor  $R_{12}$  is not loaded and the Comms pull-up/pull-down resistors are loaded according to the configuration settings above. I measured the voltage across the resistor,  $R_7$ , in the schematic. The master bottom device is currently reading 11.9mV (360μA) and the top device is currently reading 2.4mV (72μA). Neither of these currents are popping off the datasheet to tell me what is going on.

The first thing to notice on the schematic is that the center point of the capacitors C<sub>8</sub> and C<sub>10</sub> (and C<sub>7</sub> and C<sub>9</sub>) should be at the respective IC GND (see [Figure 7](#)).

1. Resistor R<sub>14</sub> is probably too big. This will work OK for stand-alone, however, because of higher currents in the Daisy Chain mode, it might cause the 3.3V supply to drop out during communications. In our designs, we use a 100 $\Omega$  resistor.
2. On the V3P3 regulator, the collector resistor R<sub>14</sub> is shown to connect to VBAT. This should connect to BAT+, otherwise the V3P3 current will also flow through R<sub>7</sub>, reducing the VBAT voltage.

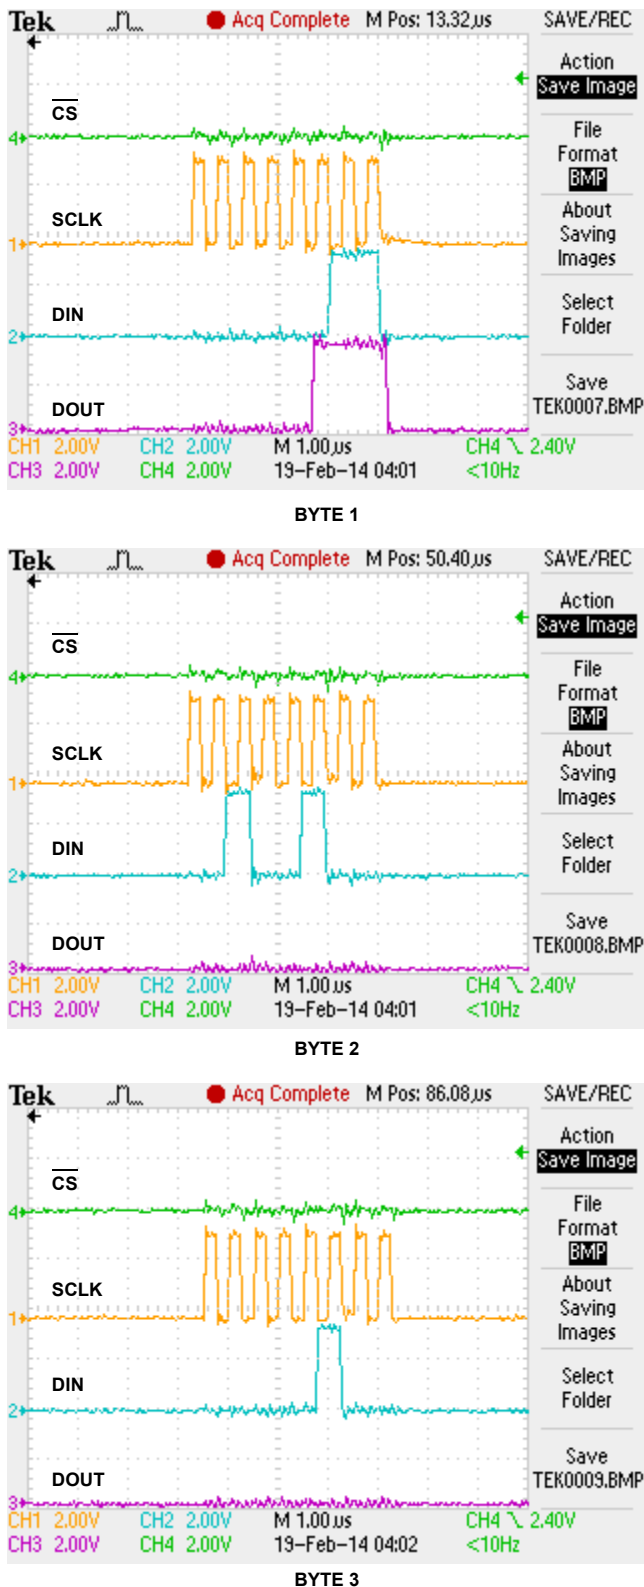
FIGURE 8. CUSTOMER REPORTED CORRECT STAND-ALONE COMMUNICATION

[Figure 8 on page 9](#) shows the SPI Identify command. The MISO data looks like 0x070000 but that's nothing valid to the best of my knowledge. If I send this command a few times in a row, I can get the MISO data to be 0x133800, which looks like a Comms Failure to me.

**A:** The fact that the upper device does not recognize the sleep/wake commands and there is no movement on the daisy chain lines means that there is something wrong with the daisy chain. *Nothing else matters until this can be cleared up.*

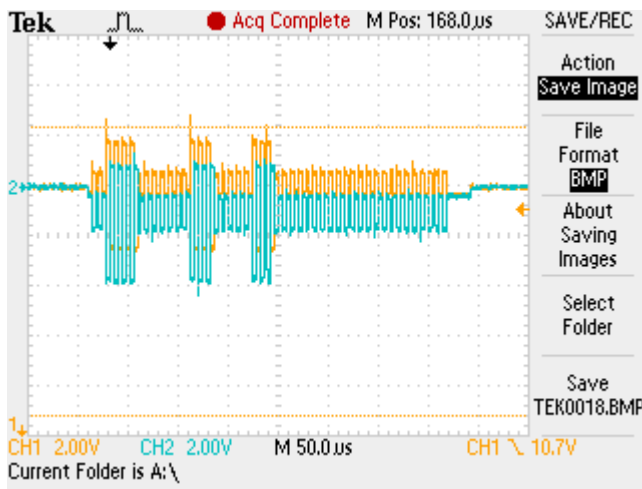
FIGURE 10. CUSTOMER DHI/DLO TRACES

So, that looks good. [Figure 10](#) is the scope waveform for the master/bottom device's DHI2 and DLO2 lines, which actually look correct now while the daisy chain interface isn't connected. DLO2 is blue and DHI2 is orange.

I checked the common points. The C<sub>7</sub>/C<sub>9</sub> common connection is connected to GND on the bottom board and the C<sub>8</sub>/C<sub>10</sub> common connection is connected to GND on the top board.

Check to make sure the top and bottom boards are completely isolated. Nothing on the top board should touch the bottom board, except the VSS of the top tying to the BAT+ of the bottom and the communications through the capacitors. The DHI2/DLO2 on the top board should be floating.

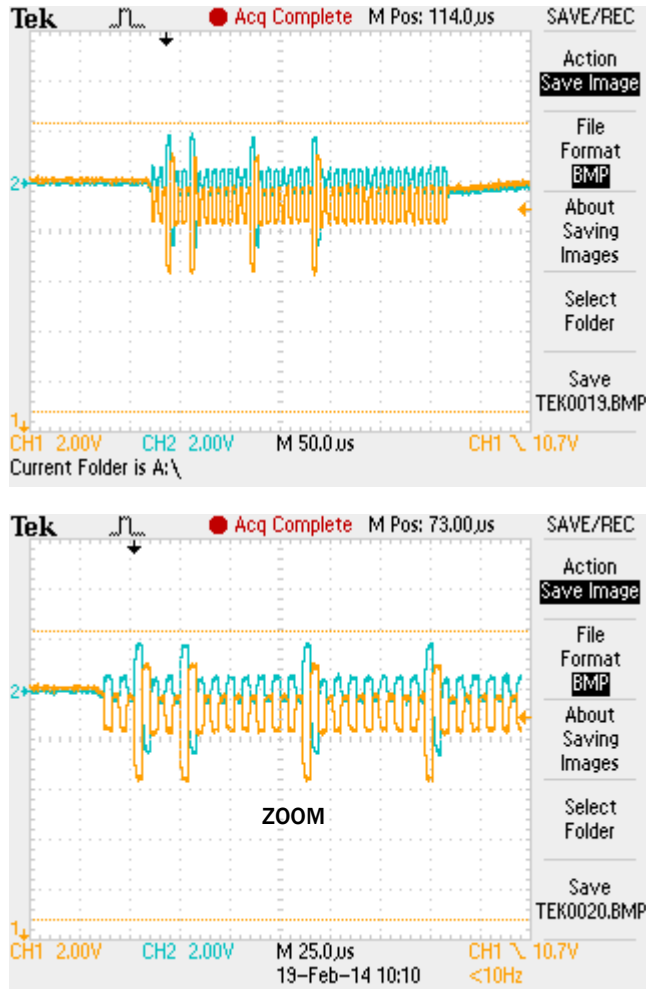
**FIGURE 12. CUSTOMER DAISY WAVEFORMS AFTER CHANGES (GOOD)**

**Q:** Wow, it's been a long day. I think I finally got it right, however, I won't be able to check if valid data is coming back down the stack until tomorrow. [Figure 12](#) are two waveforms showing my daisy chain communication. What I sent you last time was just the master/bottom side, since connecting them had the isolation issue I described. Once I fixed the isolation issue, I connected the 2-wire daisy chain interface and captured the attached waveforms.

**A:** This looks better.

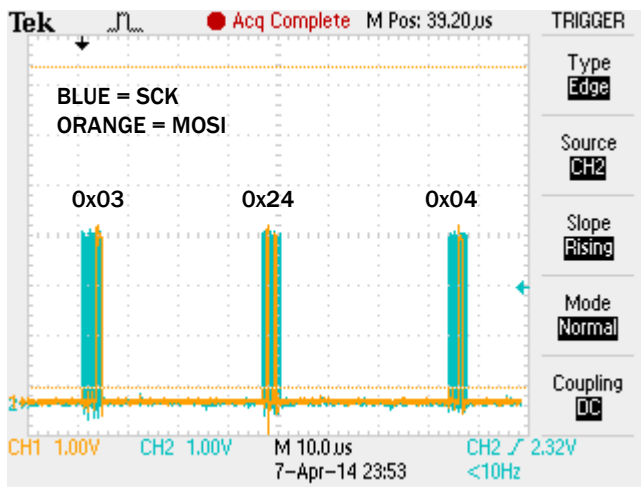
FIGURE 13. CUSTOMER BASE ID COMMAND (SPI)

- TX = 0x03 24 04
- RX = 0x00 30 00 0C (1-byte response)
- TX = 0x03 24 26
- RX = 0x03 26 20 00 (1-byte response)
- TX = 0x03 27 FE
- RX = 0x23 30 00 0B (1-byte response)
- TX = 0x13 30 0F
- RX = 0x23 2C 00 01
- RX = 0x13 30 00 06 (2-byte response)

The 'base id command' waveform (Figure 13) shows the transmission of 0x03 24 04 from the Host MCU to the bottom/master device, specifically, the timing between SPI bytes in the overall transmission of this command. The timing shows that this command meets the 100μs maximum requirement defined as the  $\overline{CS}$  high time (the time between bytes). Please let me know if you see any concerns with the timing of my command transmission.

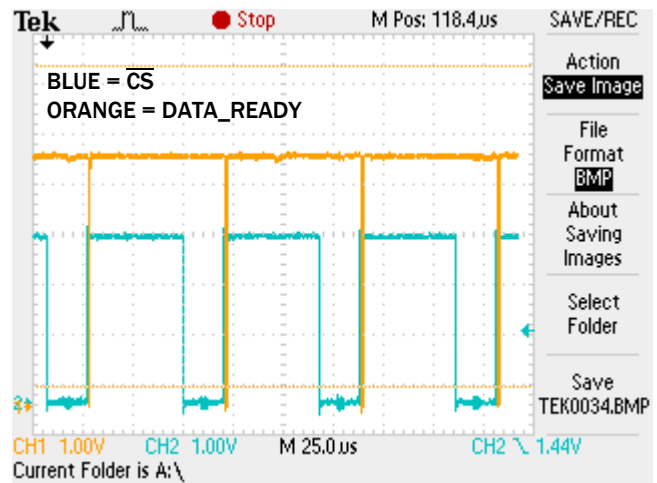
FIGURE 14. CUSTOMER DATA READY RESPONSE HANDLING TIMING

Also, the 'data\_ready response handling' waveform (Figure 14), shows the timing on servicing the  $\overline{DATA\_READY}$  line. Please note that I have a level shifter that inverts  $\overline{DATA\_READY}$  from the ISL78600. As shown in the waveform, the  $\overline{DATA\_READY}$  signal goes HIGH when a byte is available in the ISL78600 buffer. The time that  $\overline{CS}$  is low is the time it takes for me to read a SPI byte (~25μs). At the completion of each read with the rising edge of  $\overline{CS}$ , you can see  $\overline{DATA\_READY}$  dip low briefly and return HIGH, indicating another byte is available. The time from the rising edge of  $\overline{DATA\_READY}$  to  $\overline{CS}$  going low again is the time it takes for me to respond to the  $\overline{DATA\_READY}$  signal (~45-50μs). Do you think this is too long?

I went through some timing diagrams from tests I did a while ago and found a scope shot of an identify sequence from our board. See [Figure 16](#). You can see that our response to data ready (the "0" trace) is much faster than yours and is about 3-4 $\mu$ s delay from falling edge of data ready to the start of SPI communication.

Note: Our initial answer to this question is as follows: "We worked with our designers and got simulation results for the  $\overline{CS}$  to SCLK timing. As it turns out, there is a maximum time from the falling edge of  $\overline{CS}$  to the first rising edge of SCLK. This only shows up on the IDENTIFY command, not on any other command. Simulations show that there can be data corruption in the IDENTIFY response if the  $\overline{CS}$  to SCLK time exceeds 50 $\mu$ s. We will be changing the datasheet to include a comment suggesting a maximum of 30 $\mu$ s (to cover corner conditions) between these two signal edges."

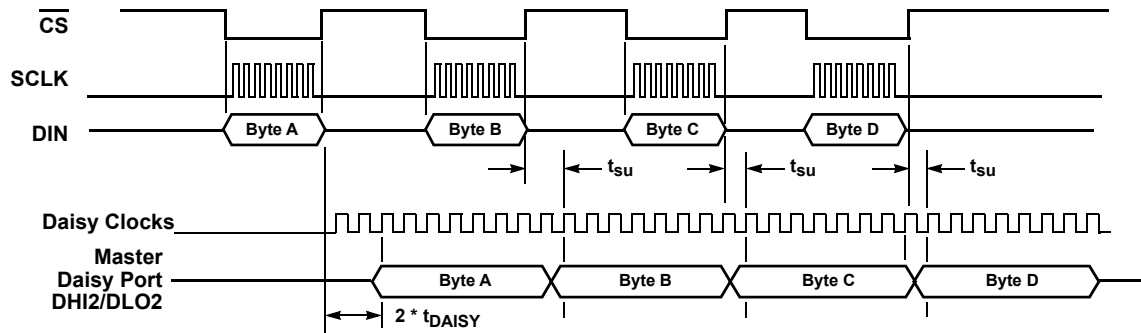
**FIGURE 15. COMMAND TIMING TO AVOID DAISY BUFFER UNDERFLOW**

**IMPORTANT:** The host microcontroller must continue to feed the buffer with command bytes before all bytes have been clocked out on the Daisy Chain. If the Host MCU cannot keep the buffer full with proper command bytes, the Daisy Chain sends bad data to the devices on the Daisy Chain. This results in the Daisy Chain device receiving a command with a bad CRC and that device responds with a NAK.

**Note:** A command byte needs to be clocked into the SPI port at least one Daisy Chain clock prior to the first Daisy clock placing that byte on the DHI2/DLO2 port. ( $t_{su} > 1 * t_{DAISY}$ )

**Q:** Thanks for the follow up on these issues I was experiencing. I have been using the daisy chain interface successfully since I sped up my host MCU clock rate and forced the  $\overline{CS}$  to SCLK time to be within the working range. I'm glad my frustrations here actually checked out with something on your end, because I spent a while scratching my head and was pretty wowed when I fixed the problem only by speeding up my MCU.
