SLG46108-EV Errata Note

This document contains the known errata for SLG46108-EV and the recommended workarounds.

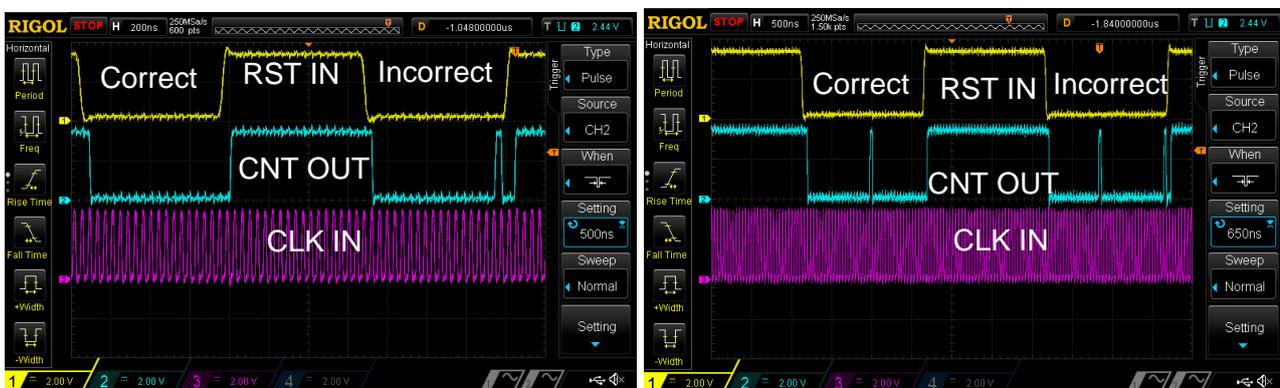
Figure 2. Testing Waveforms

If the Counter Reset is asserted at the same time as a rising clock edge, it is possible that the Counter Data will be reset incorrectly and the counter output may appear faster than expected, it doesn't depend on the edge select option. This phenomenon appears more often as the clock frequency increases.

Synchronize the RESET input of the Counter with its CLK using 2 DFF cells as shown in [Figure 3](#).

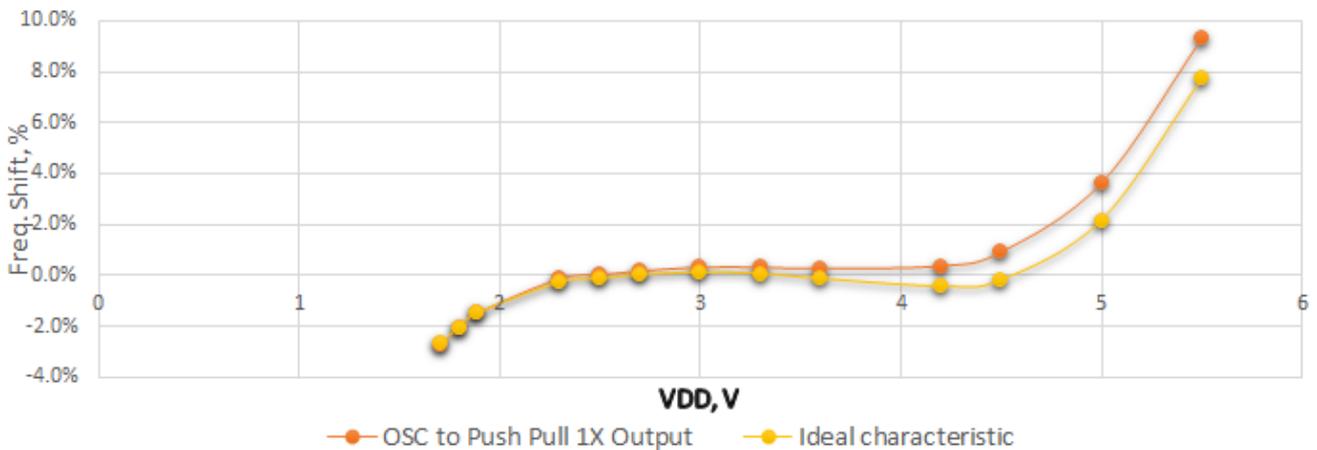
Figure 4. OSC Frequency vs. V_{DD}

While applying some high-frequency noise to the V_{DD}, OSC inaccuracy may increase. The same behavior is also present in cases where high-frequency switches are outputted from the chip using the Push-Pull type driver. See, the test results in Table 1.

- Only use frequencies lower than 2 MHz when switching the output.
- Do not use parallel PIN connections to output high-speed switching signals.

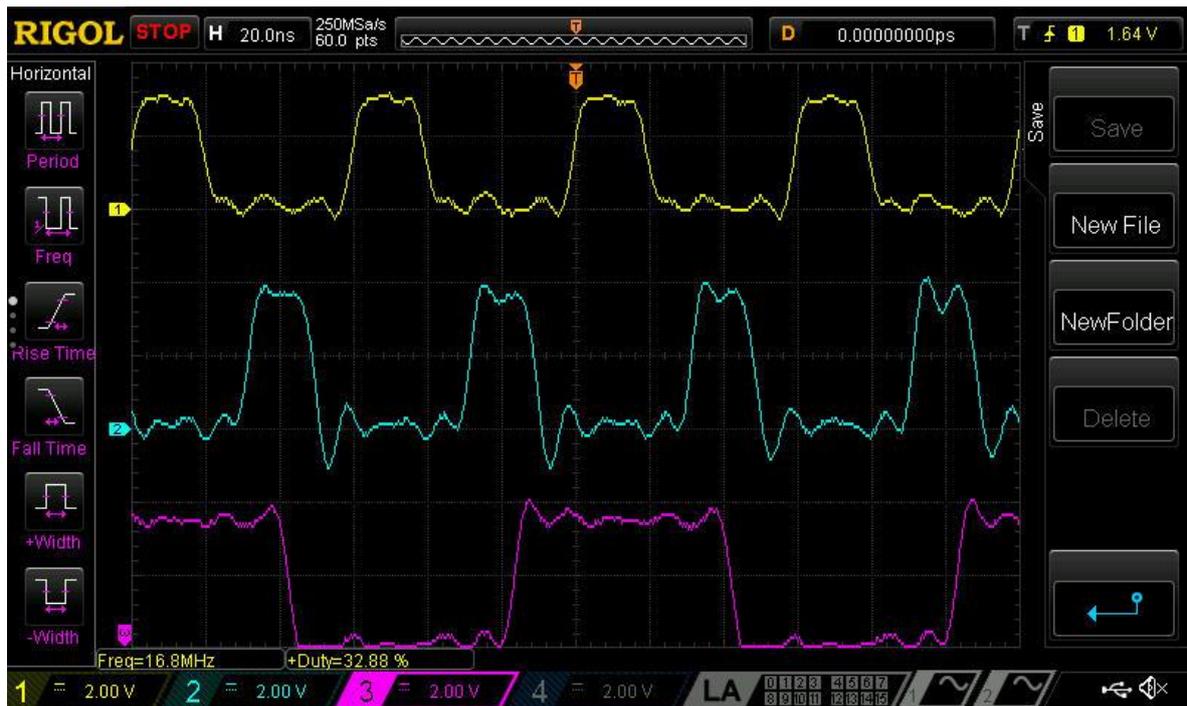
If high-frequency clock input comes in, the FILTER cell may not filter out it. There are several factors like input frequency, duty cycle, and LOW duration in such signal that may lead to its passing through the FILTER block.

Figure 8. Output Waveforms at Period = 60 ns, Pulse Width = 20 ns, DC = 33.3 % (Incorrect Functionality)

Currently, there is no workaround for this issue. Filter block is good at filtering short spontaneous glitches. It is intended to be used in a series connection before the delay cell to avoid its latching.

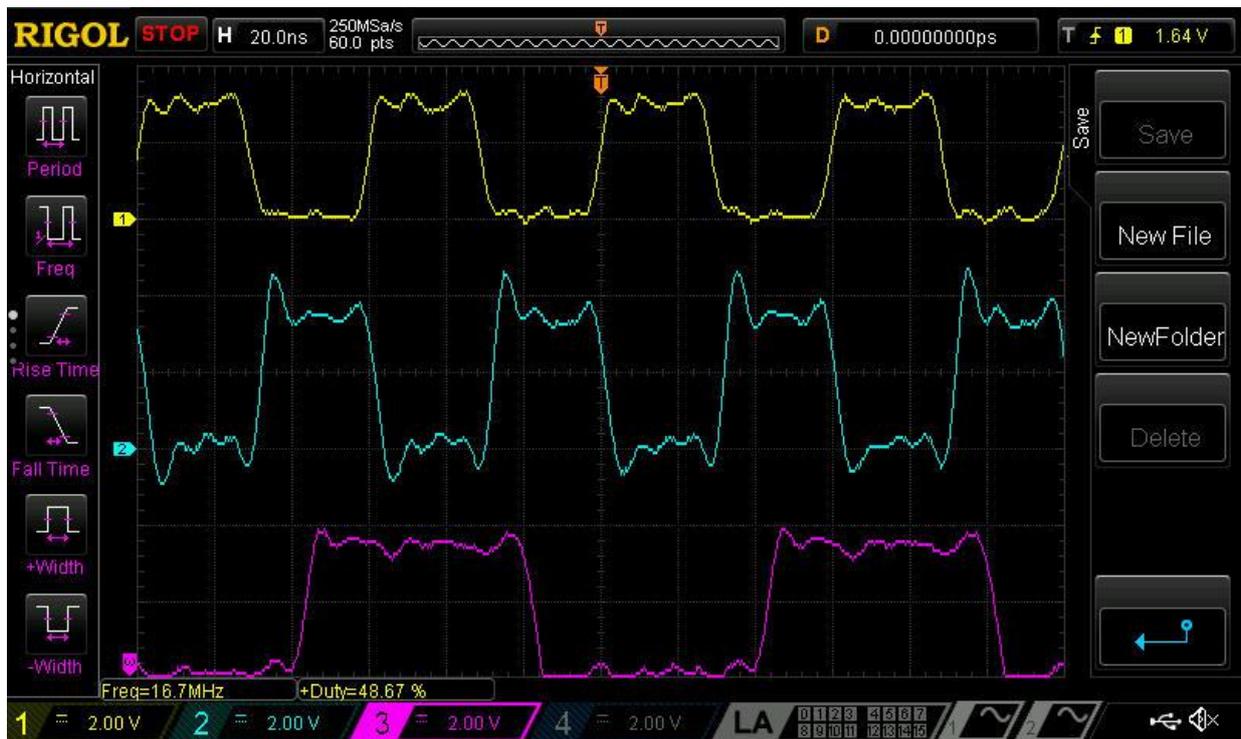
Figure 9. Output Waveforms at Period = 60 ns, Pulse Width = 30 ns, DC = 50 % (Incorrect Functionality)

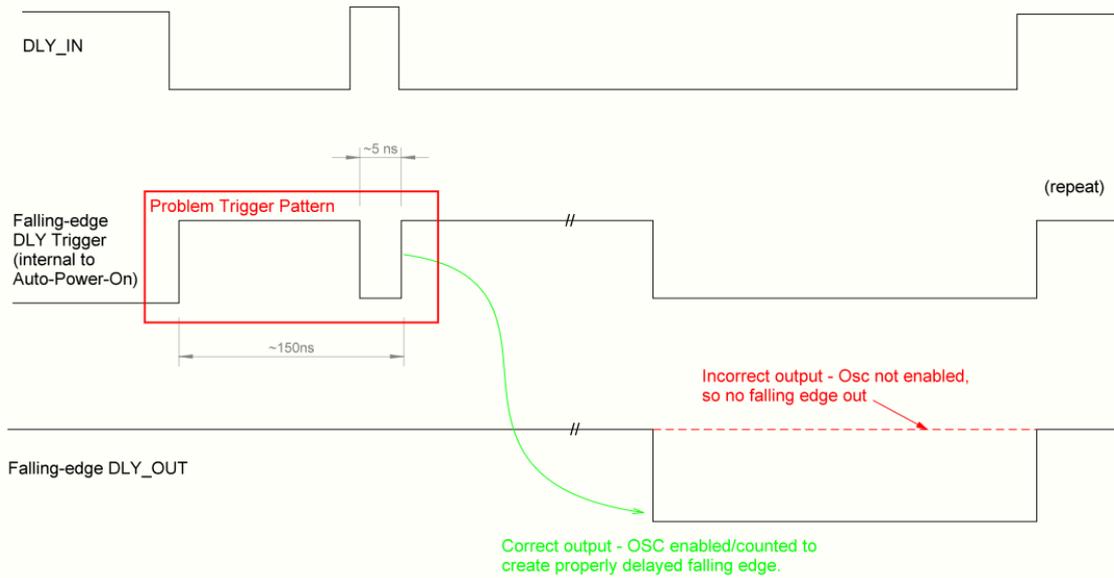
Figure 11. Problem Trigger Pattern

For this chip, the Auto Power On circuitry of the 25 kHz/2 MHz generators contains a circuit errata, which can potentially fail to power on the OSC for a specific pattern and timing of the OR of all related DLY trigger signals. The pattern is shown in Figure 11 (boxed in red) and consists of a relatively longer pulse (~145 ns) followed by a shorter (~5 ns) glitch of opposite polarity.

- Use signal conditioning circuits to prevent glitches on DLY inputs < 200 ns. Examples:
 - ACMP with Hysteresis
 - External RC in front of Digital Input with Schmitt Trigger
 - Filter cell.
- Set OSC power mode to Force Power On mode instead of Auto Power On.
- Use a different oscillator, such as 25 MHz Ring OSC, which does not have Auto Power On issue.

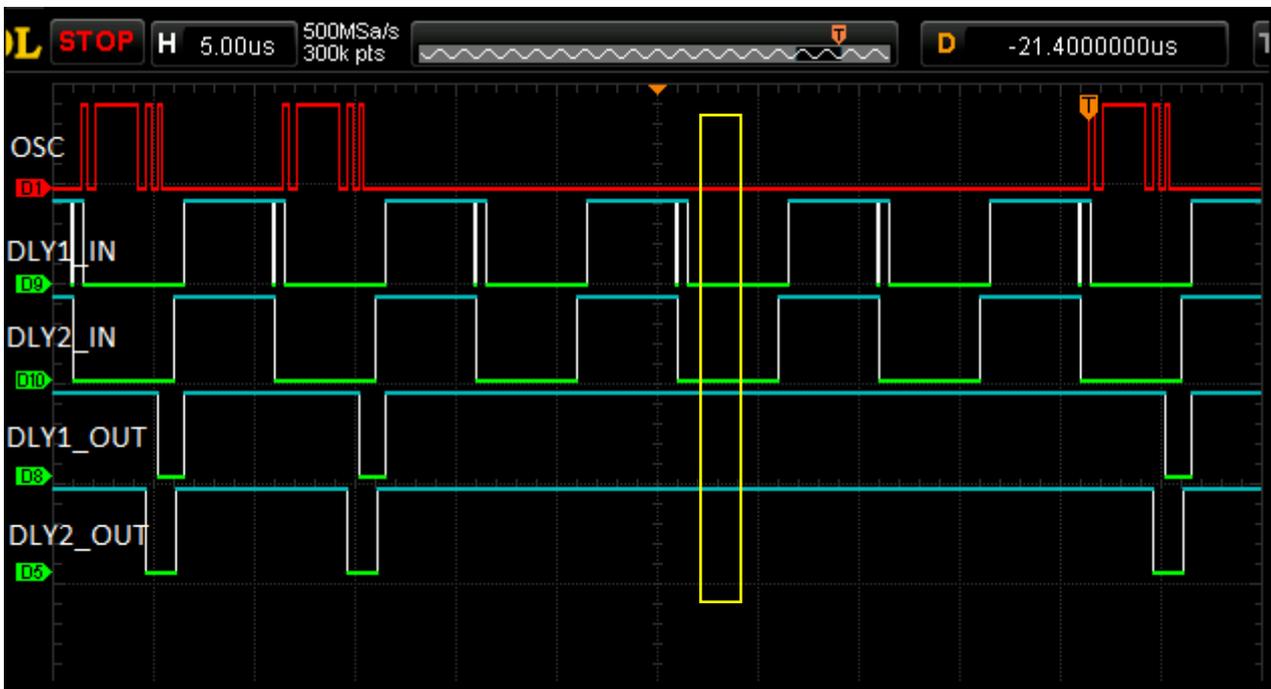
Figure 13. Errata Capture (Zoom Out)

Figure 13 shows a series of DLY output events are missing, where the OSC is correspondingly not triggering when it was supposed to. Figure 14 is a zoom-in of the boxed region from Figure 13. The total glitch/chatter time was measured in this case at 152 ns. By using the composite OR of the two delay channels, we can asynchronously strobe with tiny frequency variations, and so tune the timing to induce this errata. Note that the error is not persistent – the system is recovered when all DLYs are returned to inactive state, such as when input of falling edge DLY goes high, thus canceling delay, or after DLY out finishes.

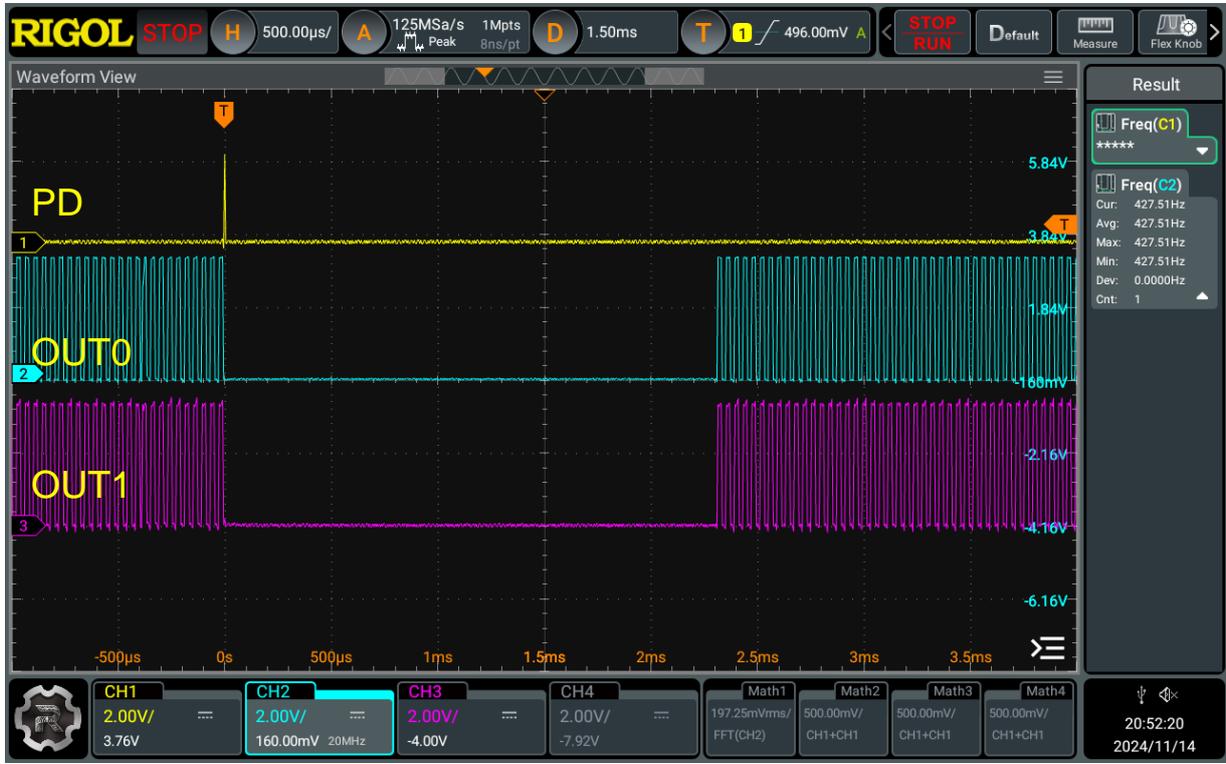
Figure 16. 25 kHz OSC Long Start-Up

If a pulse with a duration of less than ~40 ns is applied to the PWR DOWN input of the oscillator, the oscillator outputs remain stuck for milliseconds, as shown in Figure 16 and Figure 17. This issue is observed for both 25 kHz and 2 MHz oscillators.

Change the Fast Start-up setting to "Enable" (see [Figure 18](#)) or avoid applying glitches to the PWR DOWN input of the oscillator.
