## SLG46108-EV Errata Note

This document contains the known errata for SLG46108-EV and the recommended workarounds.

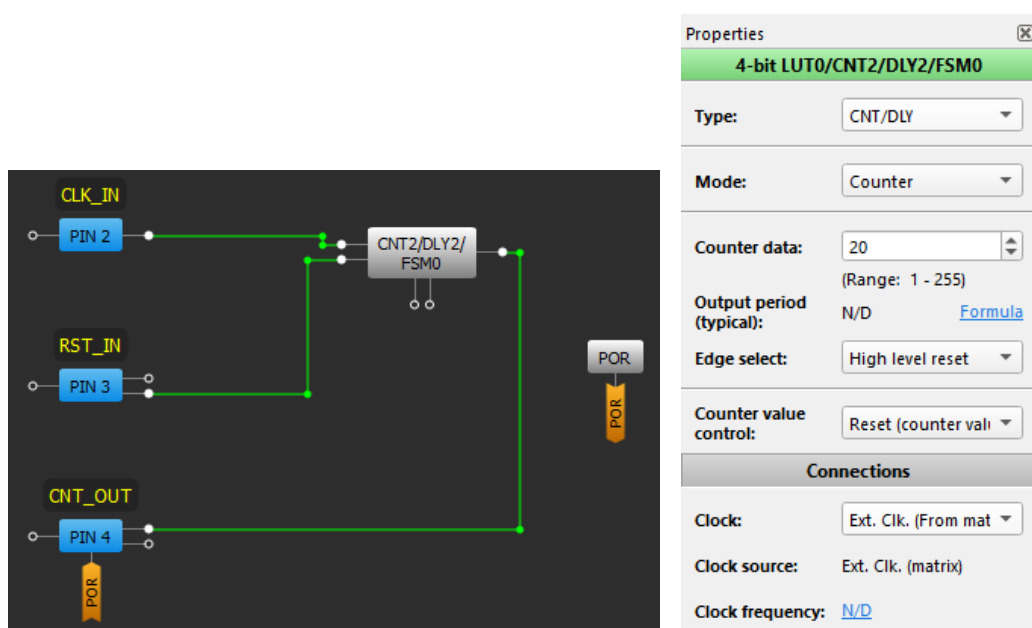
Figure 1. Testing Design and Settings

Counter Reset is asserted at the same time as a rising clock edge

##### 3.1.3. Technical Description

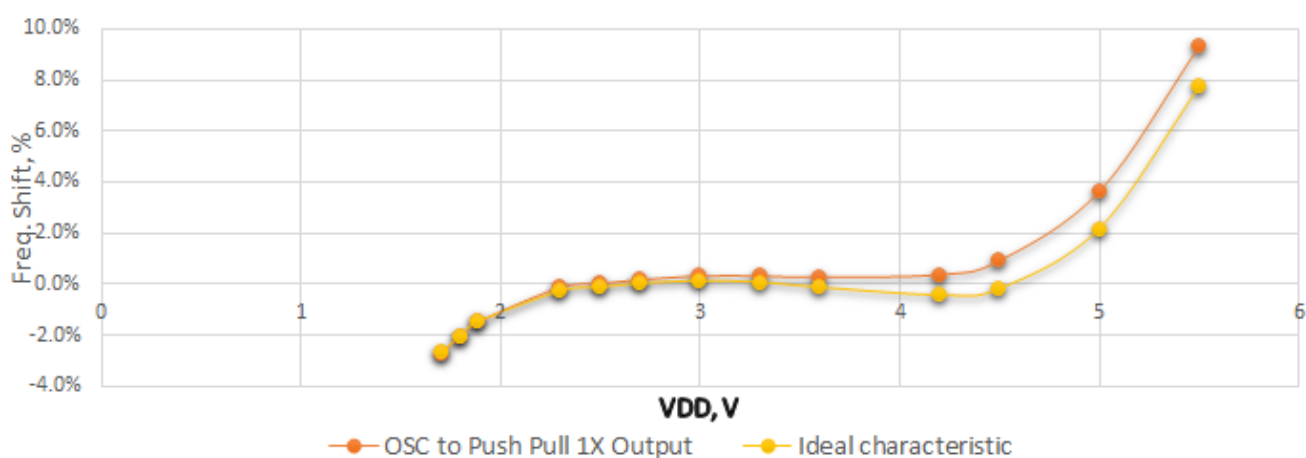
Figure 4. OSC Frequency vs. V<sub>DD</sub>

While applying some high-frequency noise to the V<sub>DD</sub>, OSC inaccuracy may increase. The same behavior is also present in cases where high-frequency switches are outputted from the chip using the Push-Pull type driver. See, the test results in [Table 1](#).

- Only use frequencies lower than 2 MHz when switching the output.
- Do not use parallel PIN connections to output high-speed switching signals.

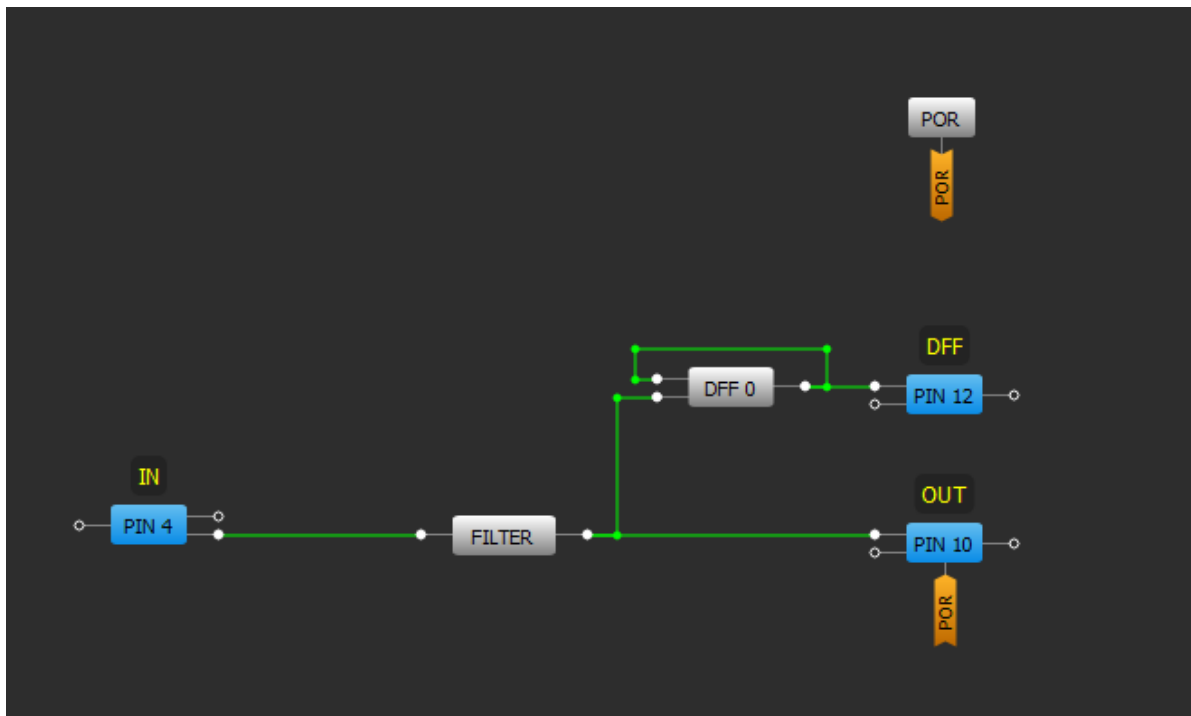
Figure 6. Testing Design

If high-frequency clock input comes in, the FILTER cell may not filter out it. There are several factors like input frequency, duty cycle, and LOW duration in such signal that may lead to its passing through the FILTER block.

Currently, there is no workaround for this issue. Filter block is good at filtering short spontaneous glitches. It is intended to be used in a series connection before the delay cell to avoid its latching.

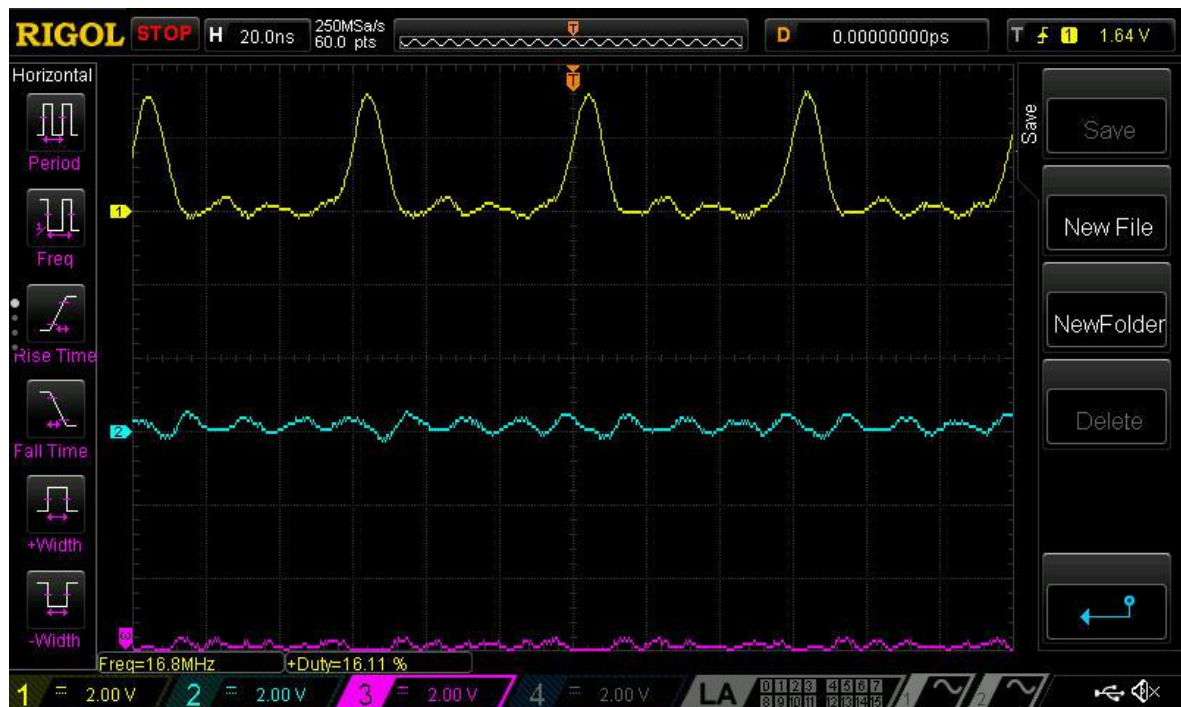
Figure 7. Output Waveforms at Period = 60 ns, Pulse Width = 10 ns, DC = 16.7 % (Correct Functionality)

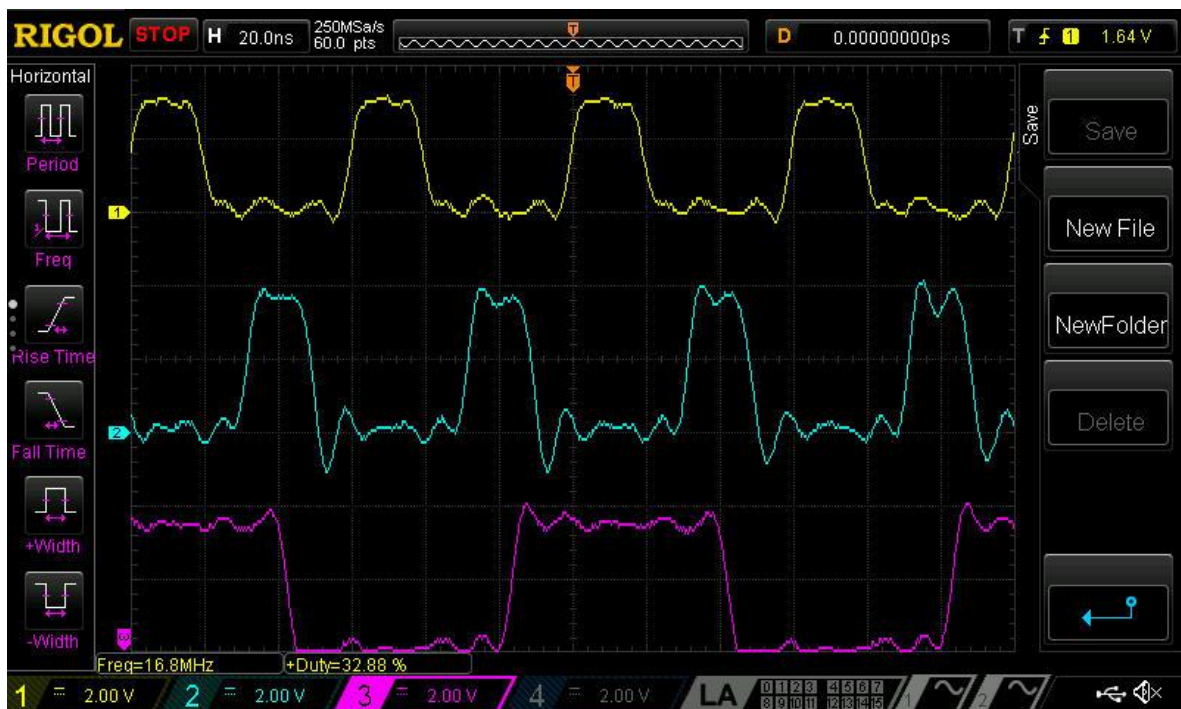
Figure 8. Output Waveforms at Period = 60 ns, Pulse Width = 20 ns, DC = 33.3 % (Incorrect Functionality)

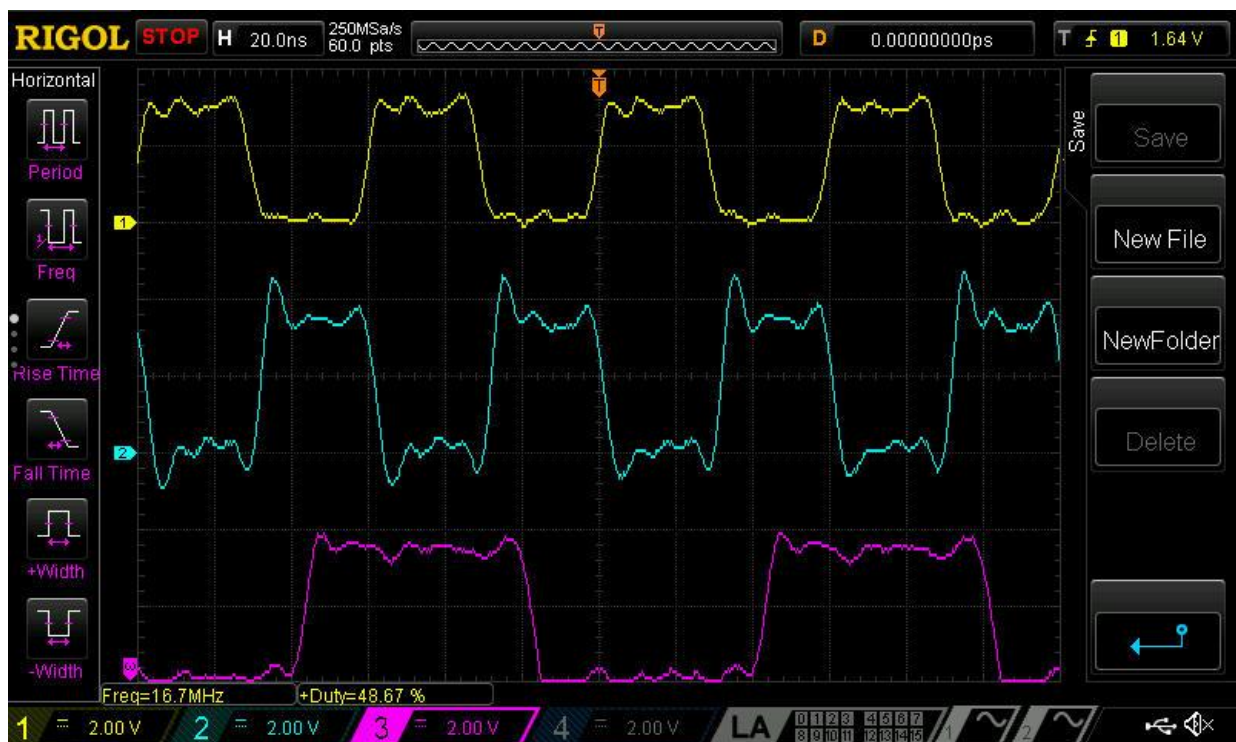
Figure 9. Output Waveforms at Period = 60 ns, Pulse Width = 30 ns, DC = 50 % (Incorrect Functionality)

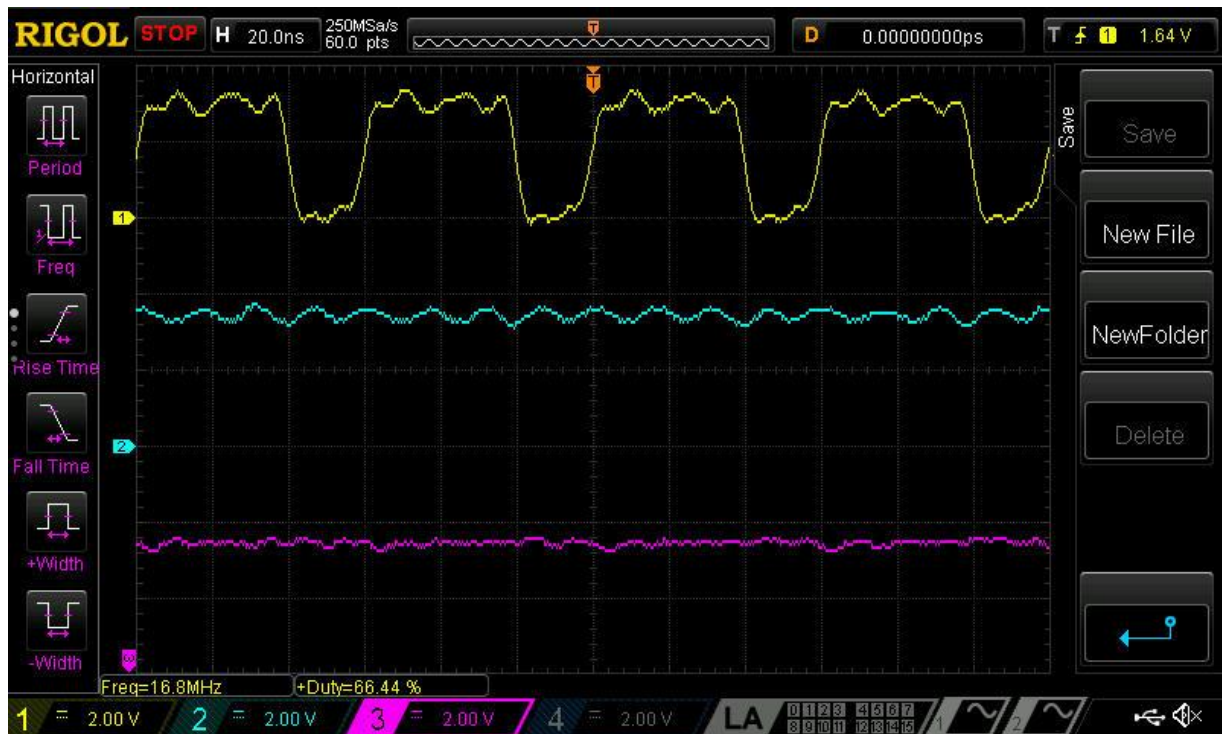
Figure 10. Output Waveforms at Period = 60 ns, Pulse Width = 40 ns, DC = 66.67% (Correct Functionality)

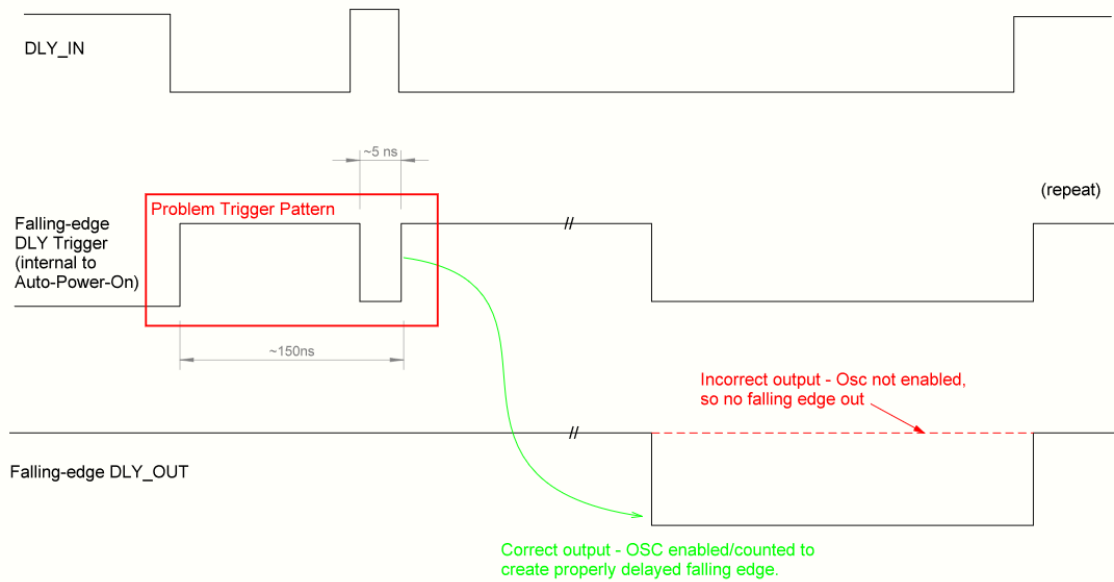
**Figure 11. Problem Trigger Pattern**

For this chip, the Auto Power On circuitry of the 25 kHz/2 MHz generators contains a circuit errata, which can potentially fail to power on the OSC for a specific pattern and timing of the OR of all related DLY trigger signals. The pattern is shown in [Figure 11](#) (boxed in red) and consists of a relatively longer pulse (~145 ns) followed by a shorter (~5 ns) glitch of opposite polarity.

- Use signal conditioning circuits to prevent glitches on DLY inputs < 200 ns. Examples:
  - ACMP with Hysteresis
  - External RC in front of Digital Input with Schmitt Trigger
  - Filter cell.
- Set OSC power mode to Force Power On mode instead of Auto Power On.
- Use a different oscillator, such as 25 MHz Ring OSC, which does not have Auto Power On issue.

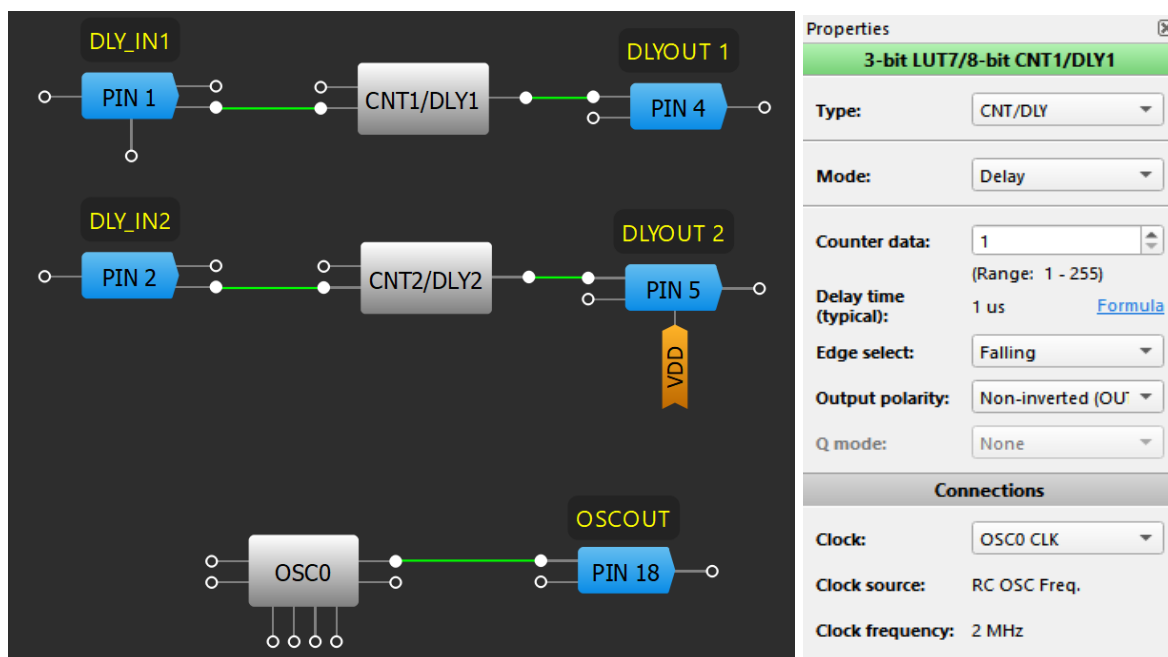
Figure 12. Test Circuit

The error is difficult to capture as the timing must be exact within ns, and short (ns) pulses are difficult to generate glitches precise enough to induce the problem. GPIO naturally filters out ns pulses, so for purposes of errata capture, two simultaneous falling-edge DLY circuits (as shown in [Figure 12](#)) were used. By lining up two delays precisely at a particular timing relationship, we can use the internal Auto Power On (OR logic) to generate the glitch pattern necessary to cause the error.

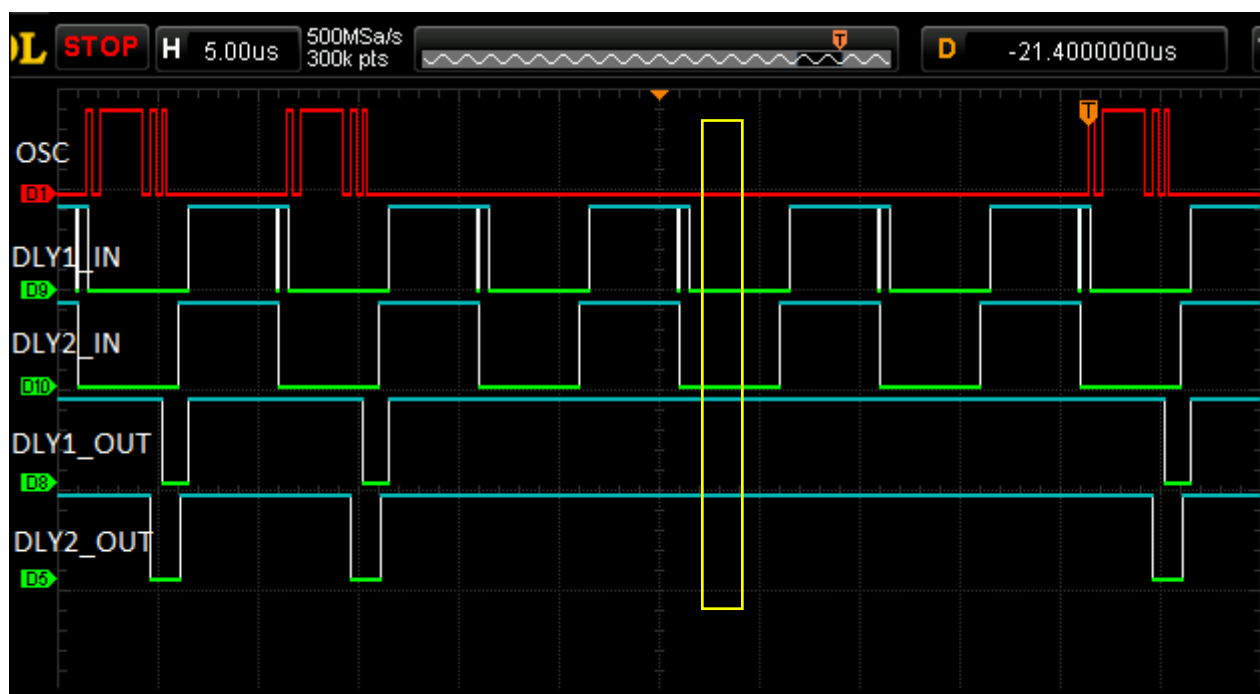
Figure 13. Errata Capture (Zoom Out)

Figure 13 shows a series of DLY output events are missing, where the OSC is correspondingly not triggering when it was supposed to. Figure 14 is a zoom-in of the boxed region from Figure 13. The total glitch/chatter time was measured in this case at 152 ns. By using the composite OR of the two delay channels, we can asynchronously strobe with tiny frequency variations, and so tune the timing to induce this errata. Note that the error is not persistent – the system is recovered when all DLYs are returned to inactive state, such as when input of falling edge DLY goes high, thus canceling delay, or after DLY out finishes.

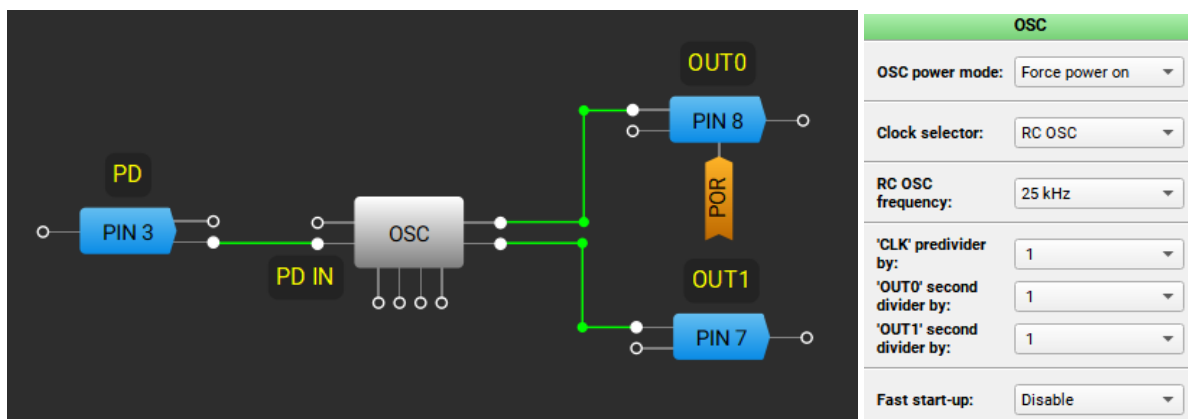
Figure 15. Test Design

When a short pulse is applied to the PWR DOWN input, the oscillator exhibits a long start-up time.

When a short pulse of less than ~40 ns is applied to the PWR DOWN input.
