Errata

SLG46121

CE-GP-019

This document contains the known errata for SLG46121 and the recommended workarounds.

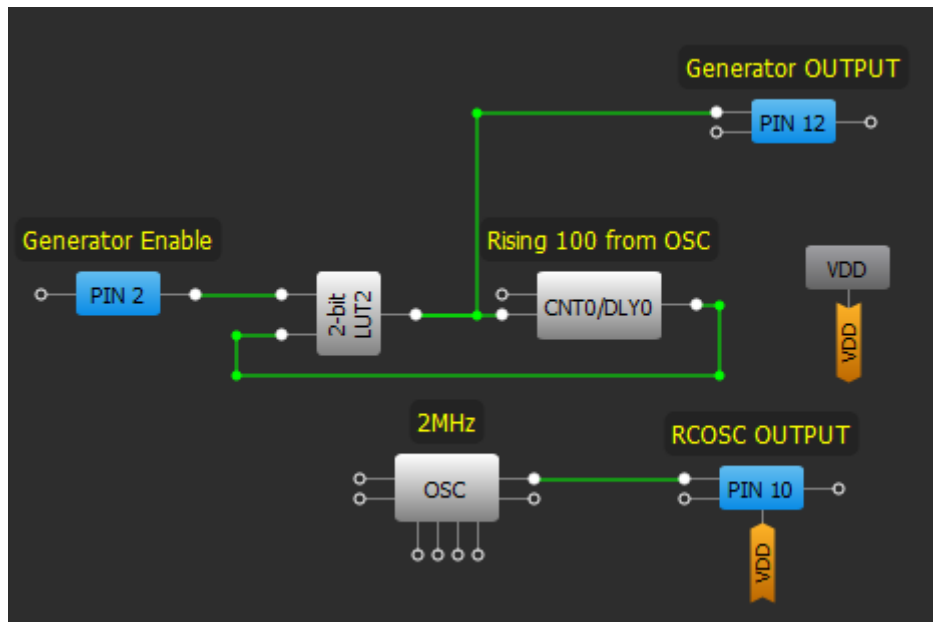
The RC OSC has a longer settling time when configured as 2 MHz with Auto Power On in the designs that have very short RC OSC disable time.

The configuration shown above generates a periodical signal with a frequency defined by the Delay cell and started by a HIGH signal on PIN2. The issue becomes apparent in a longer settling time when the scheme generates short pulses (Delay is configured as a rising edge delay only). See waveform below.

- In first case use block with longer propagation time.

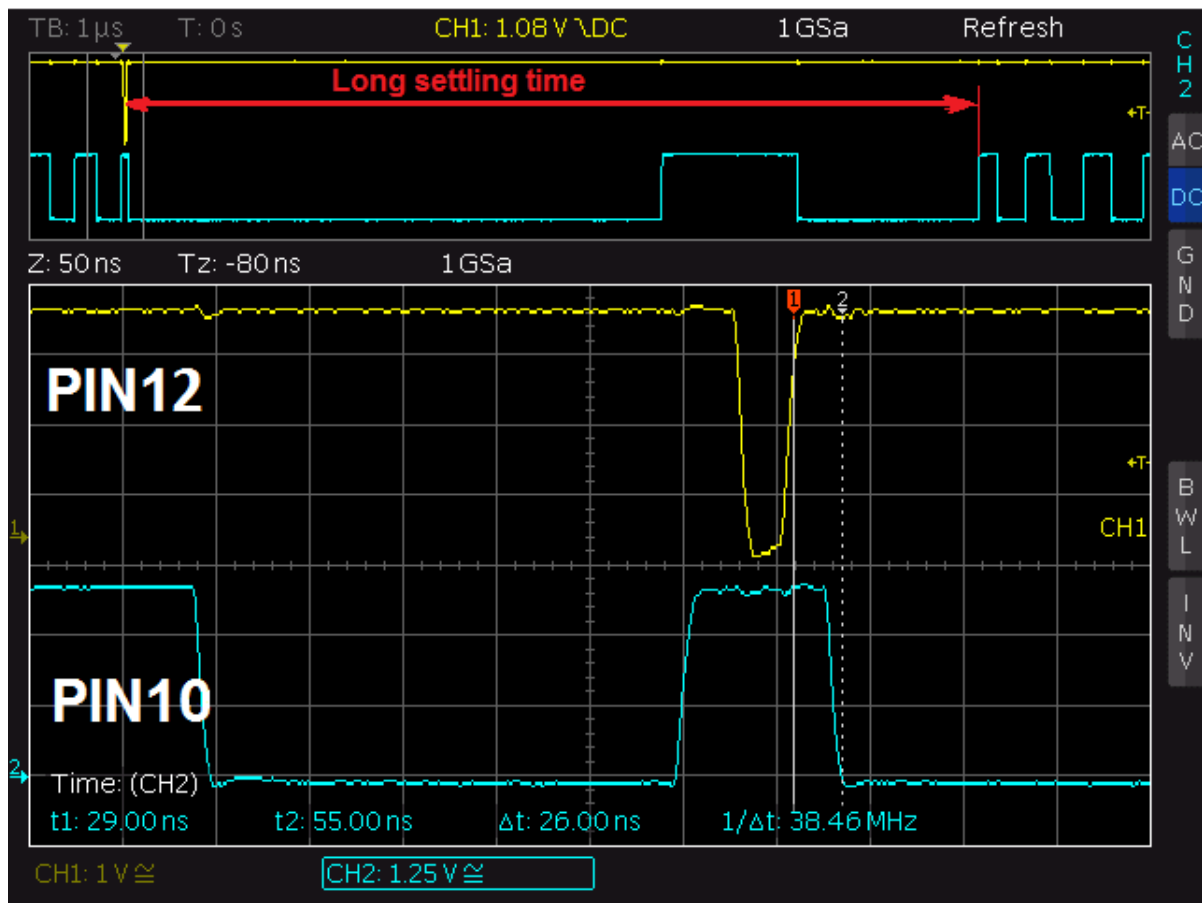
Channel 1 – 2-bit LUT0 output; Channel 2 – RC OSC output

Such behavior will lead to substantial error in period calculations if the delay time is relatively small.

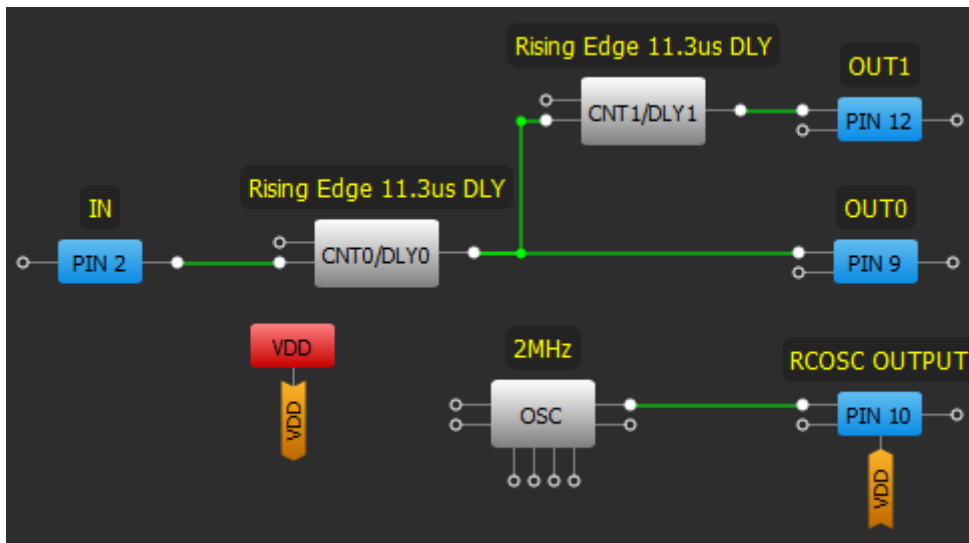
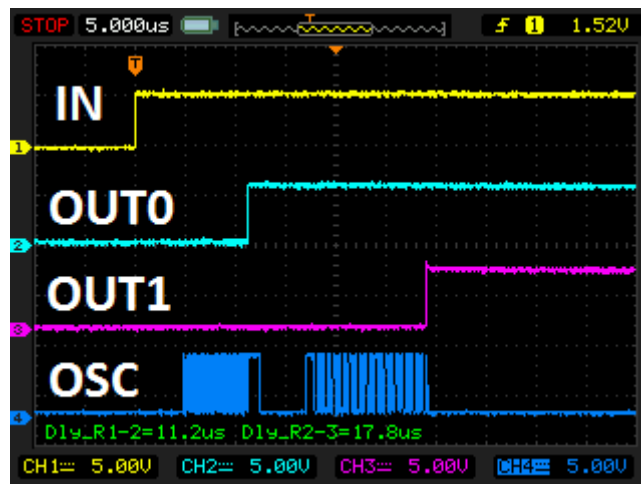
The same situation occurs while using two connected delays (all edge detect types except for a pair “Rising edge DLY – Falling edge DLY”).

In the following example, Delay0 and Delay1 are configured in the same way. However, Delay1 time is 17.8us instead of expected 11.3us (Delay0 time).

- using two delays in series (except for a pair “Rising edge DLY – Falling edge DLY”) use one Filter cell or P DLY between delay blocks. Using LUTs won’t help in this case.

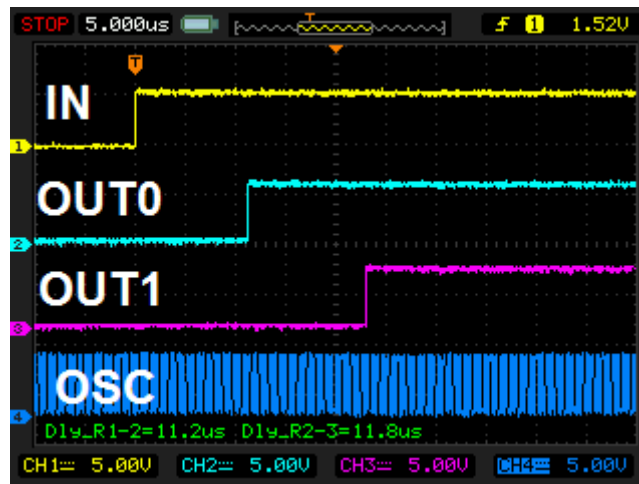
If there are some inner blocks which use RC OSC at the moment or RC OSC is forced power on when such error appears, RC OSC will be operational and delay value will be proper.

- use the “Force power on” RC OSC power control option to make the RC OSC operate at all times.

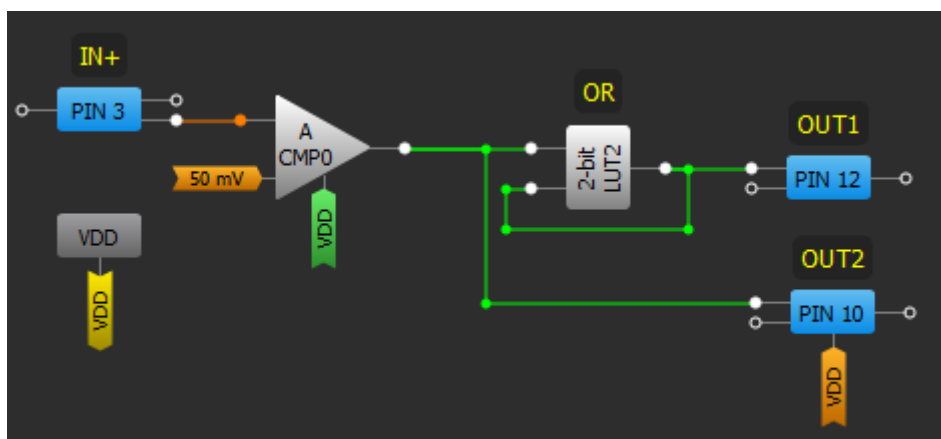
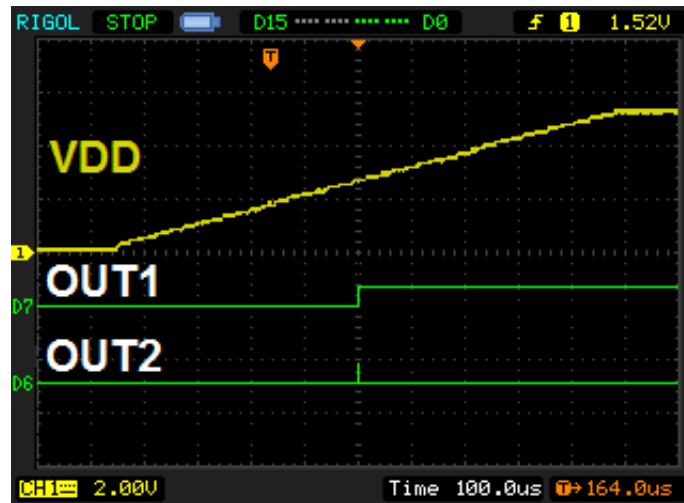
In some cases, ACMP may have short high-level glitches on its output (even if IN+ voltage is less than IN- voltage) after GreenPAK chip being powered up. Such cases may appear when using ACMP with Low Bandwidth mode enabled and Power Up is connected directly to the V_{DD} .

In order to detect such glitches, scheme with additional LUT was used. This LUT detects high level on ACMP output and stays high until chip powers down.

ACMP IN+ is connected to the Ground.

Use POR block, connected to the ACMP's Power Up pin. However, in this case ACMP will start working with low level output and will be able to go high only after POR goes high + ACMP power on time.

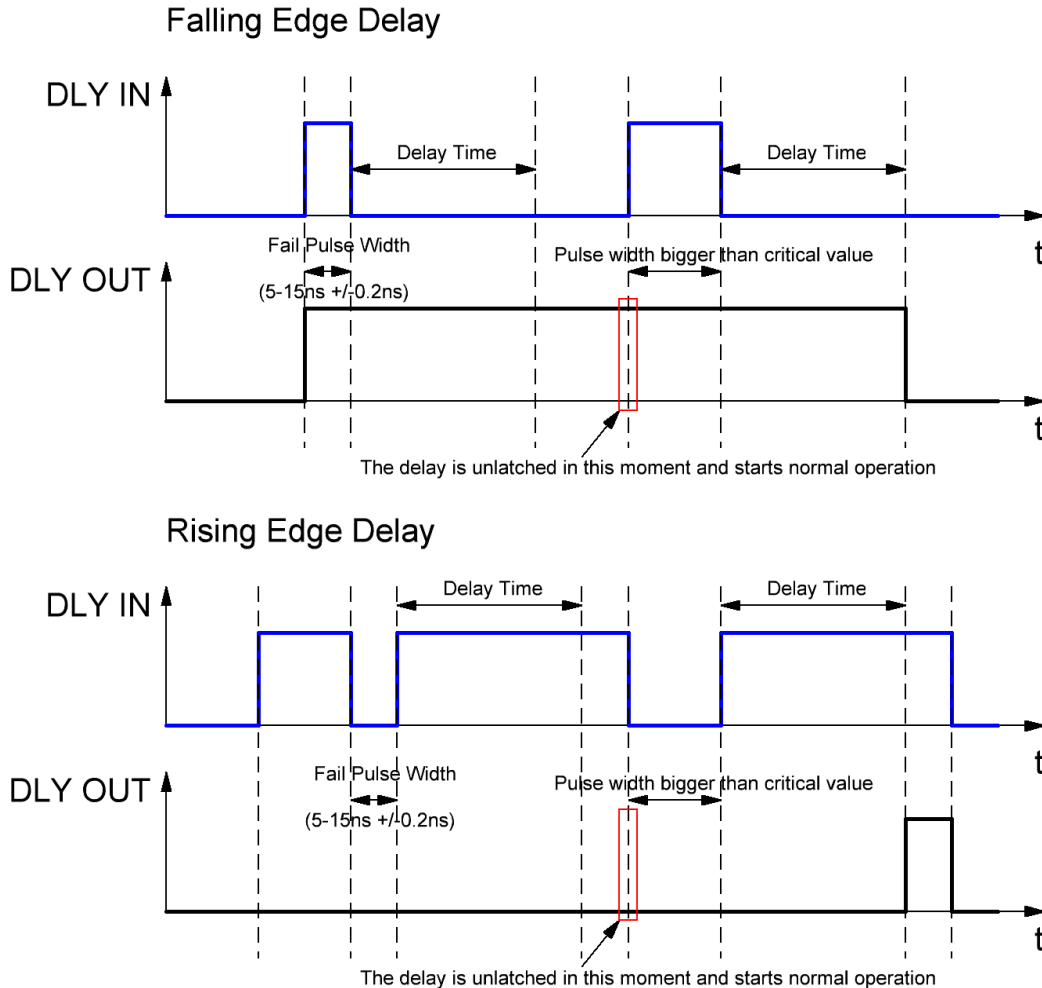
The delay output could be latched despite the input change when a short pulse is input. For example, if the delay cell is configured as a falling edge delay, the short pulse (see NOTE) appears on its input the delay cell output will switch from LOW to HIGH but may not switch from HIGH to LOW even after the delay time has passed.

NOTE: The pulse width varies from chip to chip and with different V_{DD} voltage. It is in range of 5-15ns and in the window $\pm 0.2ns$, so it should be very precise for issue happen.

Use P DLY/FILTER block configured as a both edge delay or FILTER.

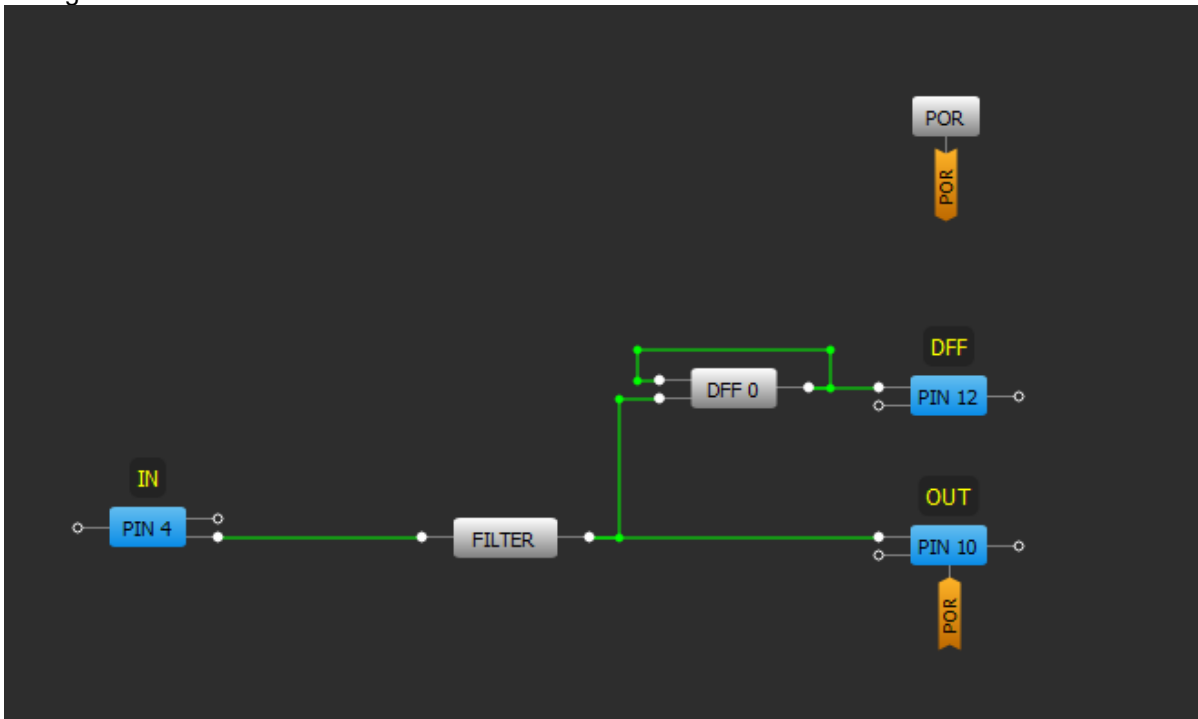
If clock type high frequency input comes in, the FILTER cell may not filter out it. There are several factors like input frequency, duty cycle and LOW duration in such signal that may lead to its passing through FILTER block.

Channel 1 (yellow/top line) – PIN#4 (IN)
 Channel 2 (light blue/2nd line) – PIN#10 (OUT)
 Channel 3 (magenta /3rd line) – PIN#12 (DFF)

1. Period is 60ns. Pulse width is 10ns DC=16.7% (Correct functionality)

Currently there is no workaround for this issue. Filter block is good at filtering short spontaneous glitches. It is intended to be used in series connection before the delay cell to avoid its latching (see issue #5).

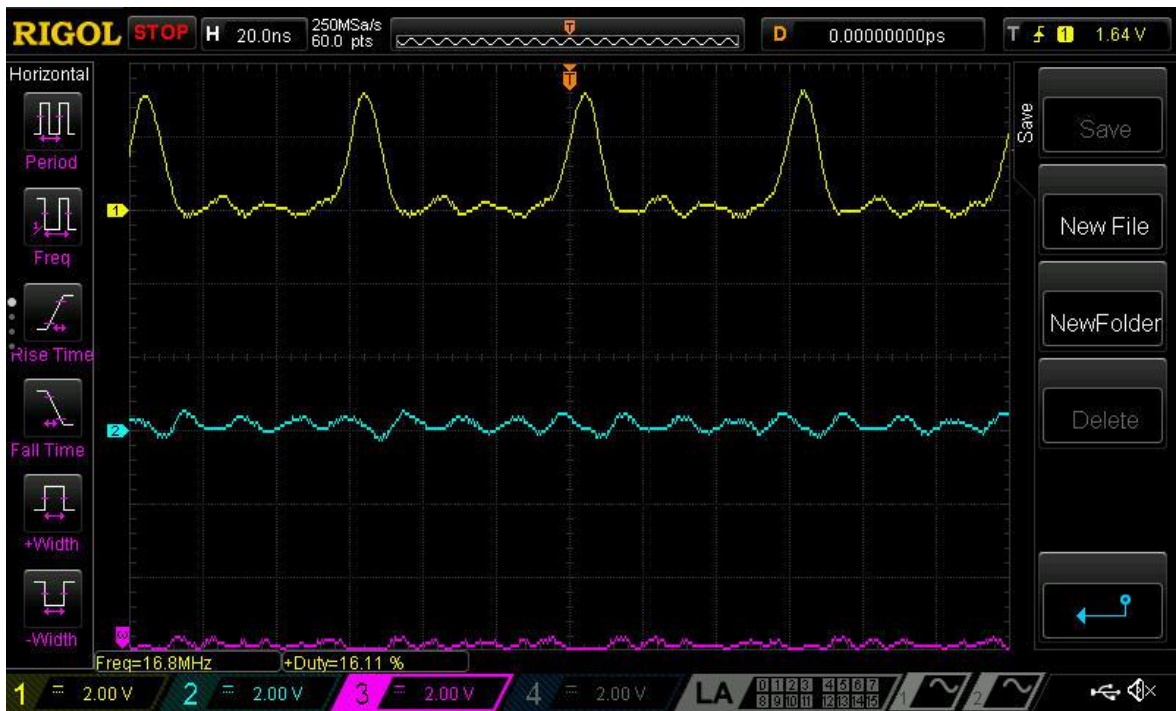
2. Period is 60ns. Pulse width is 20ns DC = 33.3% (Incorrect functionality)

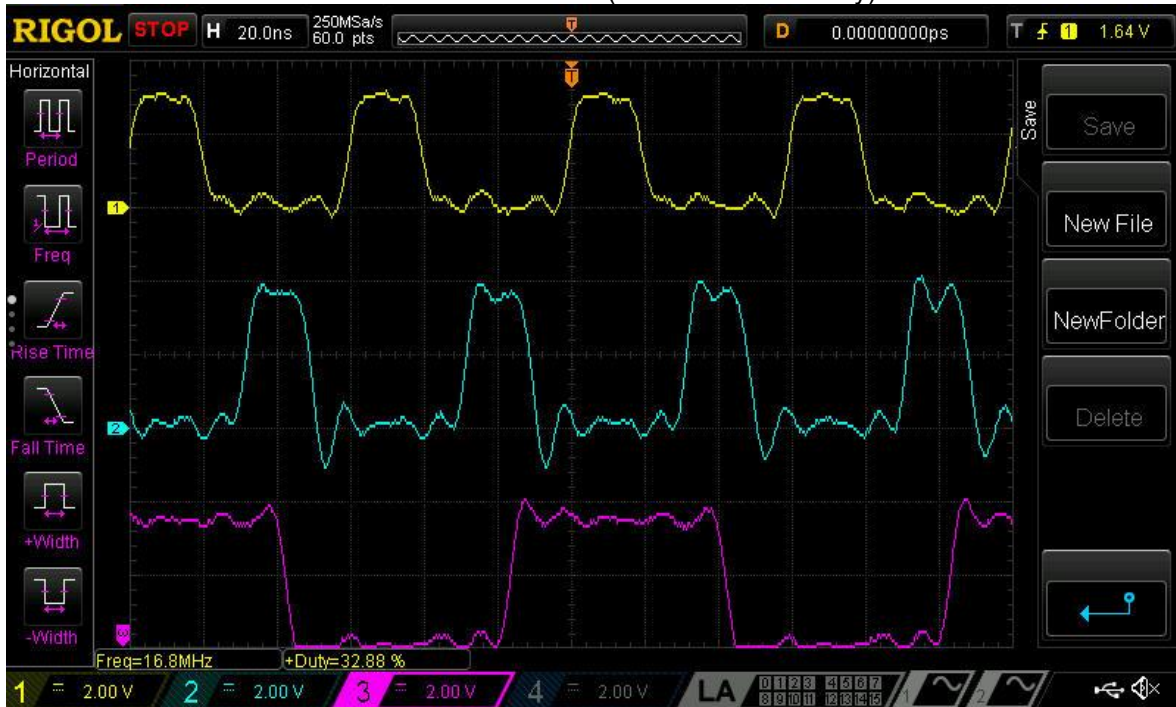
3. Period is 60ns. Pulse width is 30ns DC=50% (Incorrect functionality)

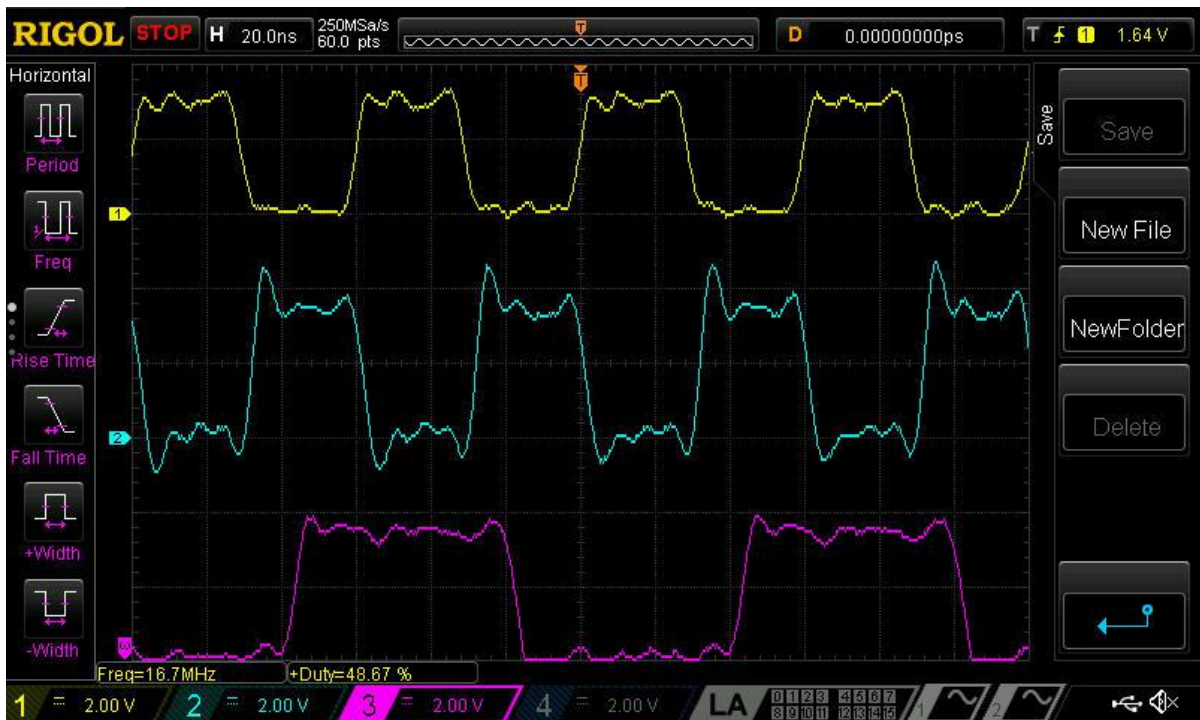
4. Period is 60ns. Pulse width is 40ns DC=66.67% (Correct functionality)

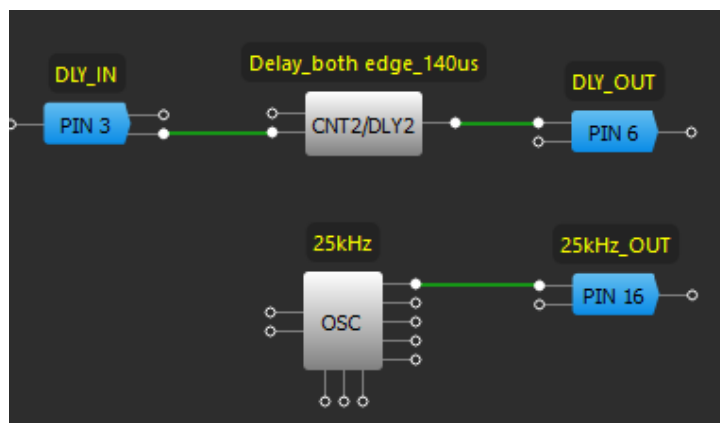
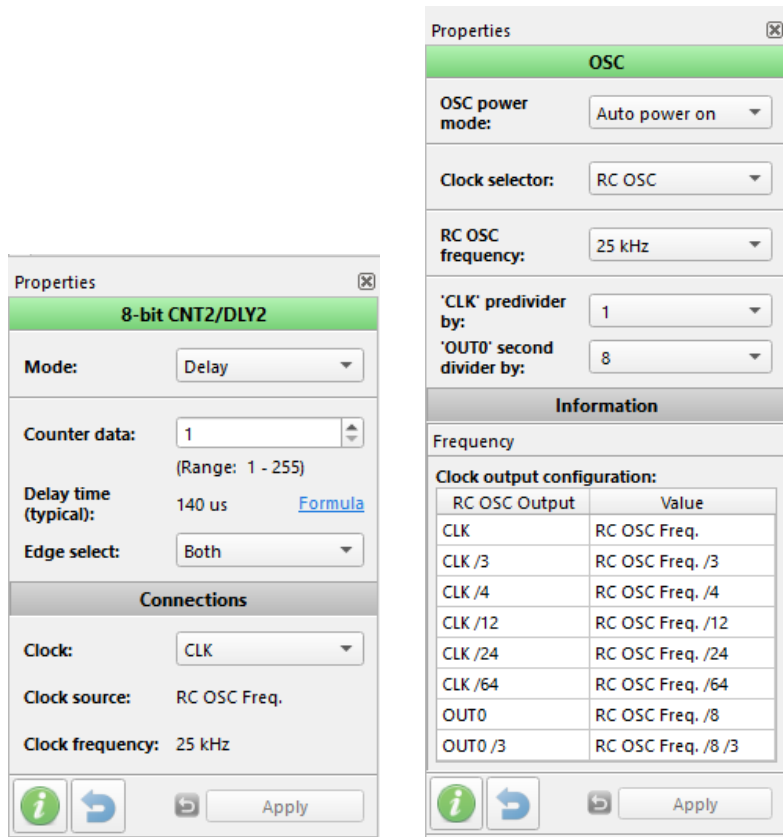
The first period of the RC OSC can be very short when OSC configured as 25 kHz with Auto Power On in the designs. This can be occurred when V_{DD} is above 4.0 V. Critical for CNT/DLY with a low counter data (less than 10) or if it is necessary to use the frequency of the OSC to clock external elements.

- Avoid V_{DD} higher than 4 V
- Force ON OSC

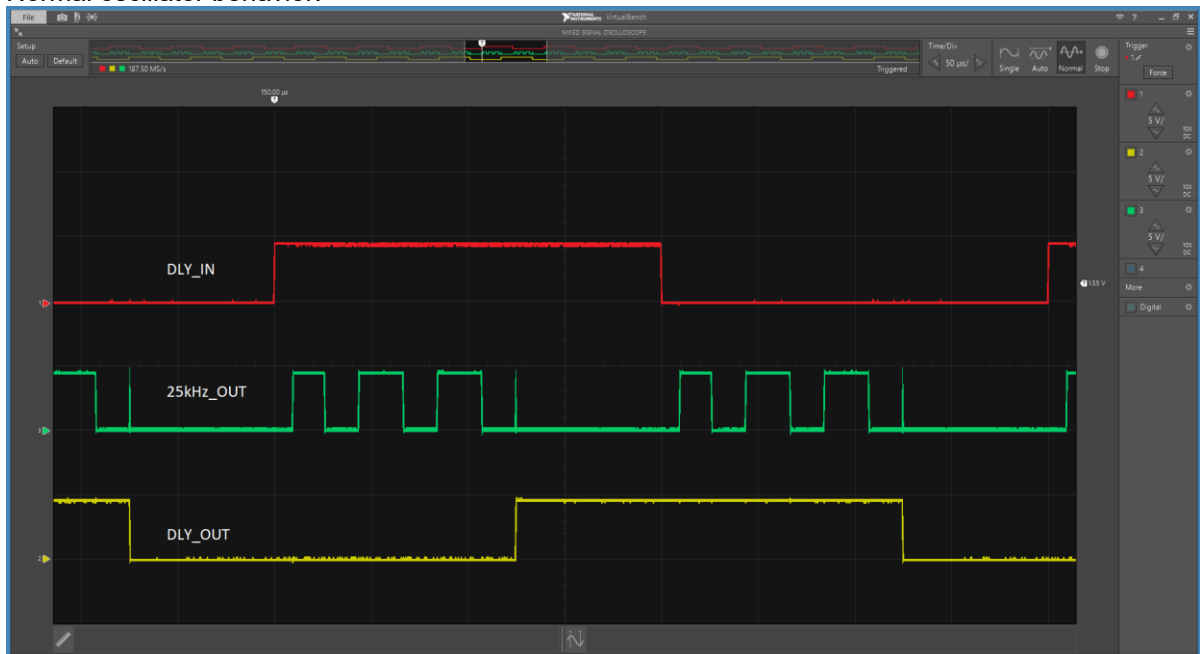
Normal oscillator behavior.

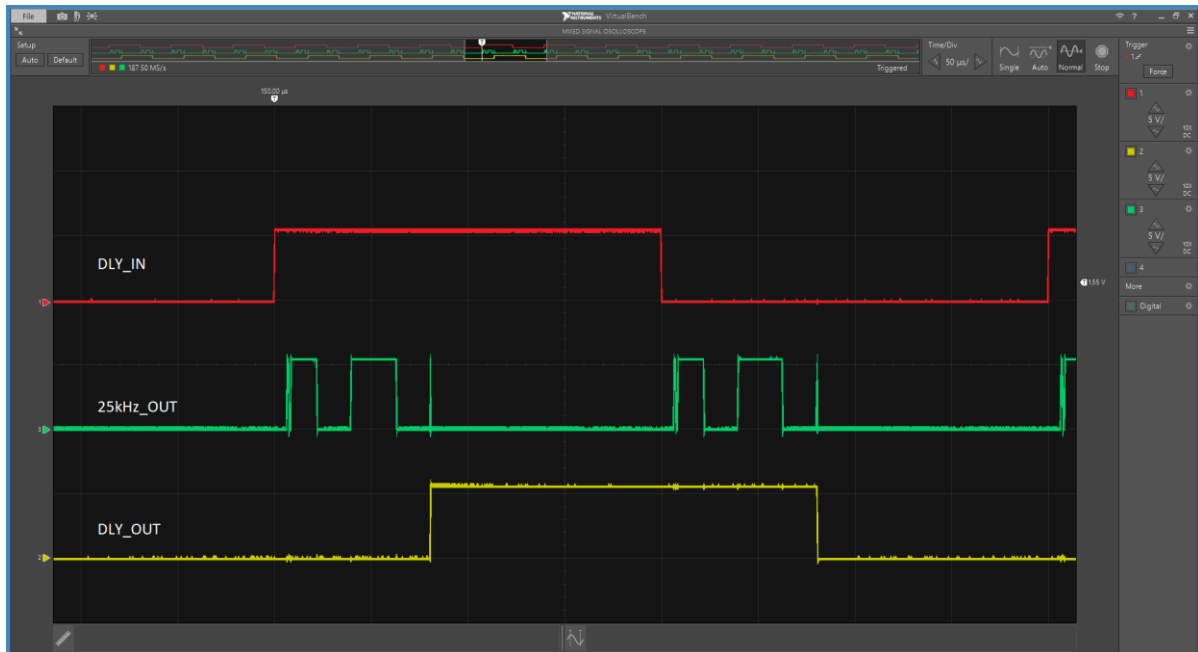
Abnormal oscillator behavior.

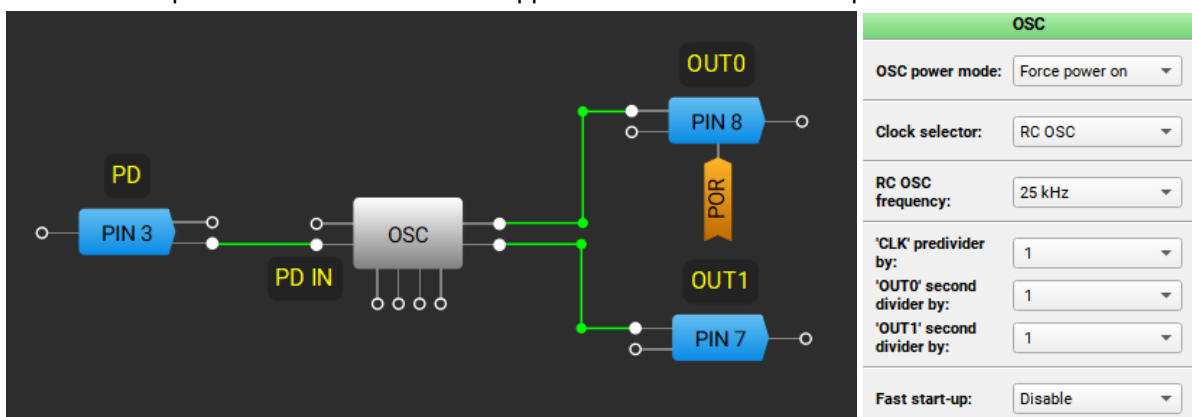
When a short pulse of less than ~40 ns is applied to the PWR DOWN input.

Change the Fast Start-up setting to "Enable" (see figure below) or avoid applying glitches to the PWR DOWN input of the oscillator.

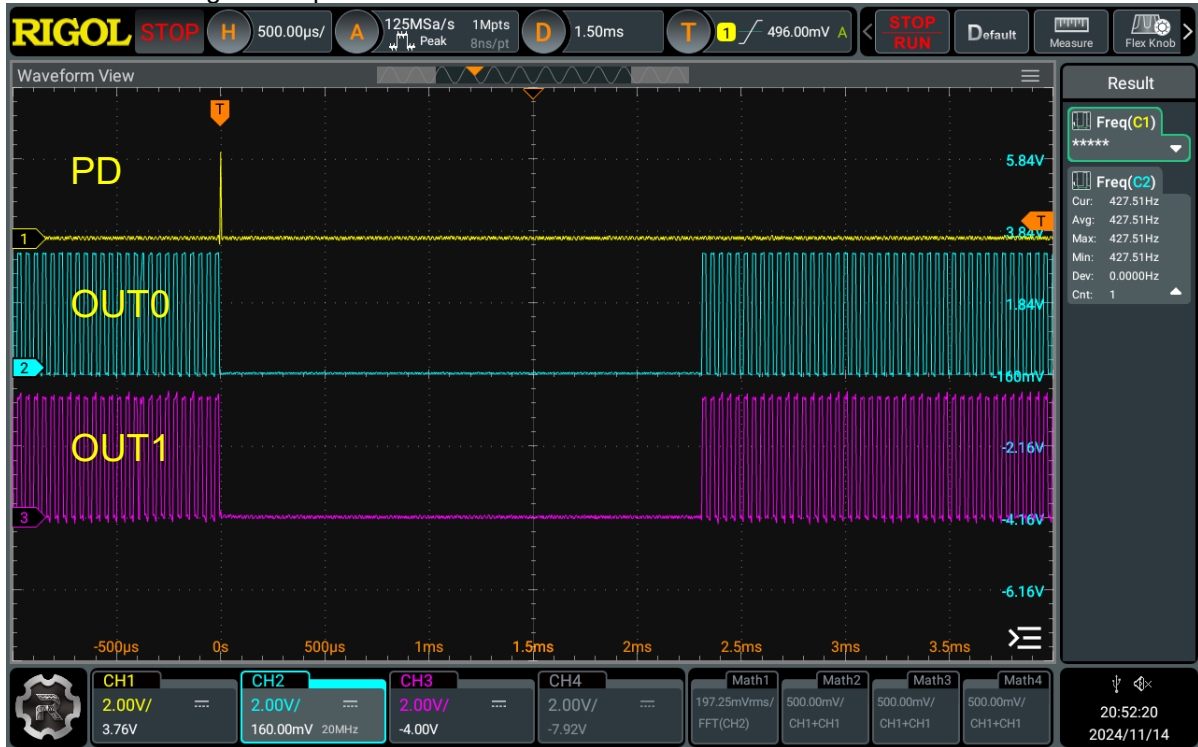
25 kHz OSC Long Start-Up:

If a pulse with a duration of less than ~40 ns is applied to the PWR DOWN input of the oscillator, the oscillator outputs remain stuck for milliseconds, as shown in figures below. This issue is observed for both 25 kHz and 2 MHz oscillators.
