# Errata

## SLG46517

### CE-GP-001

*This document contains the known errata for SLG46517 and the recommended workarounds.*

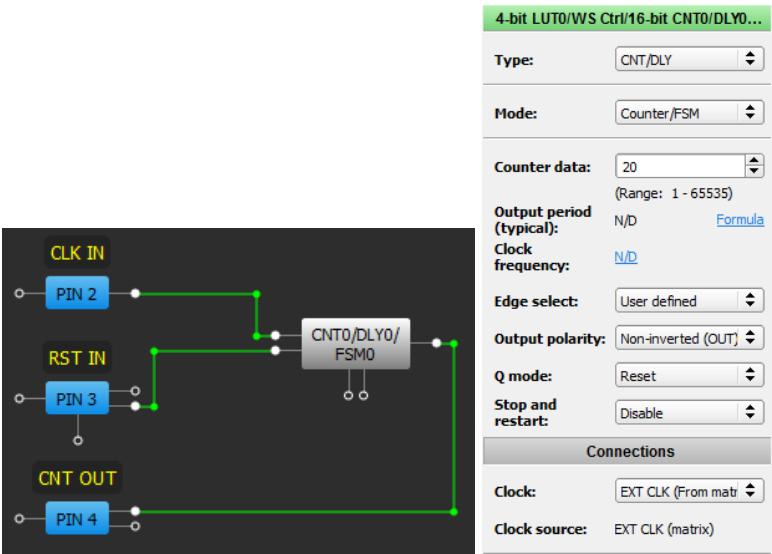
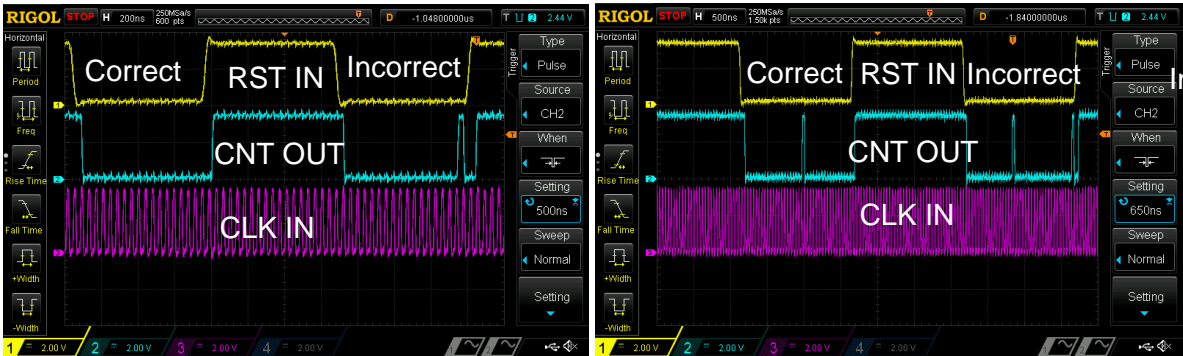
If the Counter Reset is asserted at the same time as a rising clock edge, it is possible that the Counter Data will be reset incorrectly and the counter output may appear faster than expected. This phenomenon appears more often as the clock frequency increases.

Synchronize RESET input of the Counter with its CLK using 2 DFF cells as shown on [Figure 3](#).

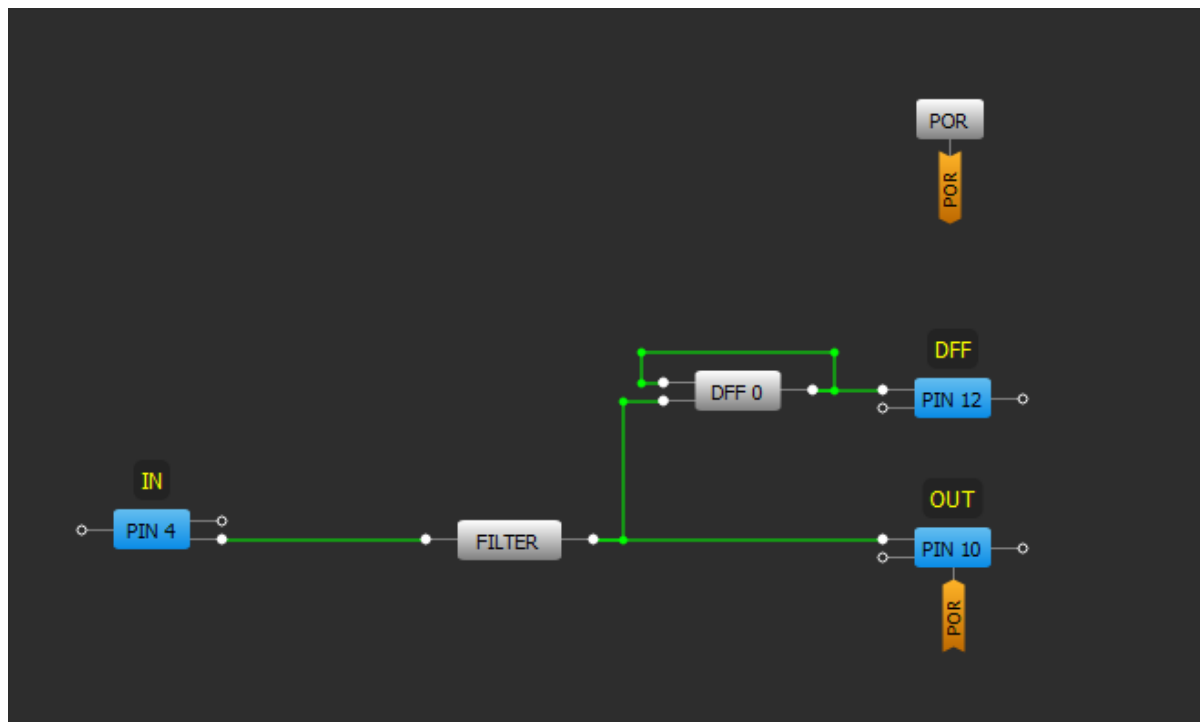
Figure 4

If clock type high frequency input comes in, the FILTER cell may not filter out it. There are several factors like input frequency, duty cycle and LOW duration in such signal that may lead to its passing through FILTER block.

Currently there is no workaround for this issue. Filter block is good at filtering short spontaneous glitches. It is intended to be used in series connection before the delay cell to avoid its latching.

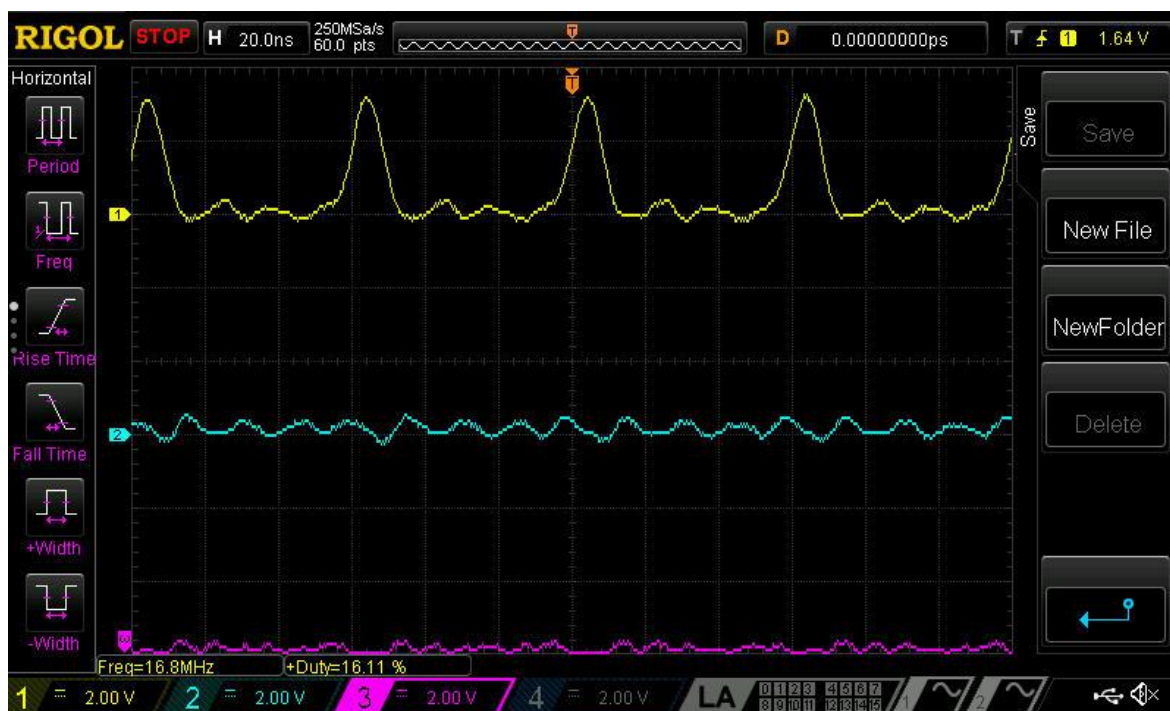
Figure 5

1. Period is 60ns. Pulse width is 10ns DC=16.7% (Correct functionality)

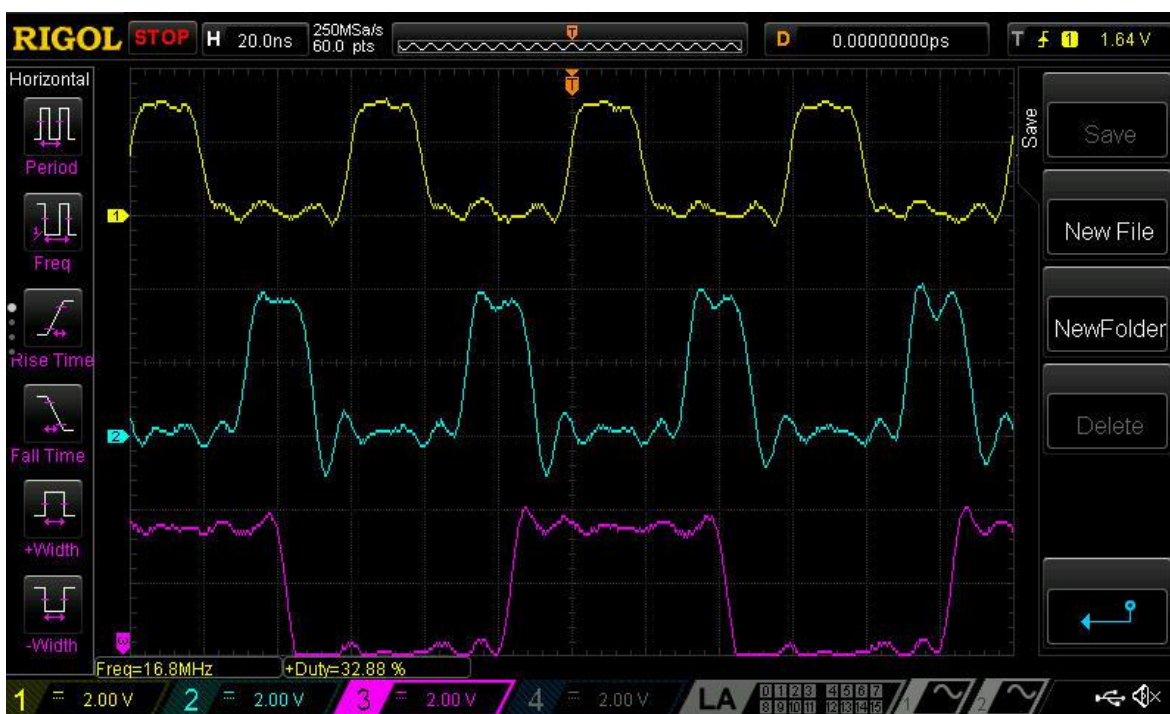
Figure 6

2. Period is 60ns. Pulse width is 20ns DC = 33.3% (Incorrect functionality)

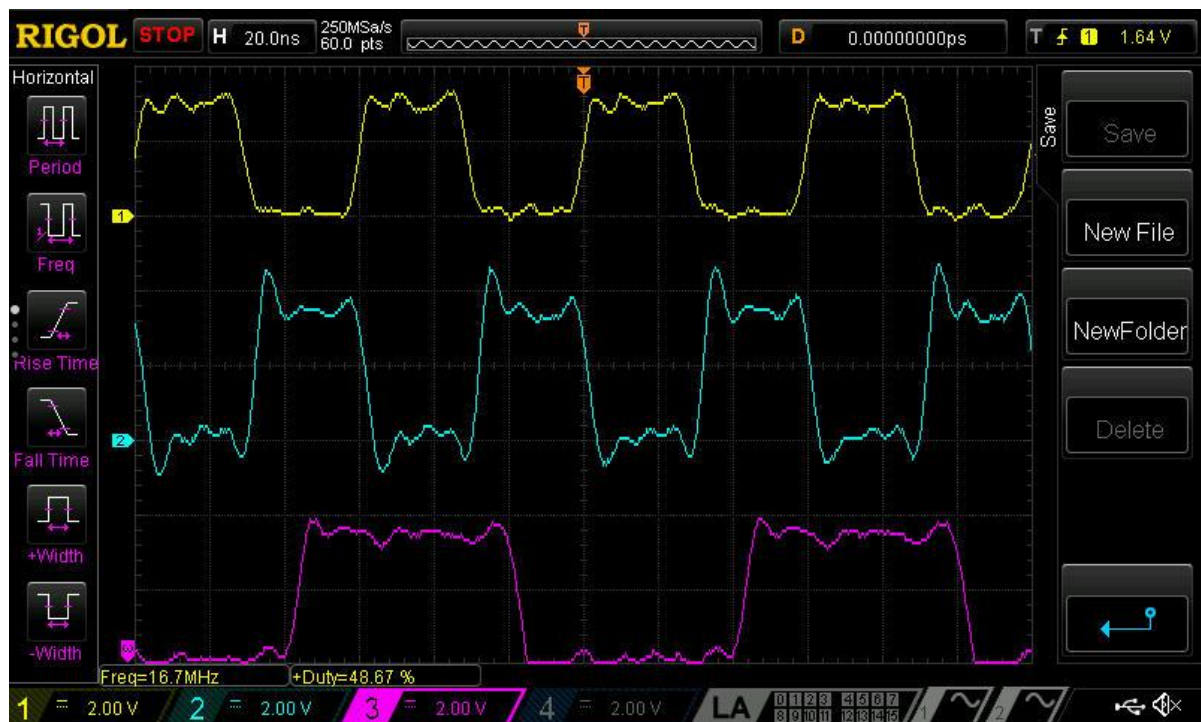
Figure 7

3. Period is 60ns. Pulse width is 30ns DC=50% (Incorrect functionality)

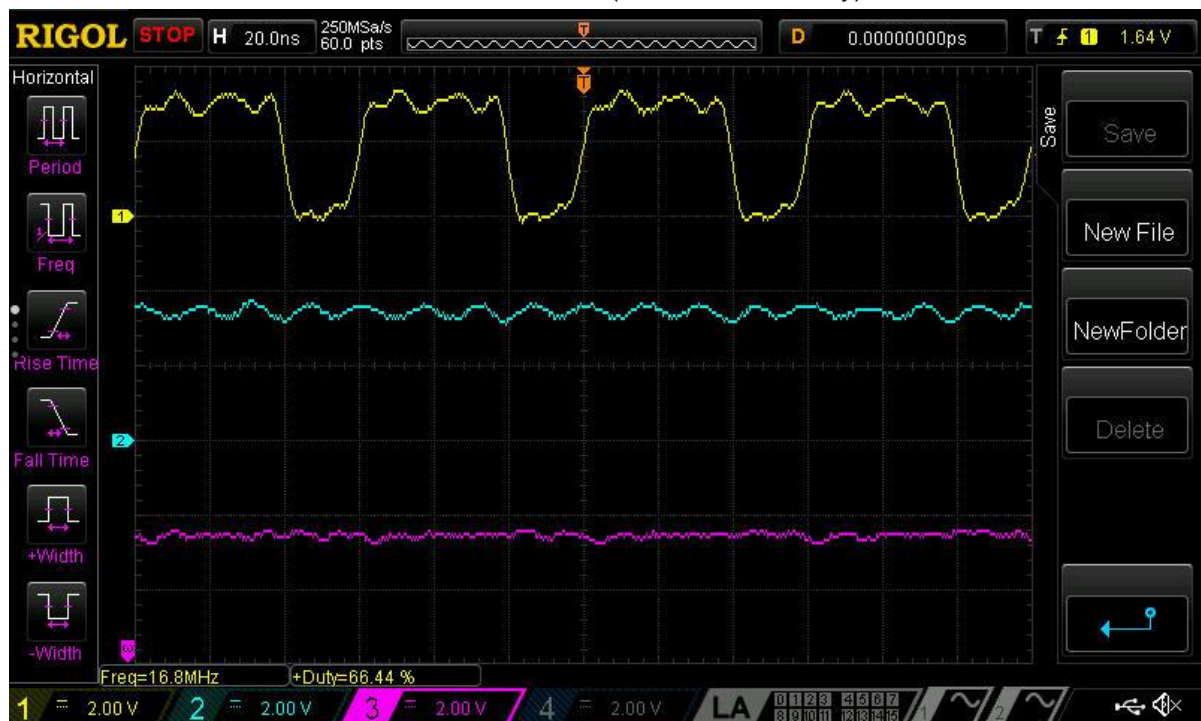
Figure 8

4. Period is 60ns. Pulse width is 40ns DC=66.67% (Correct functionality)

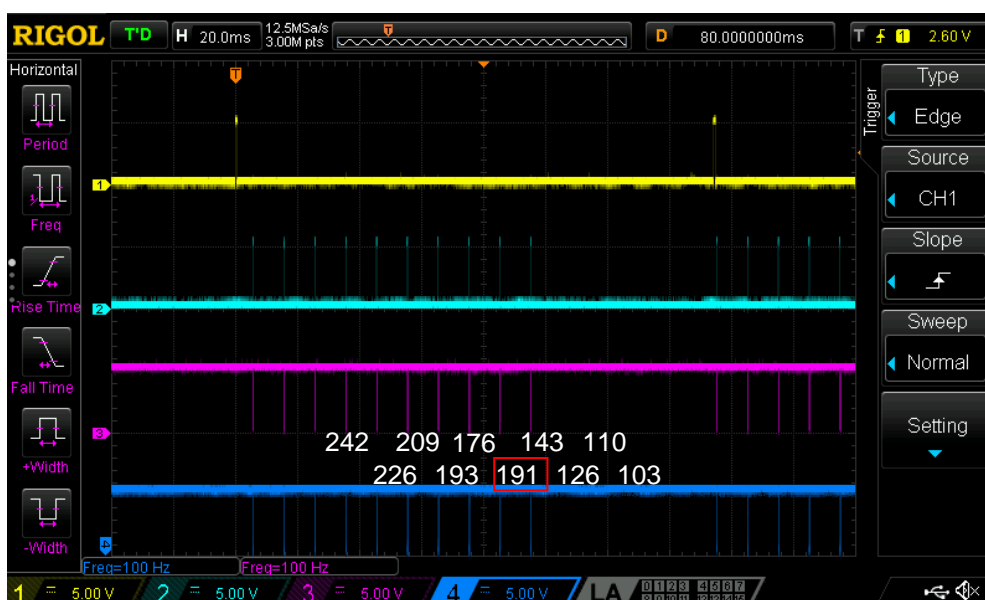
Figure 9

Asynchronous interaction between the CNT/DLY clock input and the I2C latch signal (generated by an I2C read command of the CNT/DLY block's count value) can result in an incorrect I2C data read. The CNT/DLY block will count accurately, but the count value transferred into the block's I2C read register might be loaded incompletely if the I2C latch signal and the clock input occur at about the same time.

The example data capture below shows ten periodic I2C reads of CNT2/DLY2 configured to count down at about 16 clocks per read. The sixth read sample erroneously shows a value greater than that of the fifth. The seventh sample reads as if the previous I2C error never occurred - the difference from the fifth sample (176) to the seventh (143) is 33 clocks or 16 clocks + 17 clocks as expected.

If the possibility of incorrect I2C data reads can't be accommodated for by external software checks, one can guarantee proper operation by stopping the CNT/DLY block's clock during I2C reads

through one of the following methods: by disabling the oscillator block, by reconfiguring the CNT/DLY block's clock source, or by gating an external clock using a LUT (Look-up Table) in the signal matrix. After disabling the CNT/DLY block's clock, the count registers can be read without error. Please note that this workaround will add the I2C read and processing time to the counter's overall clock period.

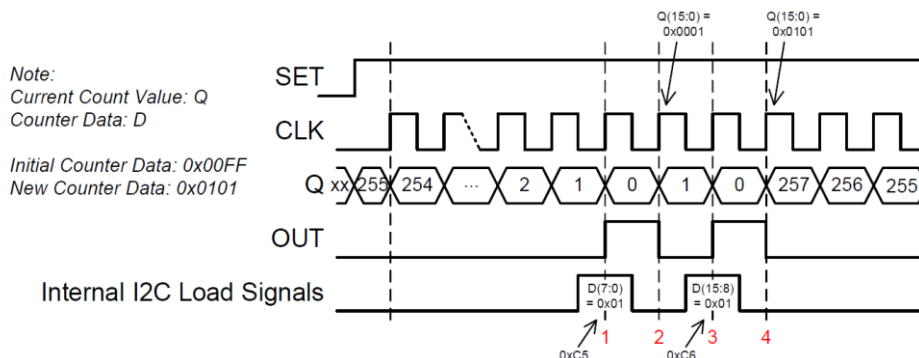
**Figure 10: I2C Write of 16-Bit Counter Data Example**

The timing diagram in [Figure 10](#) sets up a case where an improper output will be seen on the counter. In this example, the initial Counter Data value (D) is set up as 0x00FF. As you can see, the Current Count Value (Q) decrements from 255 down to 0 with rising edges on CLK. At time “1” denoted by a red number 1, an I2C command (not shown) has just been sent to the GreenPAK device to reconfigure the Counter Data value to 0x0101.

As previously mentioned, the 16-bit value is loaded from the I2C buffers to the Counter Data registers in 8-bit chunks. Right at time “1”, the LSB byte (0x01) is loaded into the Counter Data registers. This makes the Counter Data value temporarily equal to 0x0001. At time “2” between the internal I2C load signals, the counter receives a rising edge on its clock input. This causes the Current Count Value to underflow and to be loaded with the Counter Data value which is 0x0001. At time “3”, the MSB byte (0x01) is loaded into the Counter Data registers setting the Counter Data value to 0x0101. At time “4”, the Current Count Value underflows again and is set to the Counter Data value of 0x0101.

This behavior results in two output pulses on OUT when only one pulse is expected. Observing this behavior depends upon the asynchronous timing between the counter's clock and the I2C write command to the Counter Data registers. For some applications, the extra pulse on OUT can be ignored and the counter will self-correct after underflowing, overflowing, or being SET/RESET through the GreenPAK connection matrix.

I2C Write of Counter Data: Accommodate for the double pulse described in Case 1.

Disable the counter's clock during the I2C write.

Manually SET/RESET the counter after the I2C write is complete.

Disregard the first set of pulses on the counter output after an I2C write by waiting for one counter cycle to complete. This allows the counter's DFF chain to be loaded with the new Counter Data value after the counter overflows/underflows.

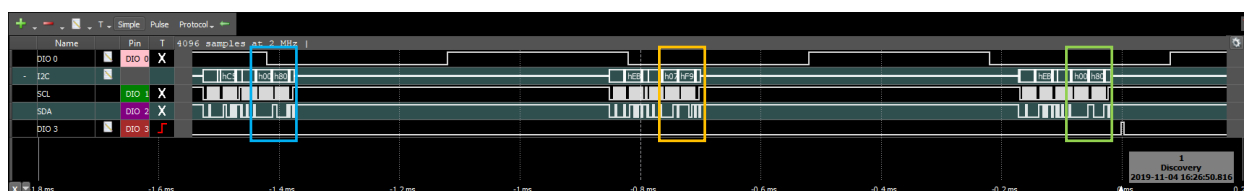
Figure 12: Counter Behavior

For the following condition, the Counter Data register contents are unexpectedly loaded into the counter’s DFF chain. This behavior occurs when there is a falling edge on the counter block’s clock input during the data return portion of an I2C read of the Counter Data registers. Figure 10 shows this falling edge boxed in light blue followed by two I2C reads of the Current Count Value registers.

As you can see by the MCU data log below, the Current Count Value gradually increases from 0xF904 to 0xF907 but is unexpectedly reset to 0x8000. Please note that the colored HEX values in the MCU Log correspond to the boxed I2C read commands shown in the waveform above. As previously described, this reset occurs because there is a falling edge on the counter’s clock input while the GreenPAK device is responding to an I2C read request to 0xC5 and 0xC6. (Note that 0xC5/0xC6 are the Counter Data registers and 0xEB/0xEC are the Current Count Value registers for CNT0.)

The reason that the counter isn’t set to 0x8000 on the I2C read immediately following the Counter Data query is because the counter requires two rising edges on its clock input to load the data from the Counter Data registers into the DFF chain. Note that all rising edges during  $T_{stop}$  will be gated internally by the “Stop and Restart” feature.

I2C Read of Counter Data: Avoid reading Counter Data via I2C while the counter is being clocked.

Within the MCU, we recommend saving the Counter Data register configuration as a software variable so that the Counter Data register doesn't need to be read during counter operation.

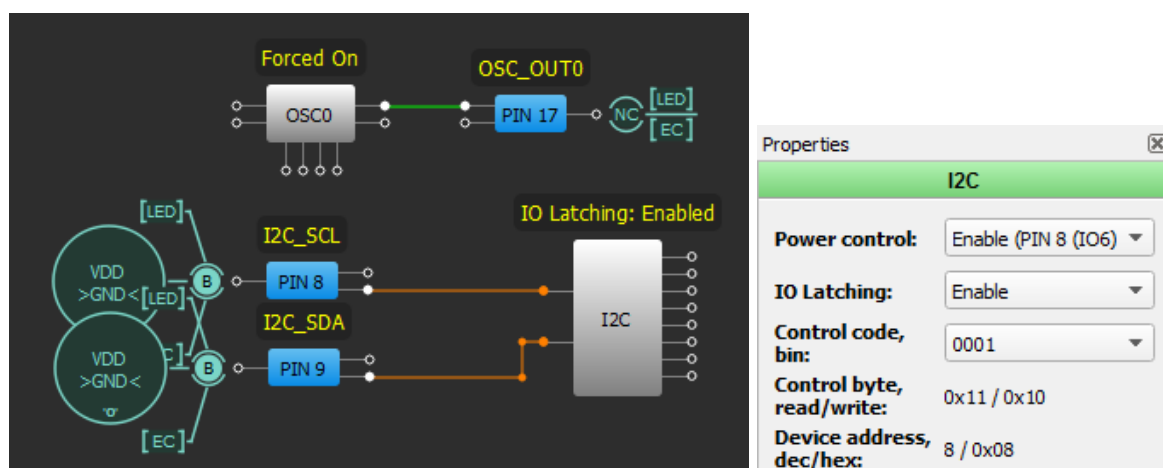
Figure 11

The GreenPAK device does not check for a matching I2C Target (Slave) address condition before triggering 'IO Latching'. A Start bit on the I2C bus will trigger IO Latching. A Start bit is when I2C\_SDA goes low first followed by I2C\_SCL going low after.

In the example below, we will be monitoring the OSC output, which is measured by a scope on Channel 3 via PIN17 ("OSC\_OUT0"). The I2C bus will be forced low to create a START bit.

Disable IO Latching in programmed OTP. This register is I2C-write locked during normal operation and therefore should be disabled in configuration file.

Do not share I2C bus with other devices and make sure the I2C bus is not powered down while the GreenPAK is still powered through VDD.

If the above cannot be satisfied, then consider using the SLG4658x devices, where this errata has been fixed.

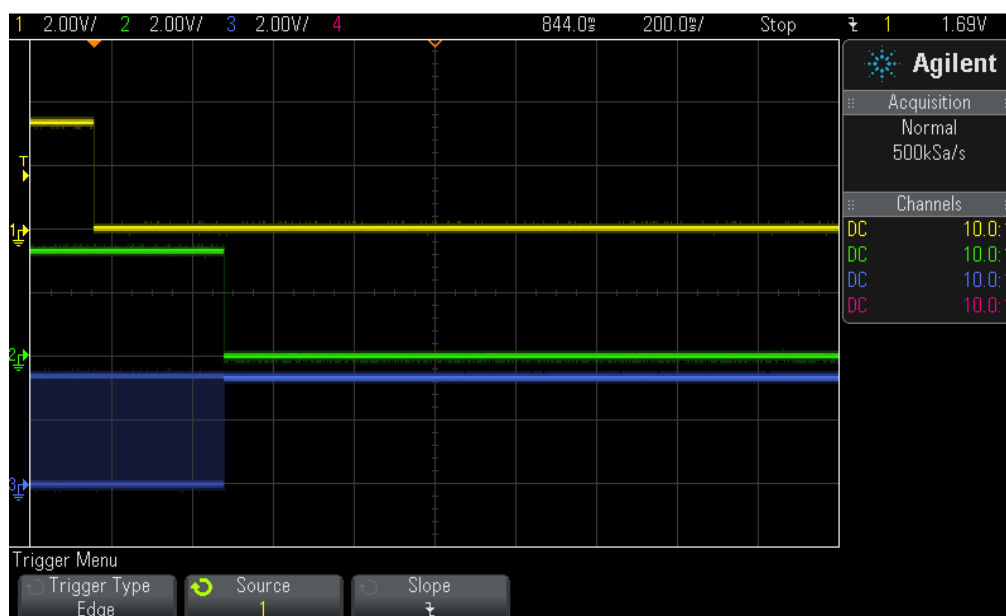
Figure 12

By toggling I2C\_SDA low and then I2C\_SCL low, the GreenPAK registers this as a start bit and latches all General Purpose Outputs such as PIN#17 (“OSC\_OUT0”). In the Figure 12, notice that PIN#17 (OSC\_OUT0) stops toggling.

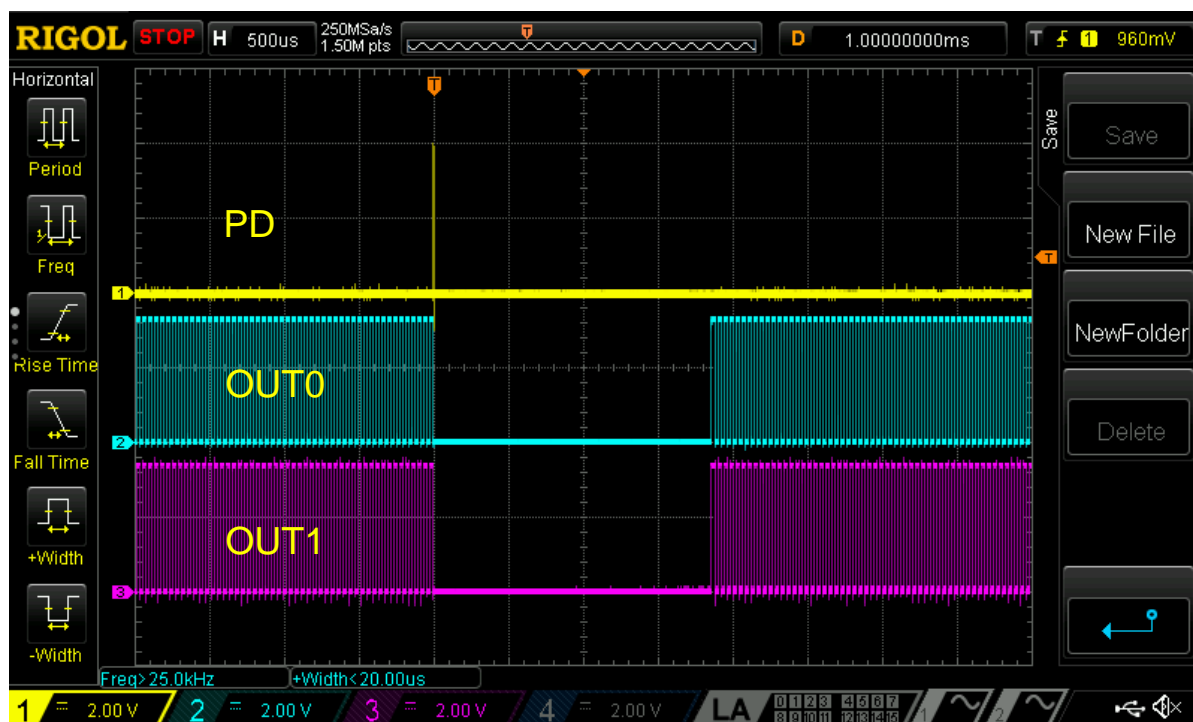
If a pulse with a duration of less than ~40 ns is applied to the PWR DOWN input of the oscillator, the oscillator outputs remain stuck for milliseconds, as shown in figures below. The issue is observed for all available oscillators.

Figure 14. 25 kHz OSC Long Start-Up

Change Fast start-up setting to Enable or omit applying glitches at PWR DOWN input in OSC.

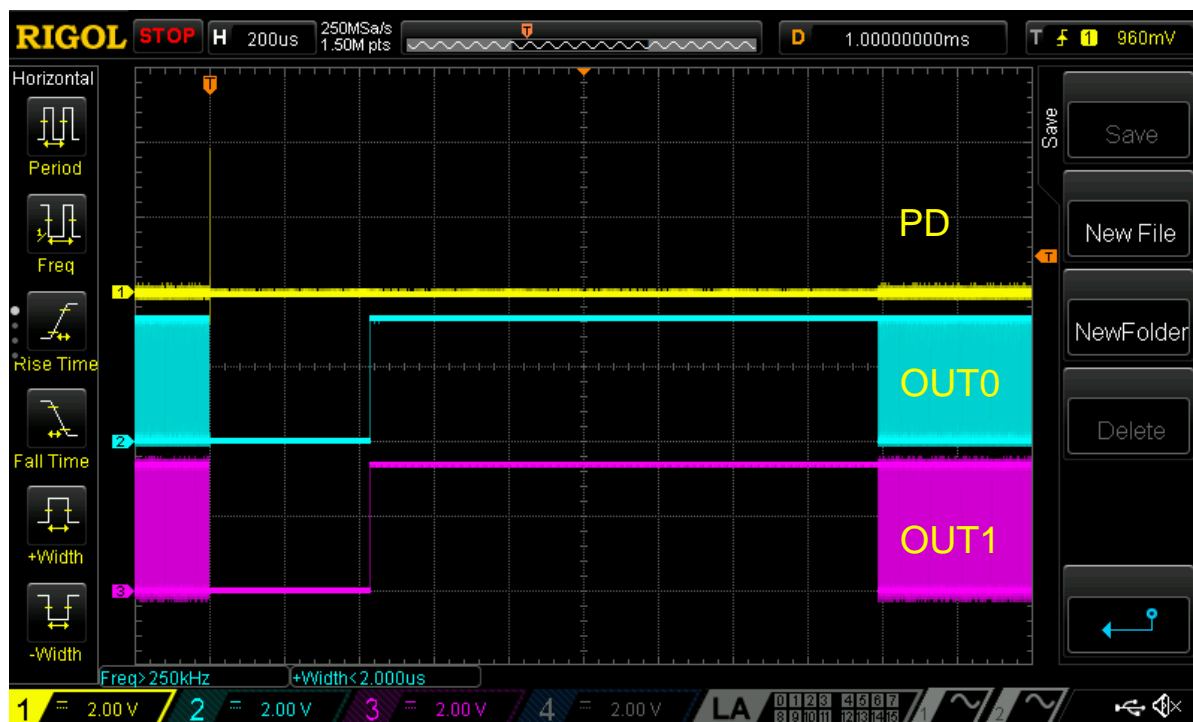
Figure 15. 2 MHz OSC Long Start-Up
