SLG46538-A Errata Note

This document contains the known errata for SLG46538-A and the recommended workarounds.

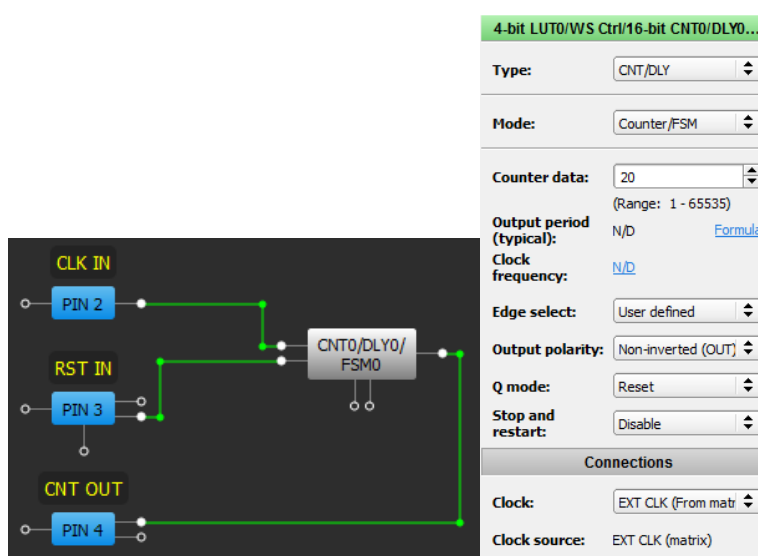
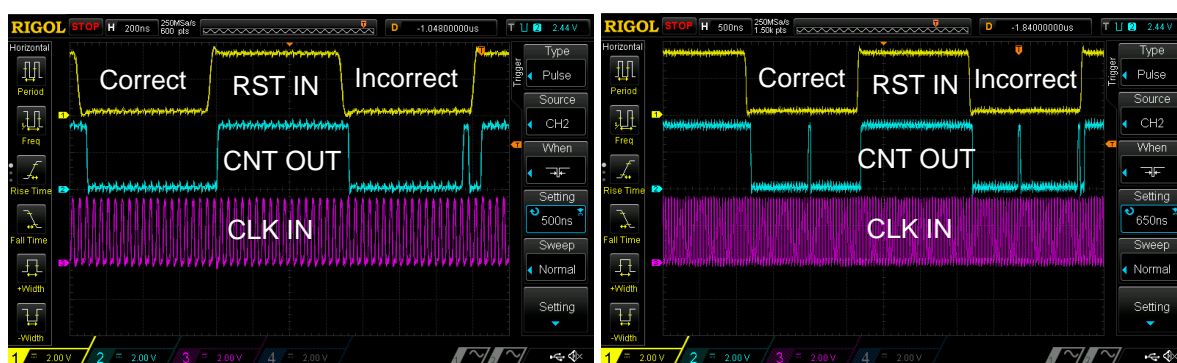
If the Counter Reset is asserted at the same time as a rising clock edge, it is possible that the Counter Data will be reset incorrectly and the counter output may appear faster than expected. This phenomenon appears more often as the clock frequency increases.

Synchronize RESET input of the Counter with its CLK using 2 DFF cells as shown on [Figure 3](#).

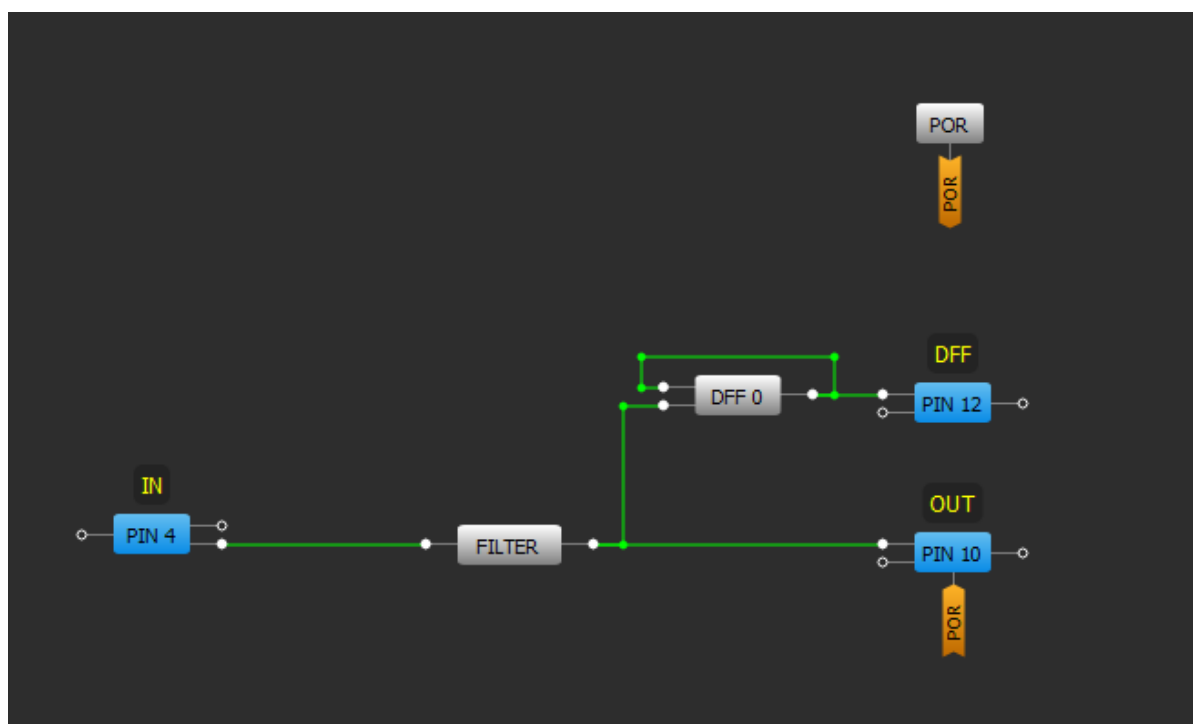
Figure 4

If clock type high frequency input comes in, the FILTER cell may not filter it out. There are several factors like input frequency, duty cycle, and LOW duration in such signal that may lead to its passing through FILTER block.

1. Period is 60 ns. Pulse width is 10 ns, DC = 16.7 % (correct functionality).

Currently there is no workaround for this issue. Filter block is good at filtering short spontaneous glitches. It is intended to be used in series connection before the delay cell to avoid its latching.

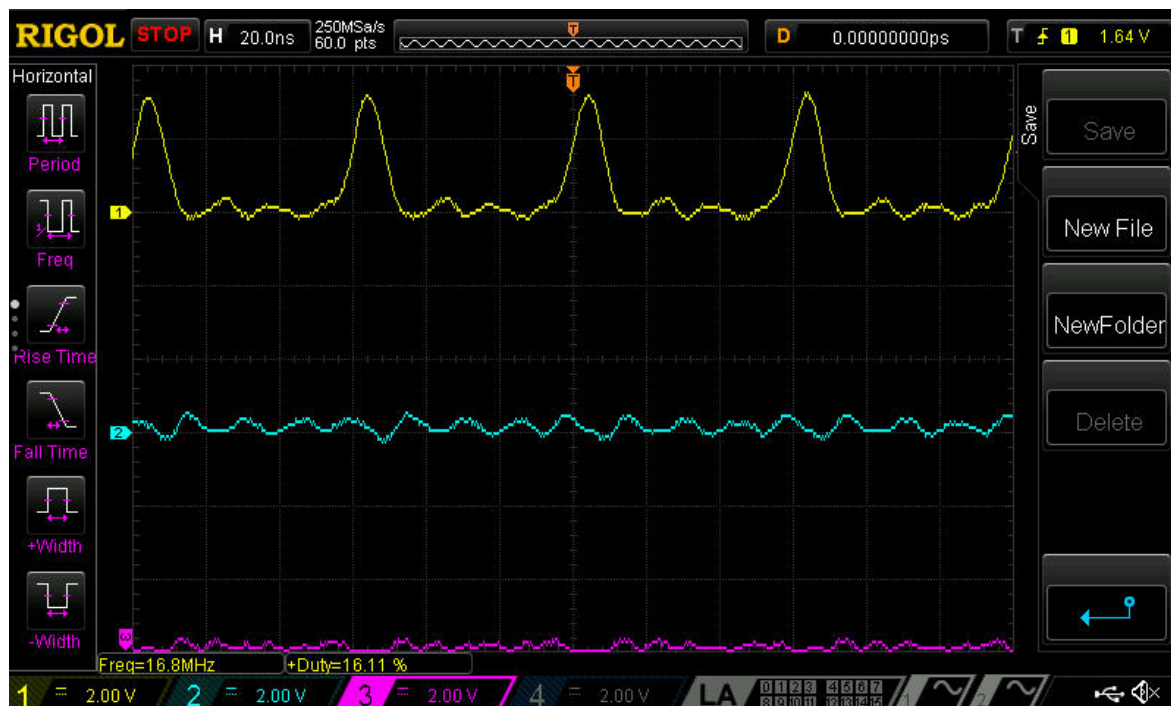
Figure 5

2. Period is 60 ns. Pulse width is 20 ns, DC = 33.3 % (incorrect functionality).

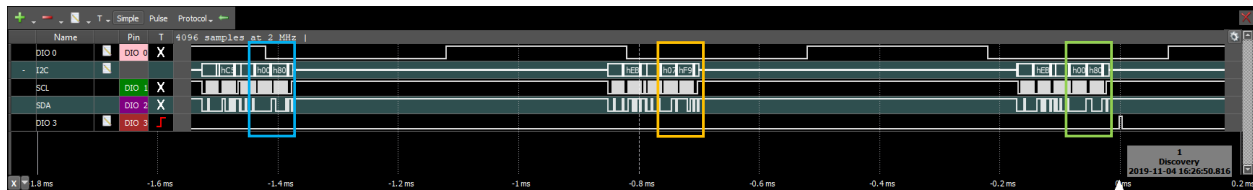
Figure 12. Counter Behavior

For the following condition, the Counter Data register contents are unexpectedly loaded into the counter's DFF chain. This behavior occurs when there is a falling edge on the counter block's clock input during the data return

portion of the I²C read of the Counter Data registers. Figure 12 shows this falling edge boxed in light blue followed by two I²C reads of the Current Count Value registers.

As you can see by the MCU data log below, the Current Count Value gradually increases from 0xF904 to 0xF907 but is unexpectedly reset to 0x8000. Please note that the colored HEX values in the MCU Log correspond to the boxed I²C read commands shown in the waveform above. As previously described, this reset occurs because there is a falling edge on the counter's clock input while the GreenPAK device is responding to the I²C read request to 0xC5 and 0xC6 (note that 0xC5/0xC6 are the Counter Data registers and 0xEB/0xEC are the Current Count Value registers for CNT0).

The reason that the counter is not set to 0x8000 on the I<sup>2</sup>C read immediately following the Counter Data query is because the counter requires two rising edges on its clock input to load the data from the Counter Data registers into the DFF chain. Note that all rising edges during  $T_{stop}$  will be gated internally by the "Stop and Restart" feature.

I<sup>2</sup>C Read of Counter Data: avoid reading Counter Data via I<sup>2</sup>C while the counter is being clocked.

Within the MCU, we recommend saving the Counter Data register configuration as a software variable so that the Counter Data register does not need to be read during counter operation.

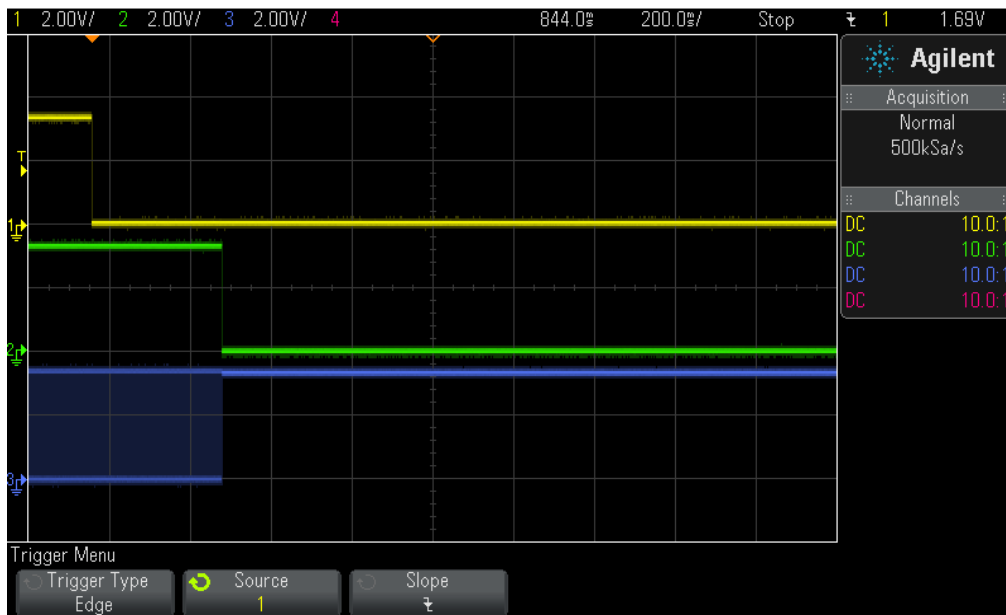
Figure 14. Waveforms

By toggling I2C\_SDA low and then I2C\_SCL low, the GreenPAK registers this as a start bit and latches all General Purpose Outputs such as PIN#17 ("OSC\_OUT0"). In Figure 14, notice that PIN#17 (OSC\_OUT0) stops toggling.

Disable IO Latching in programmed OTP. This register is I<sup>2</sup>C-write locked during normal operation and therefore should be disabled in configuration file.

Do not share I<sup>2</sup>C bus with other devices and make sure the I<sup>2</sup>C bus is not powered down while the GreenPAK is still powered through V<sub>DD</sub>.

If the above cannot be satisfied, then consider using the SLG4658x devices, where this errata has been fixed.
