SLG46538-A Errata Note

This document contains the known errata for SLG46538-A and the recommended workarounds.

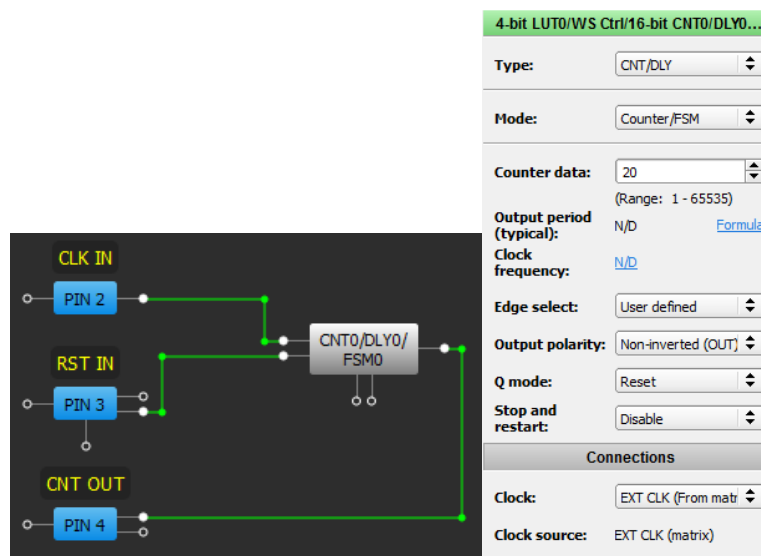
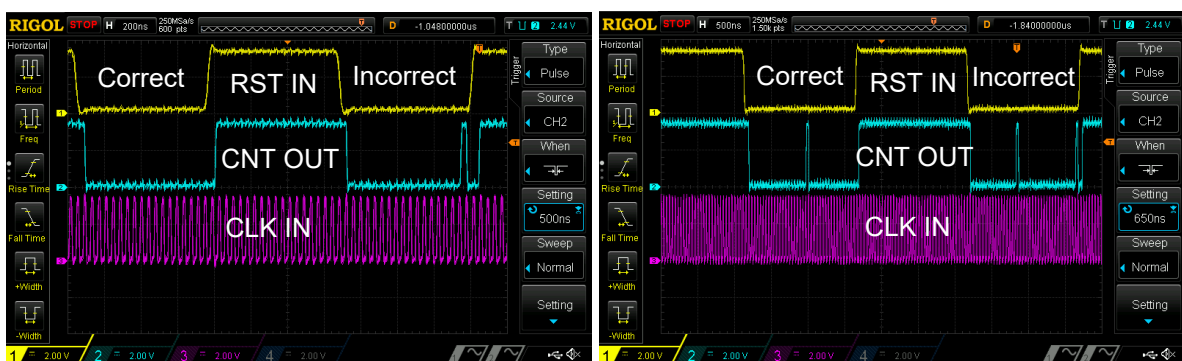
If the Counter Reset is asserted at the same time as a rising clock edge, it is possible that the Counter Data will be reset incorrectly and the counter output may appear faster than expected. This phenomenon appears more often as the clock frequency increases.

Synchronize RESET input of the Counter with its CLK using 2 DFF cells as shown on [Figure 3](#).

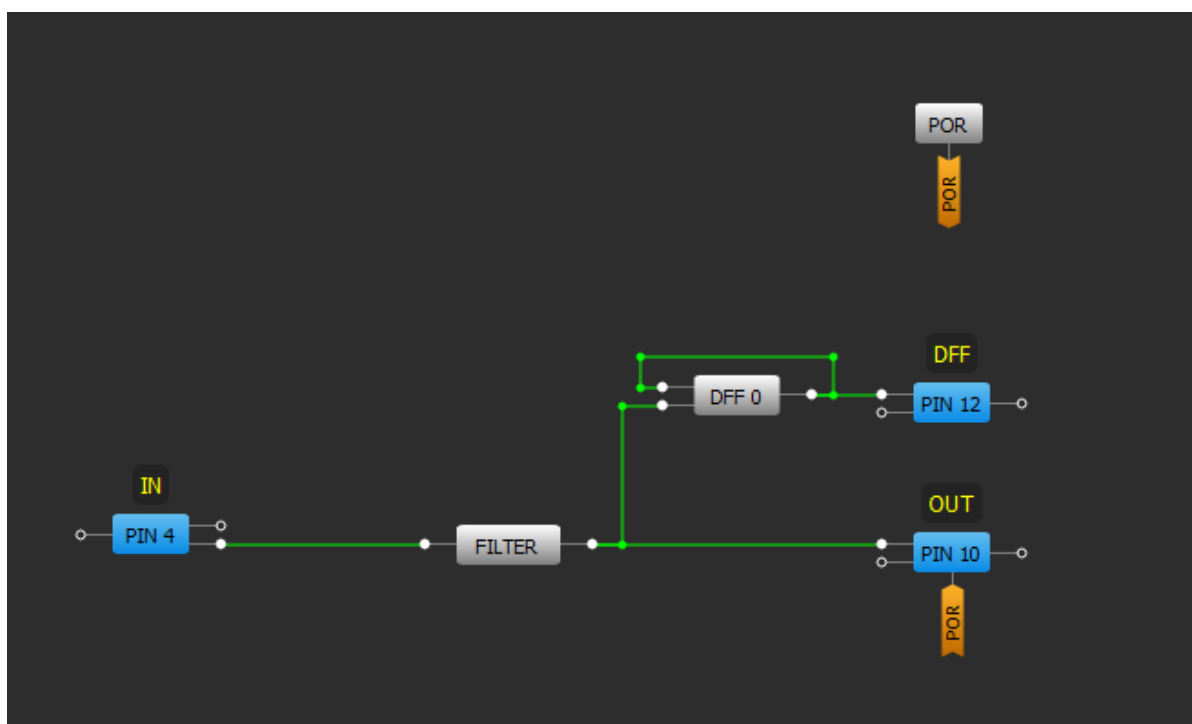
Figure 4

If clock type high frequency input comes in, the FILTER cell may not filter it out. There are several factors like input frequency, duty cycle, and LOW duration in such signal that may lead to its passing through FILTER block.

1. Period is 60 ns. Pulse width is 10 ns, DC = 16.7 % (correct functionality).

Currently there is no workaround for this issue. Filter block is good at filtering short spontaneous glitches. It is intended to be used in series connection before the delay cell to avoid its latching.

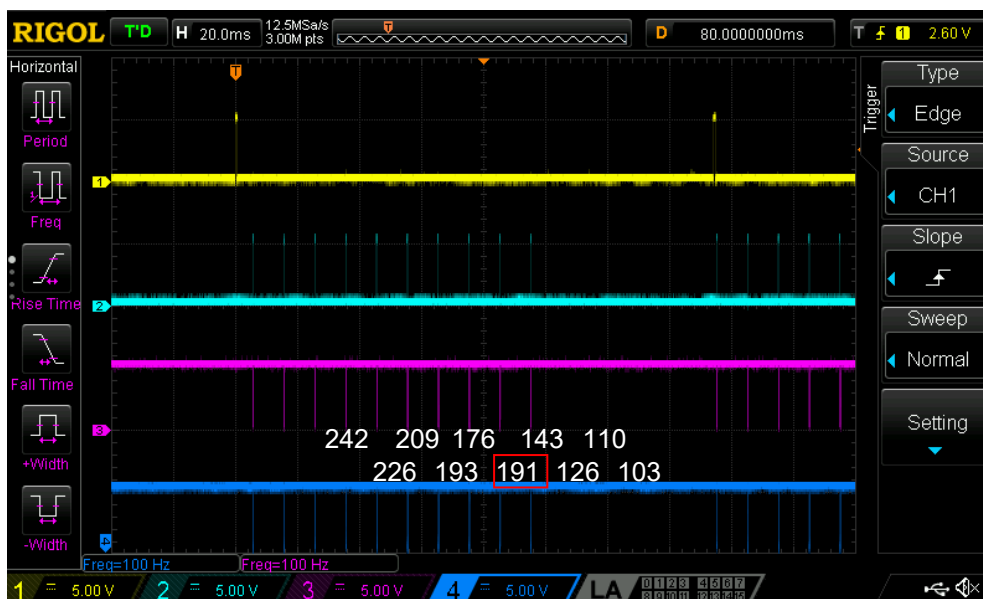
Figure 9

Asynchronous interaction between the CNT/DLY clock input and the I²C LATCH signal (generated by an I²C read command of the CNT/DLY block's count value) can result in an incorrect I²C data read. The CNT/DLY block will count accurately, but the count value transferred into the block's I²C read register might be loaded incompletely if the I²C LATCH signal and the clock input occur at about the same time.

The example data capture in [Figure 9](#) shows ten periodic I²C reads of CNT2/DLY2 configured to count down at about 16 clocks per read. The sixth read sample erroneously shows a value greater than that of the fifth. The seventh sample reads as if the previous I²C error never occurred - the difference from the fifth sample (176) to the seventh (143) is 33 clocks or 16 clocks + 17 clocks as expected.

If the possibility of incorrect I²C data reads cannot be accommodated for by external software checks, one can guarantee proper operation by stopping the CNT/DLY block's clock during I²C reads through one of the following methods: by disabling the oscillator block, by reconfiguring the CNT/DLY block's clock source, or by gating an external clock using a LUT (Look Up Table) in the signal matrix. After disabling the CNT/DLY block's clock, the count registers can be read without error. Please note that this workaround will add the I²C read and processing time to the counter's overall clock period.

The best workaround depends on the resource constraints of the application. If the oscillator block does not clock other logic elements within the design, a matrix output can be used to manually power down the oscillators for the I²C read. When the CNT/DLY block's clock source is routed internally from the oscillator block, I²C commands can temporarily reconfigure the CNT/DLY block's clock source registers to select "Ext. CLK. (From Matrix)". This action will disable the clock by connecting it to ground. If the CNT/DLY block is clocked from the signal matrix, a LUT can be used to gate the clock during the I²C read.

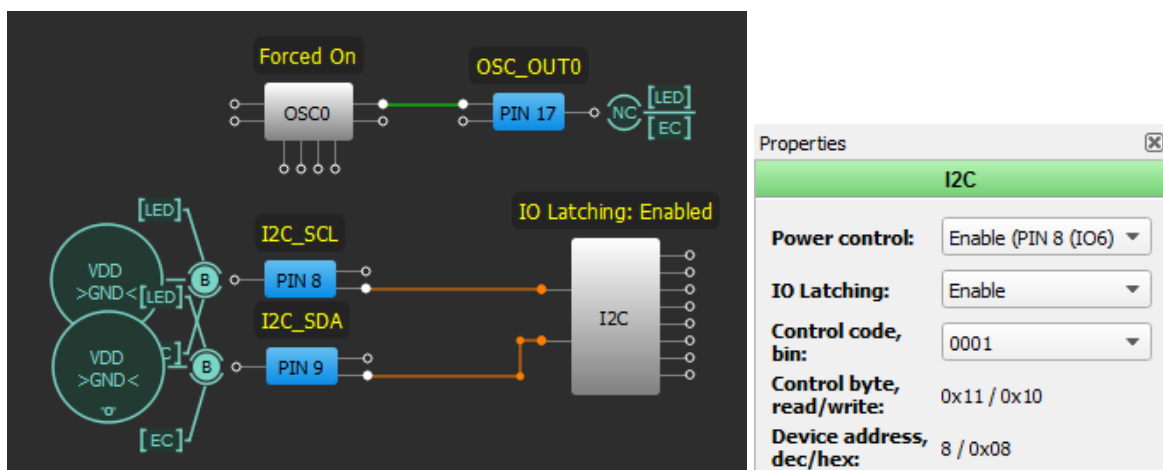
Figure 13. Test Design

The GreenPAK device does not check for a matching I²C target (slave) address condition before triggering ‘IO Latching’. A Start bit on the I²C bus will trigger IO Latching. A Start bit is when I2C_SDA goes low first followed by I2C_SCL going low after.

In the example in [Figure 13](#), we will be monitoring the OSC output, which is measured by a scope on Channel 3 via PIN17 (“OSC_OUT0”). The I²C bus will be forced low to create a START bit.

Disable IO Latching in programmed OTP. This register is I²C-write locked during normal operation and therefore should be disabled in configuration file.

Do not share I²C bus with other devices and make sure the I²C bus is not powered down while the GreenPAK is still powered through V_{DD}.

If the above cannot be satisfied, then consider using the SLG4658x devices, where this errata has been fixed.

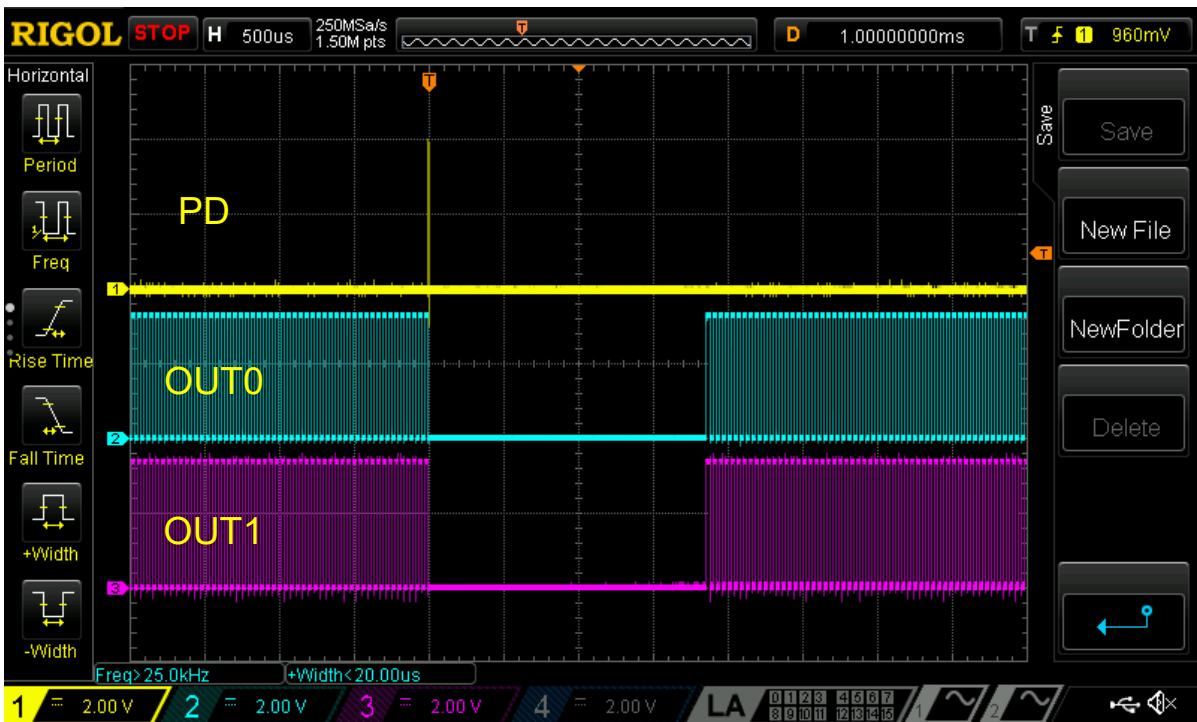
Figure 16. 25 kHz OSC Long Start-Up

If a pulse with a duration of less than ~40 ns is applied to the PWR DOWN input of the oscillator, the oscillator outputs remain stuck for milliseconds, as shown in Figure 16 and Figure 17. The issue is observed for all available oscillators.

Change Fast start-up setting to Enable or omit applying glitches at PWR DOWN input in OSC.
