SLG4653x-E Errata Note

This document contains the known errata for SLG46533-E, SLG46534-E, SLG46535-E, SLG46536-E, SLG46537-E, SLG46538-E and the recommended workarounds.

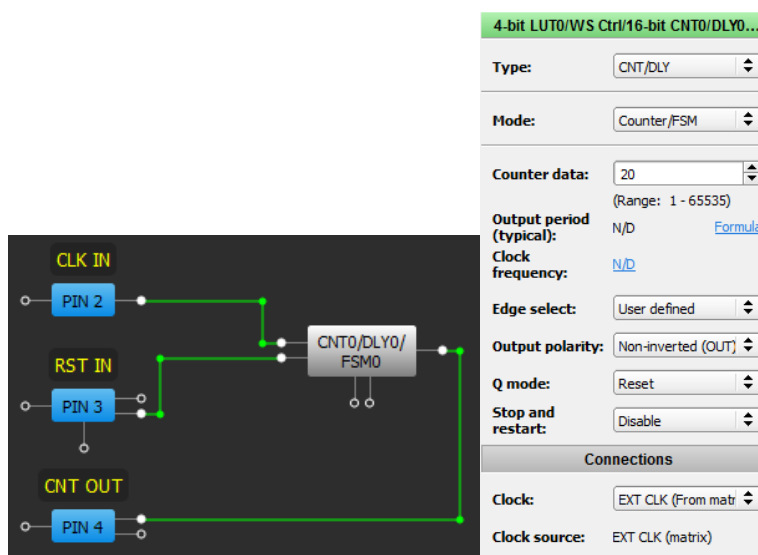
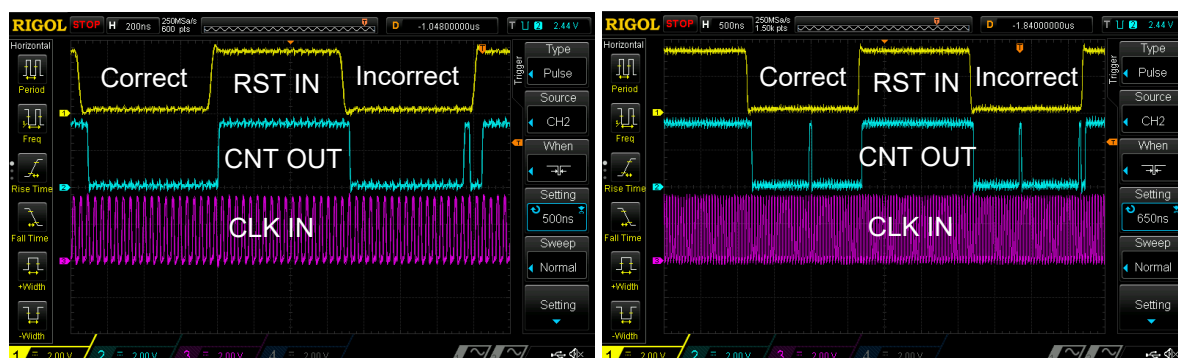
Figure 1

If the Counter Reset is asserted at the same time as a rising clock edge, it is possible that the Counter Data will be reset incorrectly and the counter output may appear faster than expected. This phenomenon appears more often as the clock frequency increases.

Synchronize RESET input of the Counter with its CLK using 2 DFF cells as shown on [Figure 3](#).

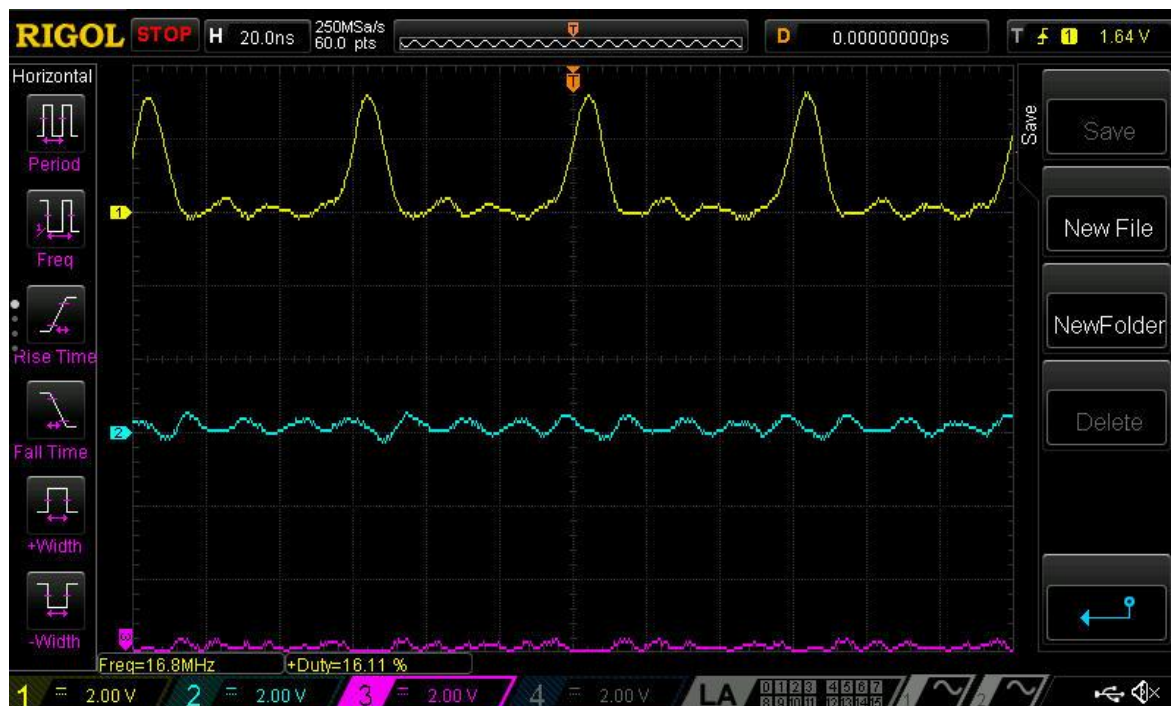
Figure 5

2. Period is 60 ns. Pulse width is 20 ns, DC = 33.3 % (incorrect functionality).

Currently there is no workaround for this issue. Filter block is good at filtering short spontaneous glitches. It is intended to be used in series connection before the delay cell to avoid its latching.

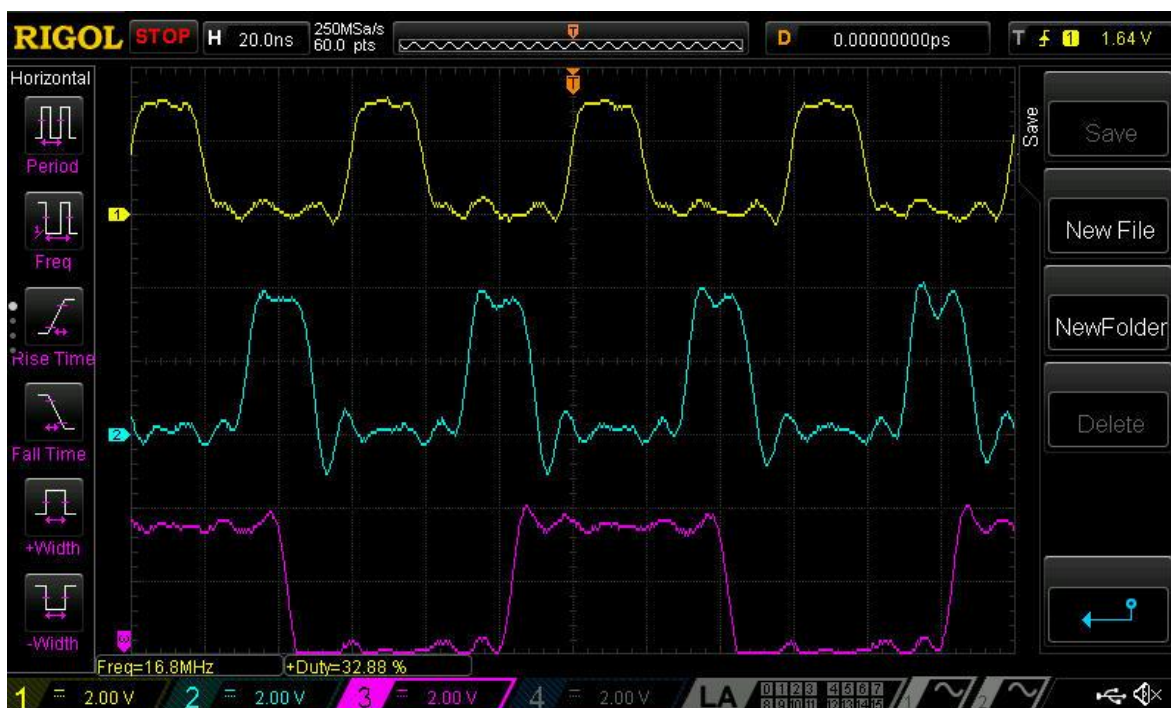
Figure 6

3. Period is 60 ns. Pulse width is 30 ns, DC = 50 % (incorrect functionality).

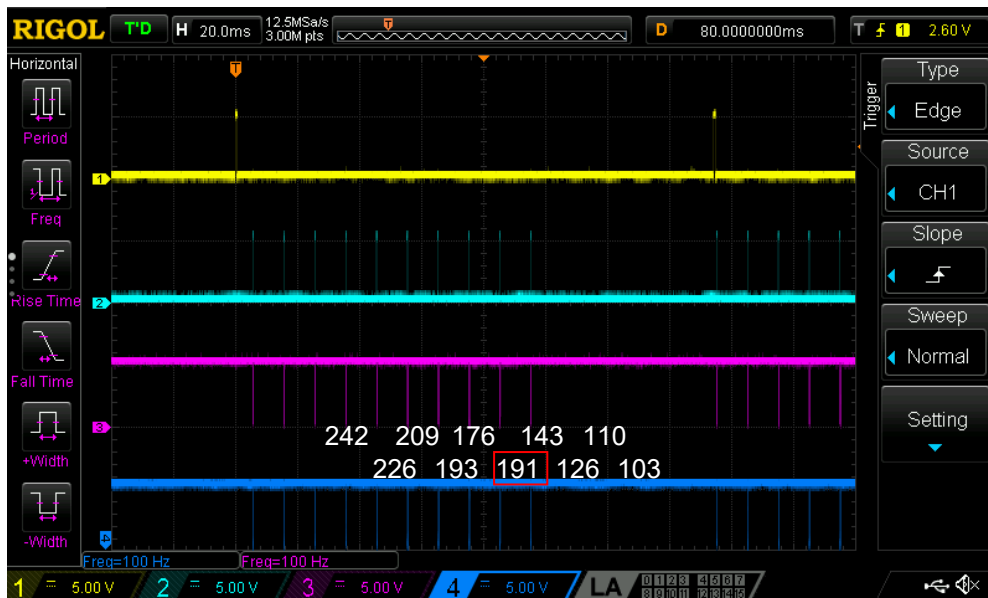
Asynchronous interaction between the CNT/DLY clock input and the I²C LATCH signal (generated by an I²C read command of the CNT/DLY block's count value) can result in an incorrect I²C data read. The CNT/DLY block will count accurately, but the count value transferred into the block's I²C read register might be loaded incompletely if the I²C LATCH signal and the clock input occur at about the same time.

The example data capture in Figure 9 shows ten periodic I²C reads of CNT2/DLY2 configured to count down at about 16 clocks per read. The sixth read sample erroneously shows a value greater than that of the fifth. The seventh sample reads as if the previous I²C error never occurred - the difference from the fifth sample (176) to the seventh (143) is 33 clocks or 16 clocks + 17 clocks as expected.

If the possibility of incorrect I²C data reads cannot be accommodated for by external software checks, one can guarantee proper operation by stopping the CNT/DLY block's clock during I²C reads through one of the following methods: by disabling the oscillator block, by reconfiguring the CNT/DLY block's clock source, or by gating an external clock using a LUT (Look Up Table) in the signal matrix. After disabling the CNT/DLY block's clock, the count registers can be read without error. Please note that this workaround will add the I²C read and processing time to the counter's overall clock period.

The best workaround depends on the resource constraints of the application. If the oscillator block does not clock other logic elements within the design, a matrix output can be used to manually power down the oscillators for the I²C read. When the CNT/DLY block's clock source is routed internally from the oscillator block, I²C commands can temporarily reconfigure the CNT/DLY block's clock source registers to select "Ext. CLK. (From Matrix)". This action will disable the clock by connecting it to ground. If the CNT/DLY block is clocked from the signal matrix, a LUT can be used to gate the clock during the I²C read.

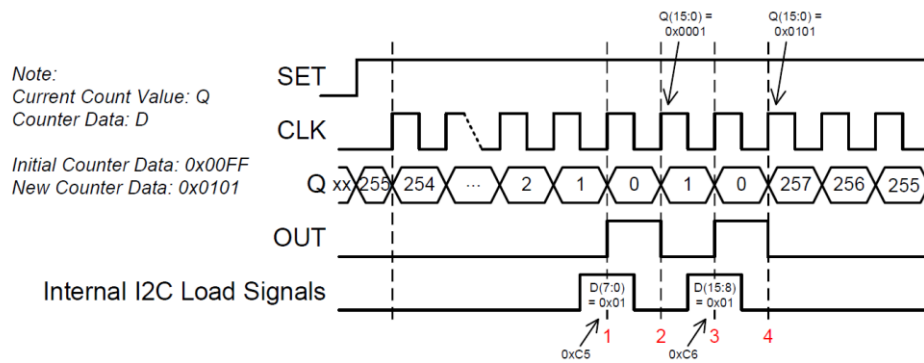
Figure 10. I²C Write of 16-Bit Counter Data Example

The timing diagram in [Figure 10](#) sets up a case where an improper output will be seen on the counter. In this example, the initial Counter Data value (D) is set up as 0x00FF. As you can see, the Current Count Value (Q) decrements from 255 down to 0 with rising edges on CLK. At time "1" denoted by a red number 1, an I²C command (not shown) has just been sent to the GreenPAK device to reconfigure the Counter Data value to 0x0101.

As previously mentioned, the 16-bit value is loaded from the I²C buffers to the Counter Data registers in 8-bit chunks. Right at time “1”, the LSB byte (0x01) is loaded into the Counter Data registers. This makes the Counter Data value temporarily equal to 0x0001. At time “2” between the internal I²C load signals, the counter receives a rising edge on its clock input. This causes the Current Count Value to underflow and to be loaded with the Counter Data value which is 0x0001. At time “3”, the MSB byte (0x01) is loaded into the Counter Data registers setting the Counter Data value to 0x0101. At time “4”, the Current Count Value underflows again and is set to the Counter Data value of 0x0101.

This behavior results in two output pulses on OUT when only one pulse is expected. Observing this behavior depends upon the asynchronous timing between the counter's clock and an I²C write command to the Counter Data registers. For some applications, the extra pulse on OUT can be ignored and the counter will self-correct after underflowing, overflowing, or being SET/RESET through the GreenPAK connection matrix.

For applications where the application processor needs to read the Current Count Value while the counter is clocking, disable the "Stop and Restart Bit." When this bit is disabled, the counter's clock will not be gated internally which avoids the loss of count values during  $T_{stop}$ . In order to guarantee the current count value after the I<sup>2</sup>C write to the Counter Data registers, the clock should be manually stopped for the I<sup>2</sup>C write or a SET/RESET command should be generated after the I<sup>2</sup>C write (Case 1).

I<sup>2</sup>C Write of Counter Data: accommodate for the double pulse described in Case 1.

Disable the counter's clock during the I<sup>2</sup>C write.

Manually SET/RESET the counter after the I<sup>2</sup>C write is complete.

Disregard the first set of pulses on the counter output after the I<sup>2</sup>C write by waiting for one counter cycle to complete. This allows the counter's DFF chain to be loaded with the new Counter Data value after the counter overflows/underflows.

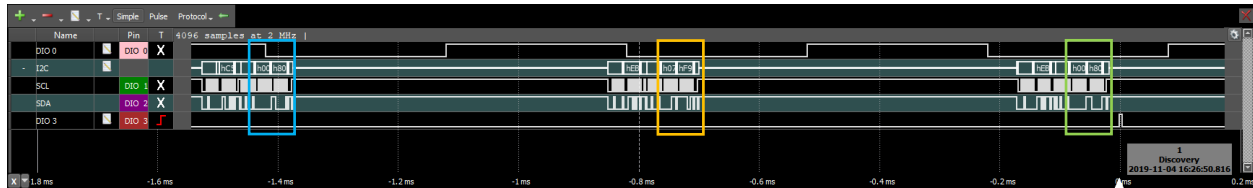
Figure 12. Counter Behavior

For the following condition, the Counter Data register contents are unexpectedly loaded into the counter's DFF chain. This behavior occurs when there is a falling edge on the counter block's clock input during the data return

portion of the I²C read of the Counter Data registers. Figure 12 shows this falling edge boxed in light blue followed by two I²C reads of the Current Count Value registers.

As you can see by the MCU data log below, the Current Count Value gradually increases from 0xF904 to 0xF907 but is unexpectedly reset to 0x8000. Please note that the colored HEX values in the MCU Log correspond to the boxed I²C read commands shown in the waveform above. As previously described, this reset occurs because there is a falling edge on the counter's clock input while the GreenPAK device is responding to the I²C read request to 0xC5 and 0xC6 (note that 0xC5/0xC6 are the Counter Data registers and 0xEB/0xEC are the Current Count Value registers for CNT0).

The reason that the counter is not set to 0x8000 on the I<sup>2</sup>C read immediately following the Counter Data query is because the counter requires two rising edges on its clock input to load the data from the Counter Data registers into the DFF chain. Note that all rising edges during  $T_{stop}$  will be gated internally by the "Stop and Restart" feature.

I<sup>2</sup>C Read of Counter Data: avoid reading Counter Data via I<sup>2</sup>C while the counter is being clocked.

Within the MCU, it is recommended saving the Counter Data register configuration as a software variable so that the Counter Data register does not need to be read during counter operation.

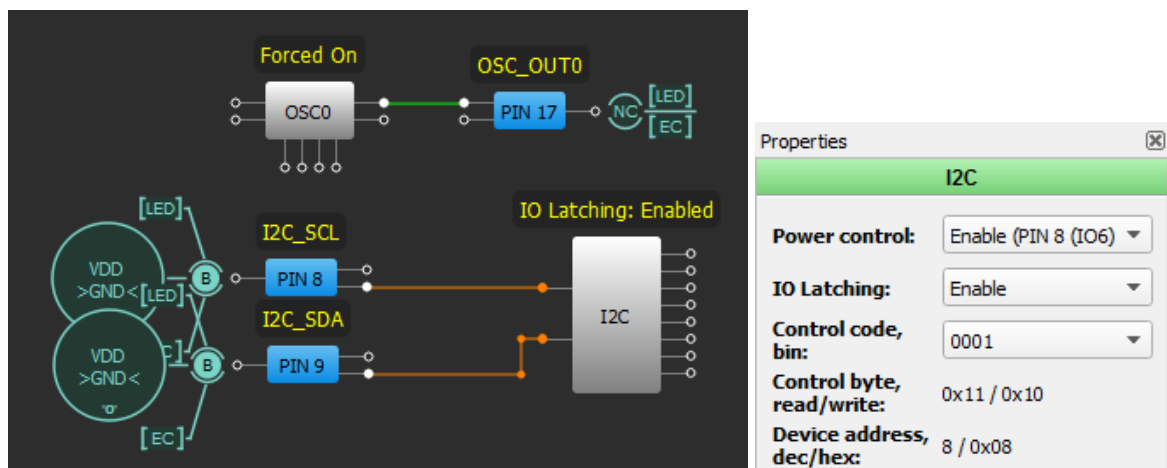
Figure 13.

The GreenPAK device does not check for a matching I<sup>2</sup>C Target address condition before triggering ‘IO Latching’. A Start bit on the I<sup>2</sup>C bus will trigger IO Latching. A Start bit is when I2C\_SDA goes low first followed by I2C\_SCL going low after.

In the example in [Figure 13](#), it will be monitored the OSC output, which is measured by a scope on Channel 3 via PIN17 (“OSC\_OUT0”). The I<sup>2</sup>C bus will be forced low to create a START bit.

Disable IO Latching in programmed OTP. This register is I<sup>2</sup>C-write locked during normal operation and therefore should be disabled in configuration file.

Do not share I<sup>2</sup>C bus with other devices and make sure the I<sup>2</sup>C bus is not powered down while the GreenPAK is still powered through V<sub>DD</sub>.

If the above cannot be satisfied, then consider using the SLG4658x devices, where this errata has been fixed.

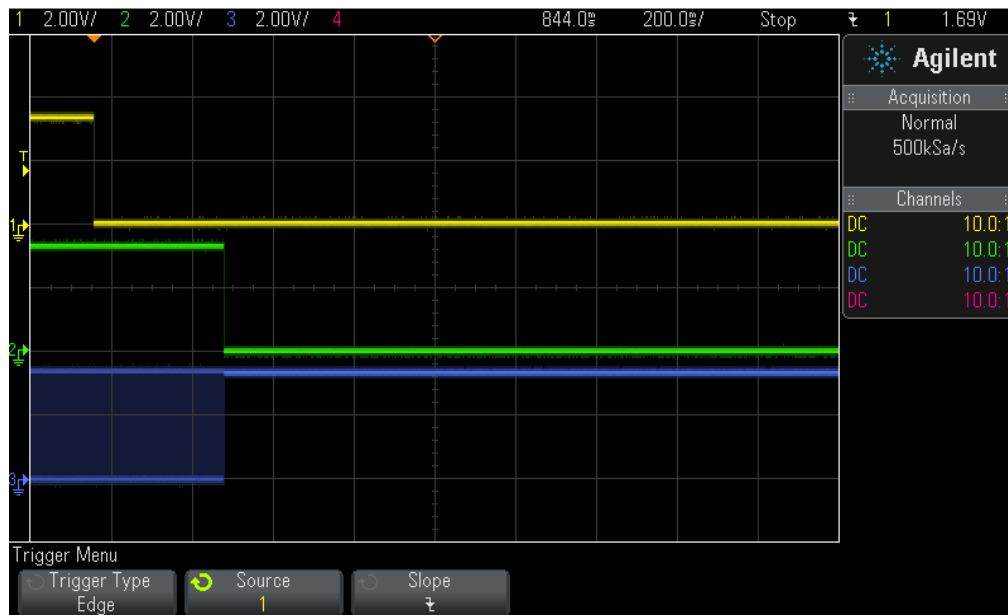
Figure 14.

By toggling I2C\_SDA low and then I2C\_SCL low, the GreenPAK registers this as a start bit and latches all General Purpose Outputs such as PIN#17 ("OSC\_OUT0"). In Figure 14, notice that PIN#17 (OSC\_OUT0) stops toggling.

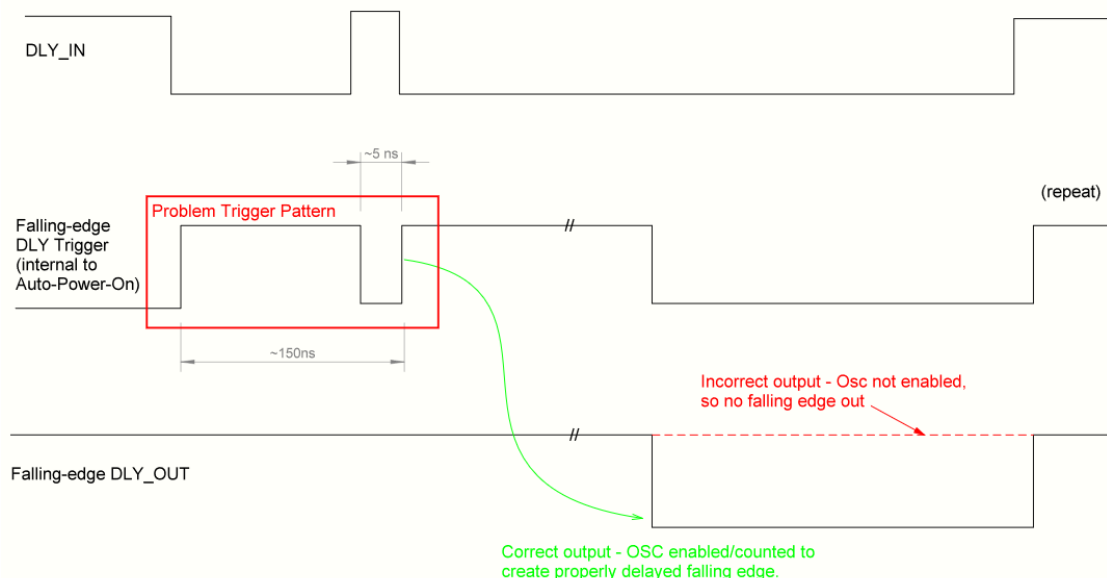
Figure 15. Problem Trigger Pattern

For this chip, the Auto Power On circuitry of the 25 kHz/2 MHz generators contains a circuit errata, which can potentially fail to power on the OSC for a specific pattern and timing of the OR of all related DLY trigger signals. The pattern is shown in Figure 15 (boxed in red) and consists of a relatively longer pulse (~145 ns) followed by a shorter (~5 ns) glitch of opposite polarity.

1. Use signal conditioning circuits to prevent glitch on DLY inputs < 200 ns. Examples:
  - a. ACMP with Hysteresis

- b. External RC in front of Digital Input with Schmitt Trigger
  - c. Filter cell.
2. Set OSC power mode to Force Power On mode instead of Auto Power On.
  3. Use different oscillator, such as 25 MHz Ring OSC, which does not have Auto Power On issue.

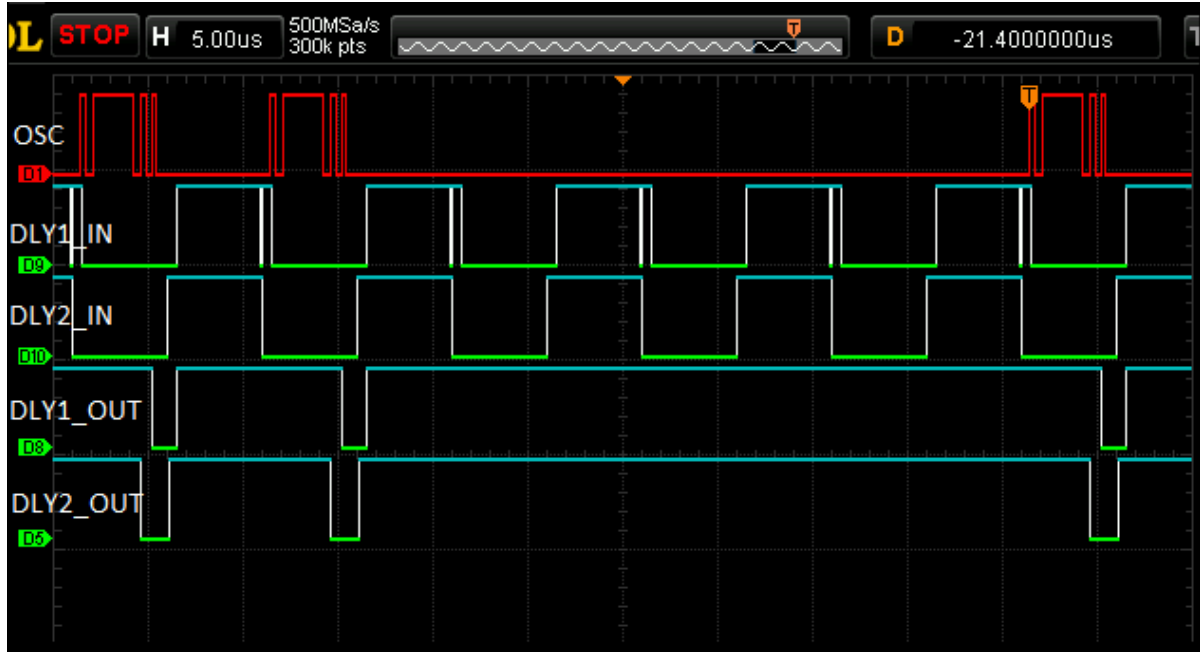
Figure 17. Errata Capture (Zoom Out)

Figure 17 shows a series of DLY output events are missing, where the OSC is correspondingly not triggering when it was supposed to. Figure 18 is a zoom in of the boxed region from Figure 17. The total glitch/chatter time was measured in this case at 152 ns. By using the composite OR of the two delay channels, it can be strobed asynchronously with tiny frequency variations, and so tune the timing to induce this errata. Note that the error is not persistent – the system is recovered when all DLYs are returned to inactive state, such as when input of falling edge DLY goes high, thus canceling delay, or after DLY out finishes.

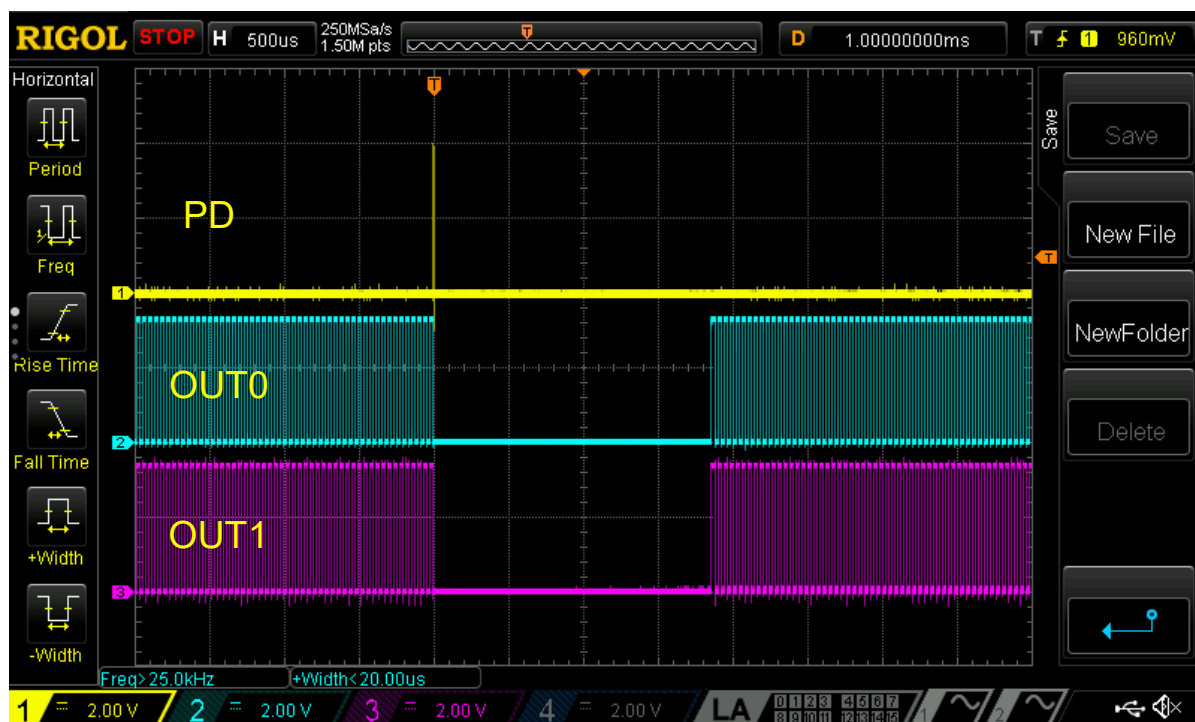
Figure 20. 25 kHz OSC Long Start-Up

If a pulse with a duration of less than ~40 ns is applied to the PWR DOWN input of the oscillator, the oscillator outputs remain stuck for milliseconds, as shown in [Figure 20](#) and [Figure 21](#). The issue is observed for all available oscillators.

Change Fast start-up setting to Enable or omit applying glitches at PWR DOWN input in OSC.

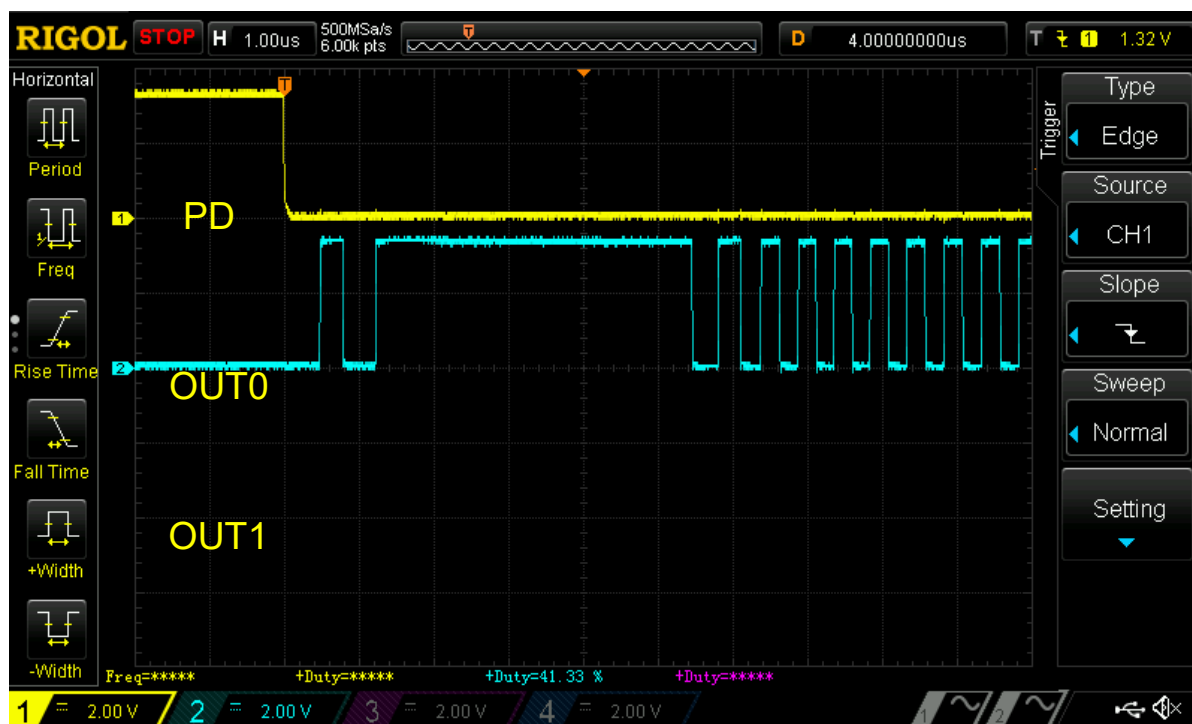
2 MHz OSC has an additional ~ 9 cycles settling period. Higher  $V_{DD}$  shows longer settling time.

Figure 23. Channel 1 – OSC Power Down; Channel 2 –OSC Output

Such behavior will lead to substantial error in period calculations if the delay time is relatively small.

Enable Fast Start-up option. Fast Start-up means forcing bias ready at the power-up instead of automatic enabling at OSC event. The standby current consumption difference between Fast start-up disabled and enabled is only an additional 300 nA.

Use the “Force power on” OSC power control option to make the OSC operate at all times. However, this will cause increased constant current consumption.
