SLG4653x Errata

CE-GP-002

This document contains the known errata for SLG46533, SLG46534, SLG46535, SLG46536, SLG46537, SLG46538 and the recommended workarounds.

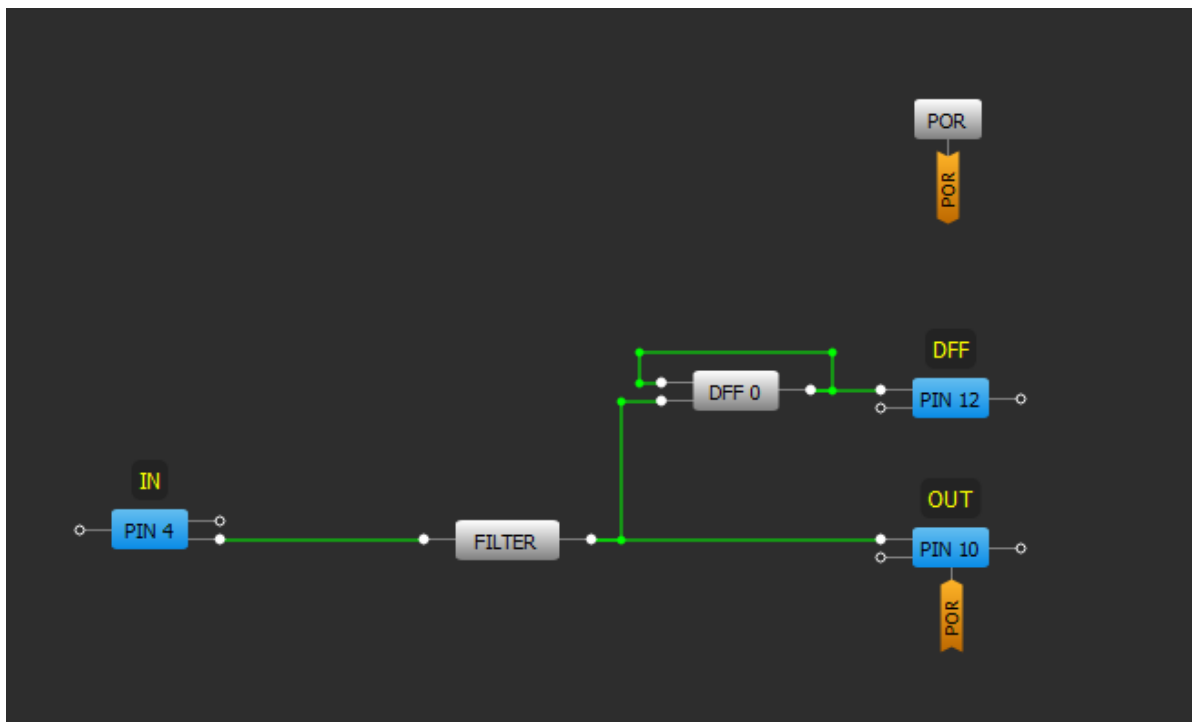
Figure 4

If clock type high frequency input comes in, the FILTER cell may not filter out it. There are several factors like input frequency, duty cycle, and LOW duration in such signal that may lead to its passing through FILTER block.

Currently there is no workaround for this issue. Filter block is good at filtering short spontaneous glitches. It is intended to be used in series connection before the delay cell to avoid its latching.

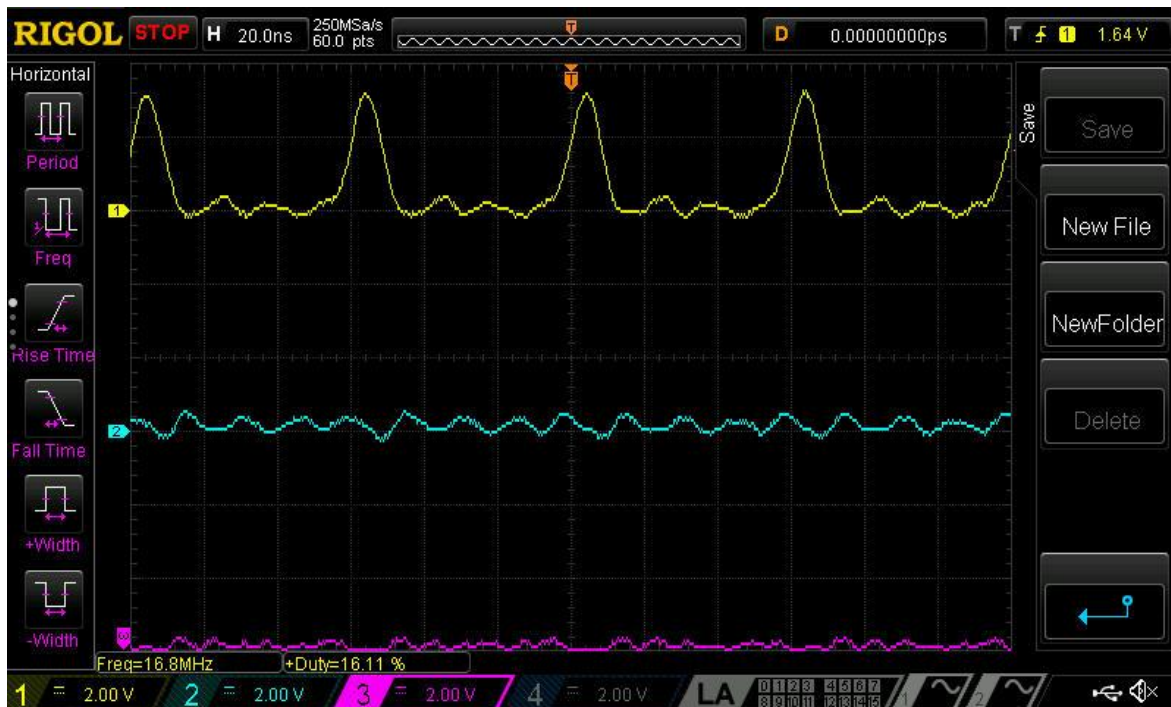
Figure 5

1. Period is 60 ns. Pulse width is 10 ns, DC = 16.7 % (correct functionality).

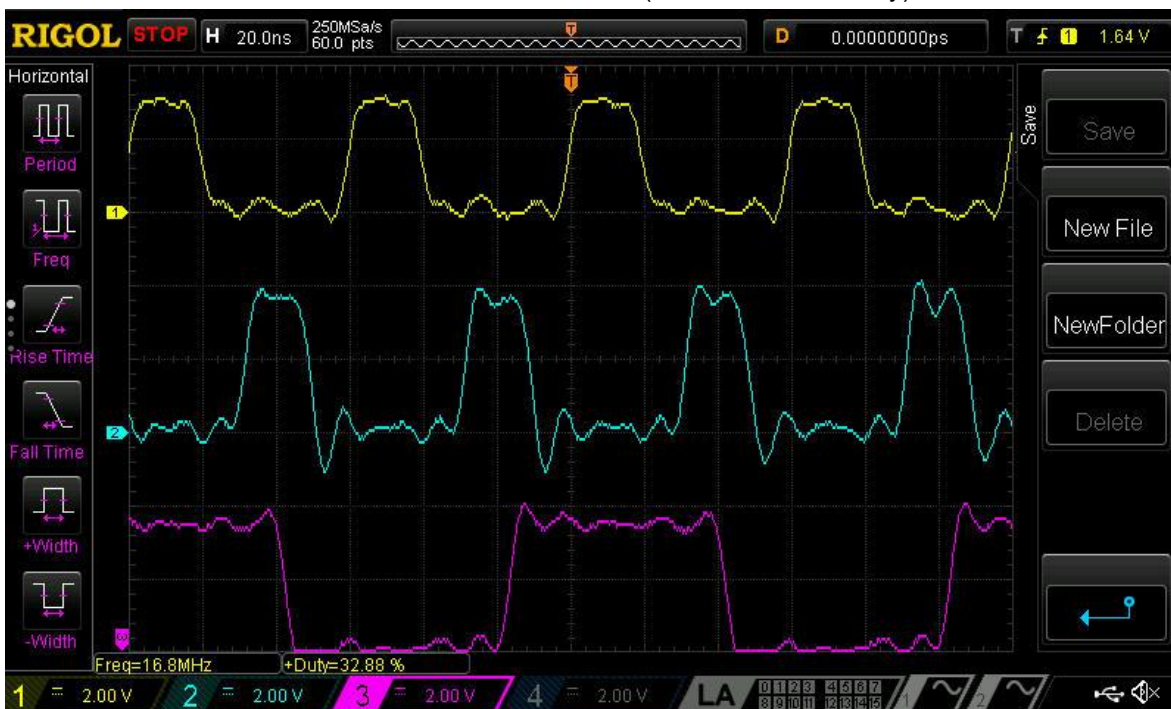
Figure 6

2. Period is 60 ns. Pulse width is 20 ns, DC = 33.3 % (incorrect functionality).

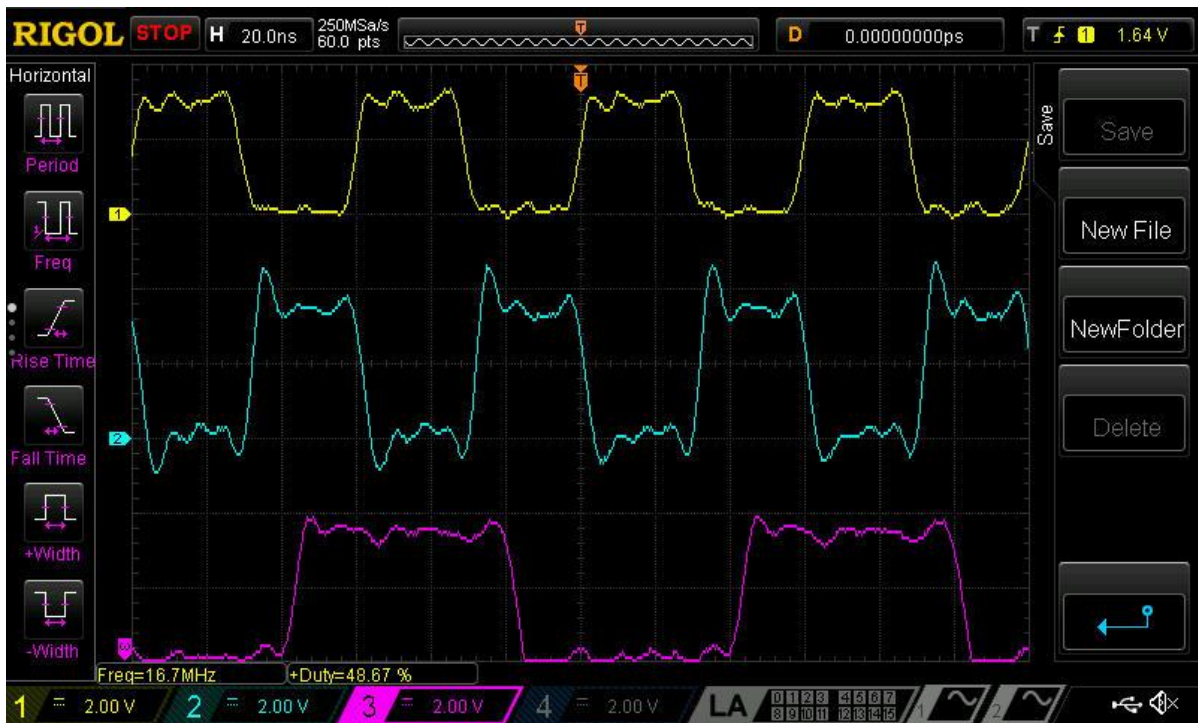
Figure 7

3. Period is 60 ns. Pulse width is 30 ns, DC = 50 % (incorrect functionality).

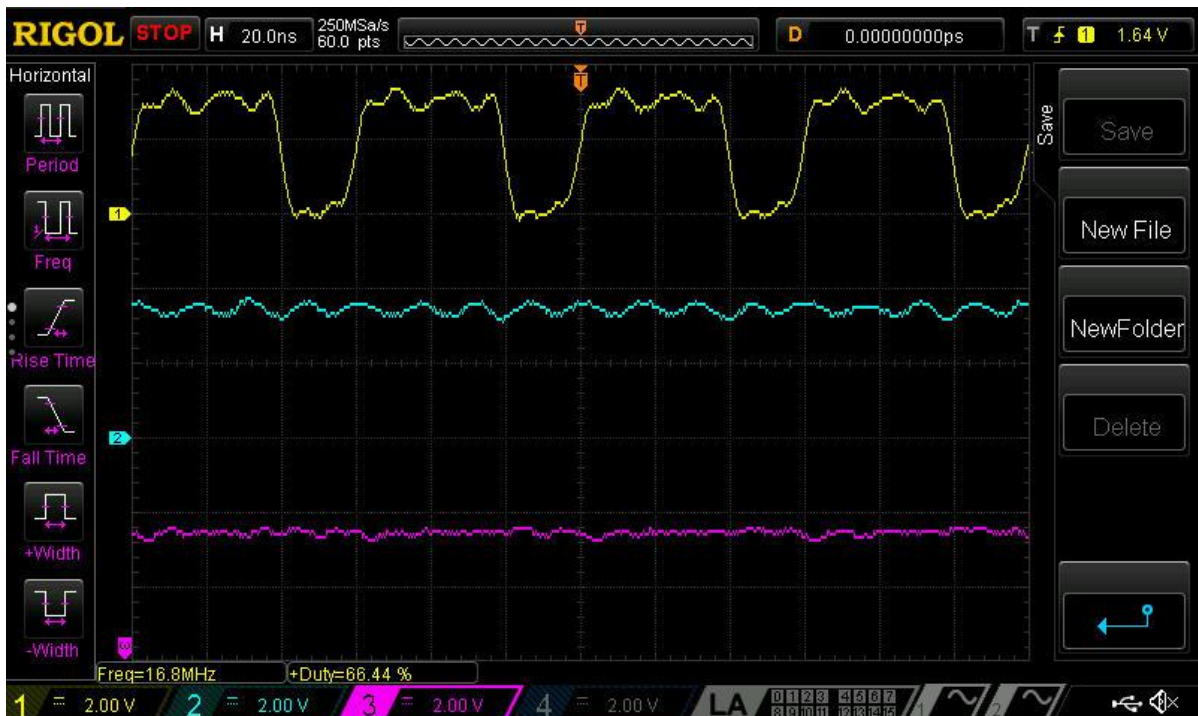
Figure 8

4. Period is 60 ns. Pulse width is 40 ns, DC = 66.67 % (correct functionality).

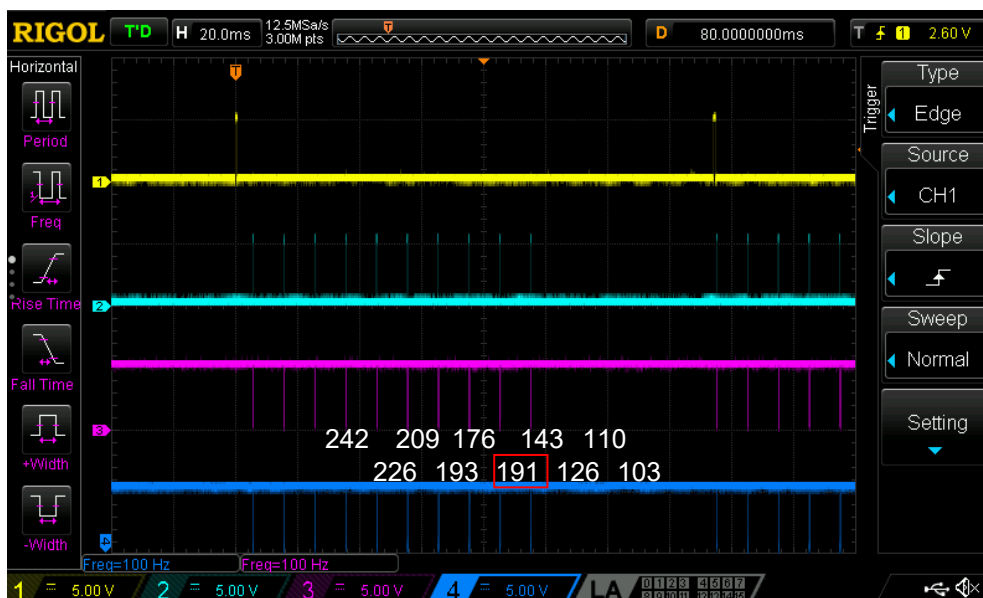
Figure 9

Asynchronous interaction between the CNT/DLY clock input and the I2C latch signal (generated by an I2C read command of the CNT/DLY block's count value) can result in an incorrect I2C data read. The CNT/DLY block will count accurately, but the count value transferred into the block's I2C read register might be loaded incompletely if the I2C latch signal and the clock input occur at about the same time.

The example data capture below shows ten periodic I2C reads of CNT2/DLY2 configured to count down at about 16 clocks per read. The sixth read sample erroneously shows a value greater than that of the fifth. The seventh sample reads as if the previous I2C error never occurred - the difference from the fifth sample (176) to the seventh (143) is 33 clocks or 16 clocks + 17 clocks as expected.

If the possibility of incorrect I2C data reads can't be accommodated for by external software checks, one can guarantee proper operation by stopping the CNT/DLY block's clock during I2C reads through one of the following methods: by disabling the oscillator block, by reconfiguring the CNT/DLY block's clock source, or by gating an external clock using a LUT (Look-up Table) in the signal matrix. After disabling the CNT/DLY block's clock, the count registers can be read without error. Please note that this workaround will add the I2C read and processing time to the counter's overall clock period.

The best workaround depends on the resource constraints of the application. If the oscillator block doesn't clock other logic elements within the design, a matrix output can be used to manually power down the oscillators for the I2C read. When the CNT/DLY block's clock source is routed internally from the oscillator block, I2C commands can temporarily reconfigure the CNT/DLY block's clock source registers to select "Ext. CLK. (From Matrix)." This action will disable the clock by connecting it to ground. If the CNT/DLY block is clocked from the signal matrix, a LUT can be used to gate the clock during an I2C read.

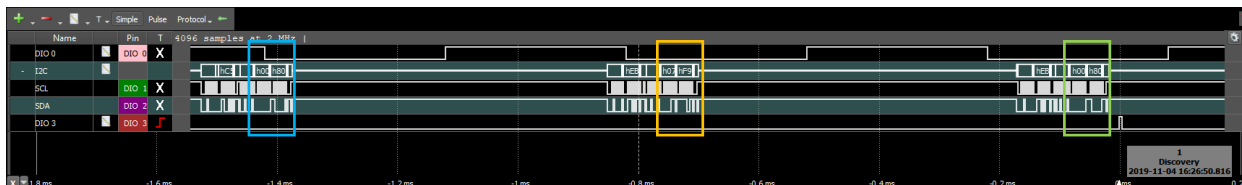
Figure 12: Counter Behavior

For the following condition, the Counter Data register contents are unexpectedly loaded into the counter's DFF chain. This behavior occurs when there is a falling edge on the counter block's clock input during the data return portion of an I2C read of the Counter Data registers. Figure 12 shows this falling edge boxed in light blue followed by two I2C reads of the Current Count Value registers.

As you can see by the MCU data log below, the Current Count Value gradually increases from 0xF904 to 0xF907 but is unexpectedly reset to 0x8000. Please note that the colored HEX values in the MCU Log correspond to the boxed I2C read commands shown in the waveform above. As previously described, this reset occurs because there is a falling edge on the counter's clock input while the GreenPAK device is responding to an I2C read request to 0xC5 and 0xC6. (Note that 0xC5/0xC6 are the Counter Data registers and 0xEB/0xEC are the Current Count Value registers for CNT0.)

The reason that the counter isn't set to 0x8000 on the I2C read immediately following the Counter Data query is because the counter requires two rising edges on its clock input to load the data from the Counter Data registers into the DFF chain. Note that all rising edges during Tstop will be gated internally by the "Stop and Restart" feature.

For systems that require I2C write access to the Counter Data registers while the counter is clocking, enable the "Stop and Restart Bit." (Case 2)

I2C Read of Counter Data: Avoid reading Counter Data via I2C while the counter is being clocked.

Within the MCU, we recommend saving the Counter Data register configuration as a software variable so that the Counter Data register does not need to be read during counter operation.

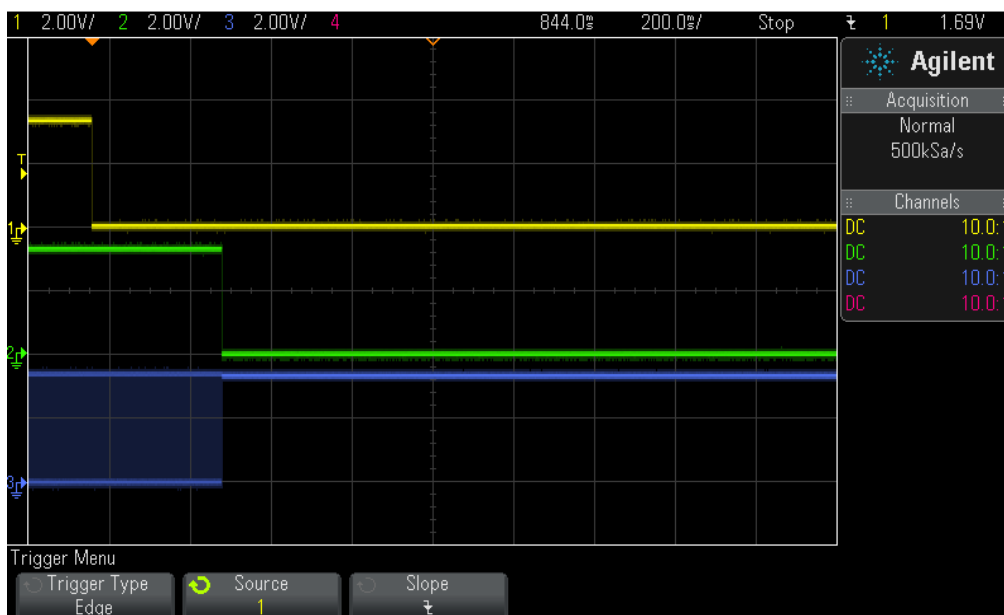
Figure 14

By toggling I2C_SDA low and then I2C_SCL low, the GreenPAK registers this as a start bit and latches all General Purpose Outputs such as PIN#17 (“OSC_OUT0”). In the [Figure 14](#), notice that PIN#17 (OSC_OUT0) stops toggling.

Disable IO Latching in programmed OTP. This register is I2C-write locked during normal operation and therefore should be disabled in configuration file.

Do not share I2C bus with other devices and make sure the I2C bus is not powered down while the GreenPAK is still powered through VDD.

If the above cannot be satisfied, then consider using the SLG4658x devices, where this errata has been fixed.

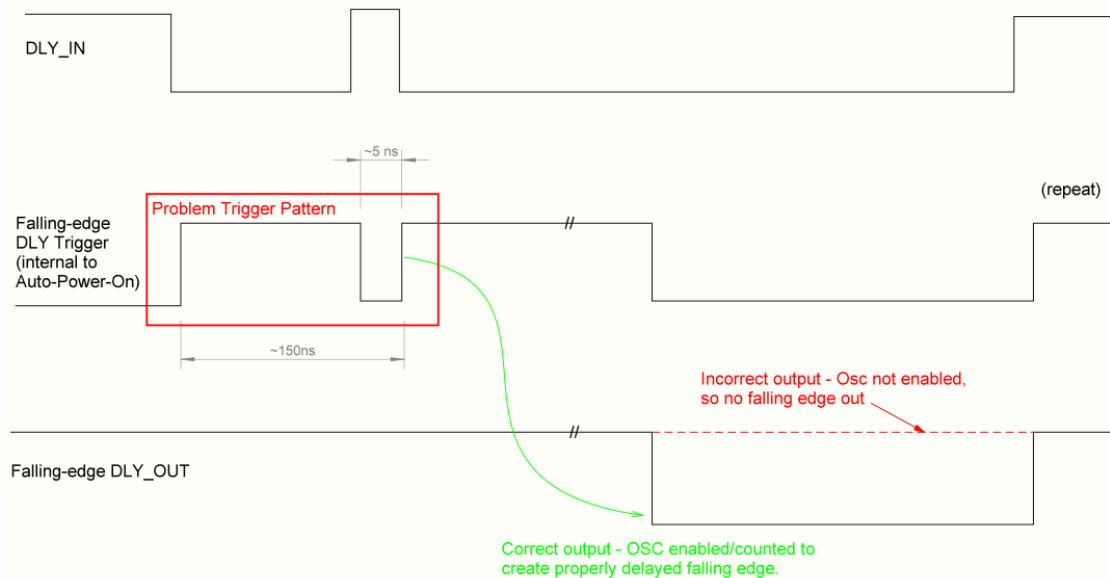
Figure 15: Problem Trigger Pattern

For this chip, the Auto Power On circuitry of the 25 kHz/2 MHz generators contains a circuit errata, which can potentially fail to power on the OSC for a specific pattern and timing of the OR of all related DLY trigger signals. The pattern is shown in [Figure 15](#) (boxed in red) and consists of a relatively longer pulse (~145 ns) followed by a shorter (~5 ns) glitch of opposite polarity.

1. Use signal conditioning circuits to prevent glitch on DLY inputs < 200 ns. Examples:
 - a. ACMP with Hysteresis
 - b. External RC in front of Digital Input with Schmitt Trigger
 - c. Filter cell.
2. Set OSC power mode to Force Power On mode instead of Auto Power On.
3. Use different oscillator, such as 25 MHz Ring OSC, which does not have Auto Power On issue.

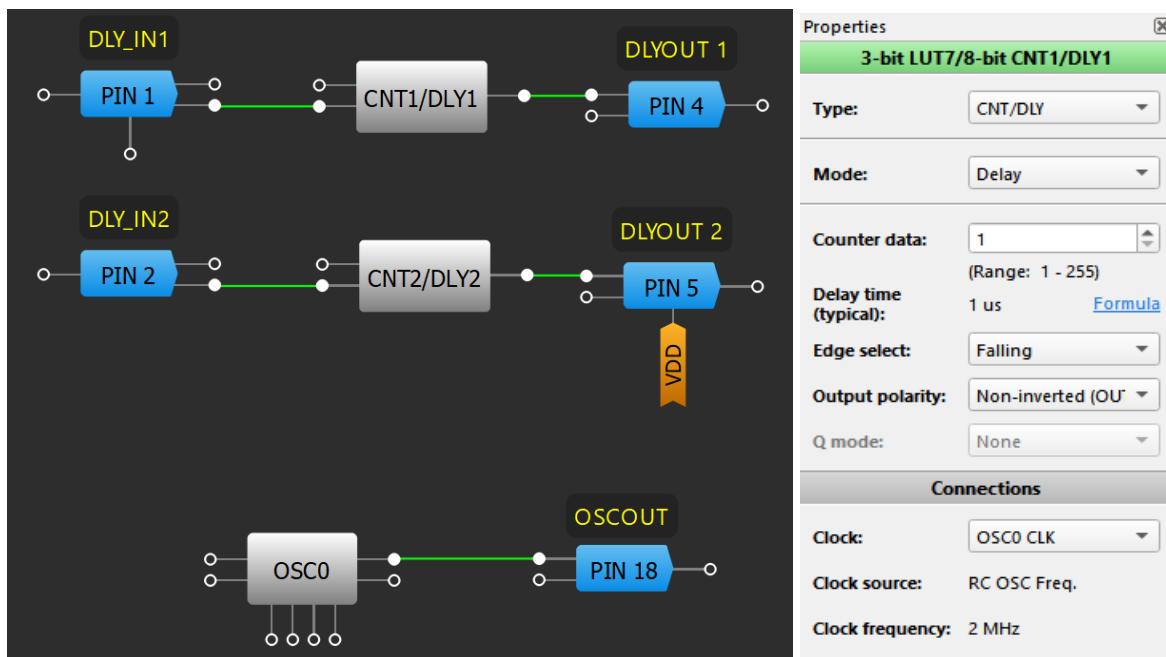
Figure 16: Test Circuit

The error is difficult to capture as the timing must be exact within ns, and short (ns) pulses are difficult to generate glitch precise enough to induce the problem. GPIO naturally filter out ns pulses, so for purposes of errata capture, two simultaneous falling-edge DLY circuits (as shown in [Figure 16](#)) were used. By lining up two delays precisely at a particular timing relationship, we can use the internal Auto Power On (OR logic) to generate the glitch pattern necessary to cause the error.

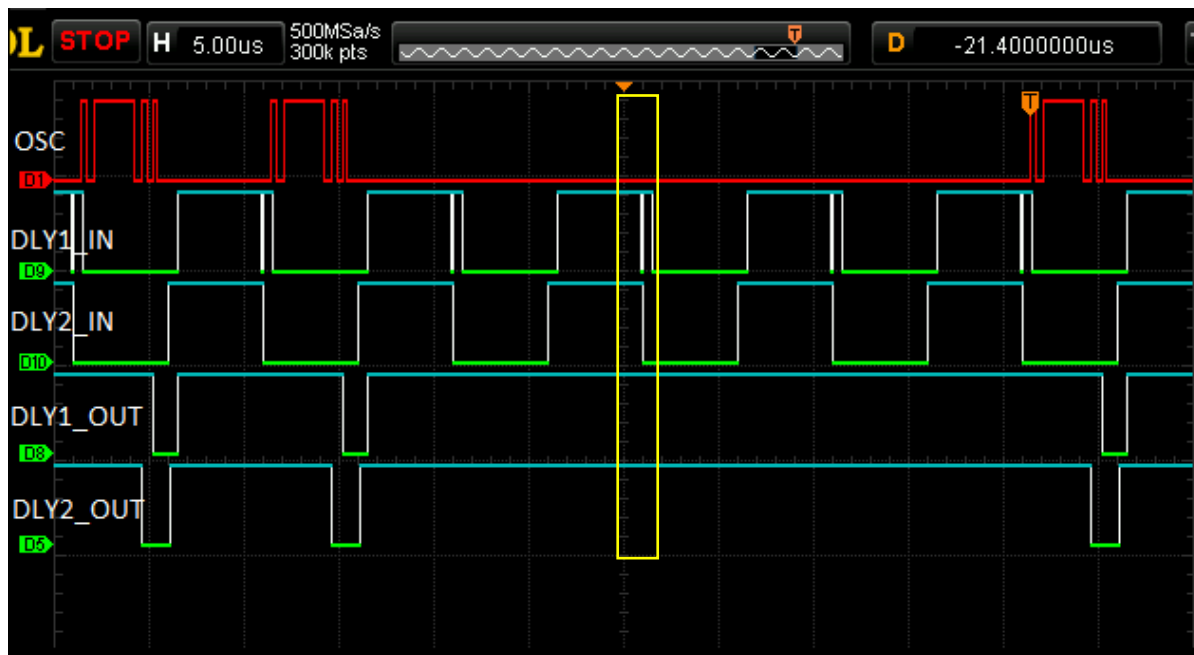
Figure 17: Errata Capture (Zoom Out)

Figure 17 shows a series of DLY output events are missing, where the OSC is correspondingly not triggering when it was supposed to. Figure 18 is a zoom in of the boxed region from Figure 17. The total glitch/chatter time was measured in this case at 152 ns. By using the composite OR of the two delay channels, we can asynchronously strobe with tiny frequency variations, and so tune the timing to induce this errata. Note that the error is not persistent – the system is recovered when all DLYs are returned to inactive state, such as when input of falling edge DLY goes high, thus canceling delay, or after DLY out finishes.

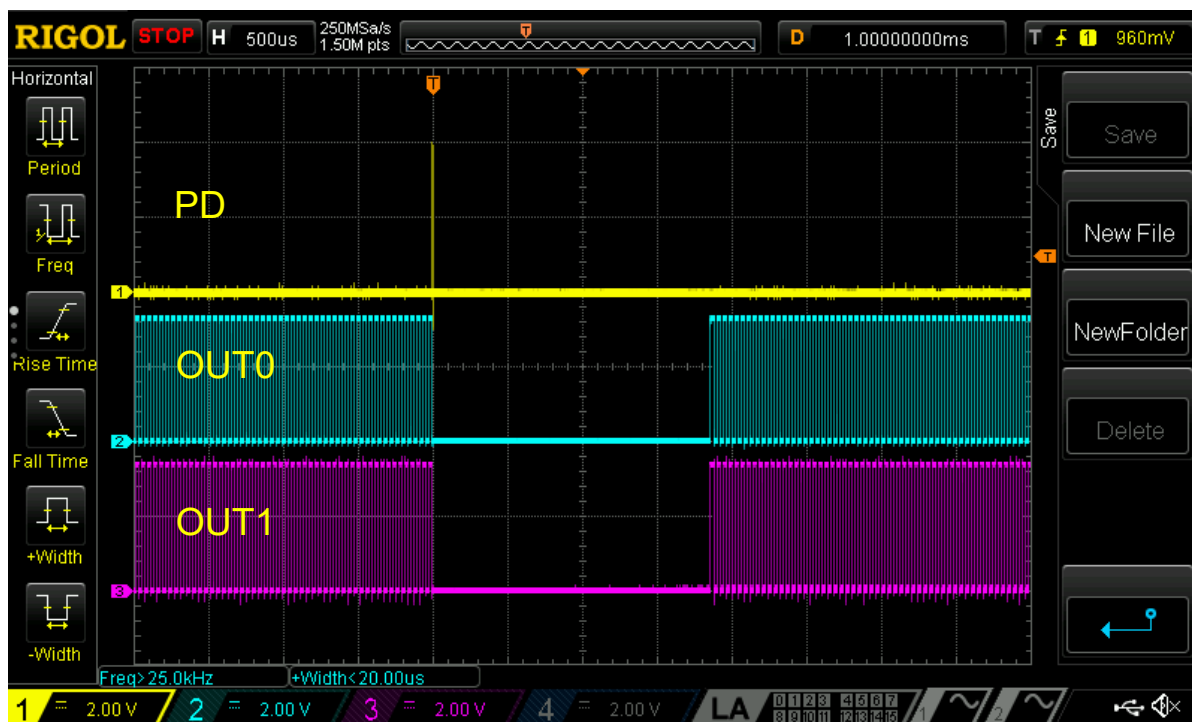
If a pulse with a duration of less than ~40 ns is applied to the PWR DOWN input of the oscillator, the oscillator outputs remain stuck for milliseconds, as shown in figures below. The issue is observed for all available oscillators.

Change Fast start-up setting to Enable or omit applying glitches at PWR DOWN input in OSC.

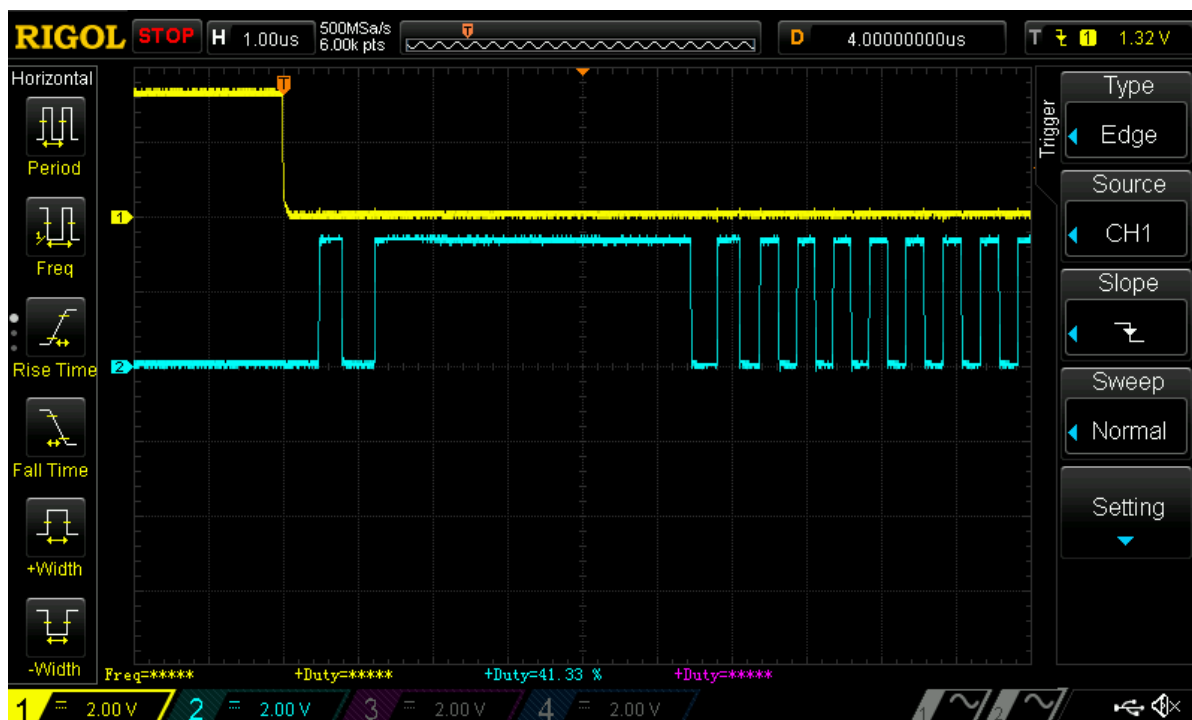
Figure 23. Channel 1 – OSC Power Down; Channel 2 –OSC output

2 MHz OSC has an additional ~ 9 cycles settling period. Higher VDD shows longer settling time.

Such behavior will lead to substantial error in period calculations if the delay time is relatively small.

Enable Fast Start-up option. Fast Start-up means forcing bias ready at the power-up instead of automatic enabling at OSC event. The standby current consumption difference between Fast start-up disabled and enabled is only an additional 300 nA.

Use the “Force power on” OSC power control option to make the OSC operate at all times. However, this will cause increased constant current consumption.
