# Errata

## SLG46580 Errata

### CE-GP-002

*This document contains the known errata for SLG46580 and the recommended workarounds.*

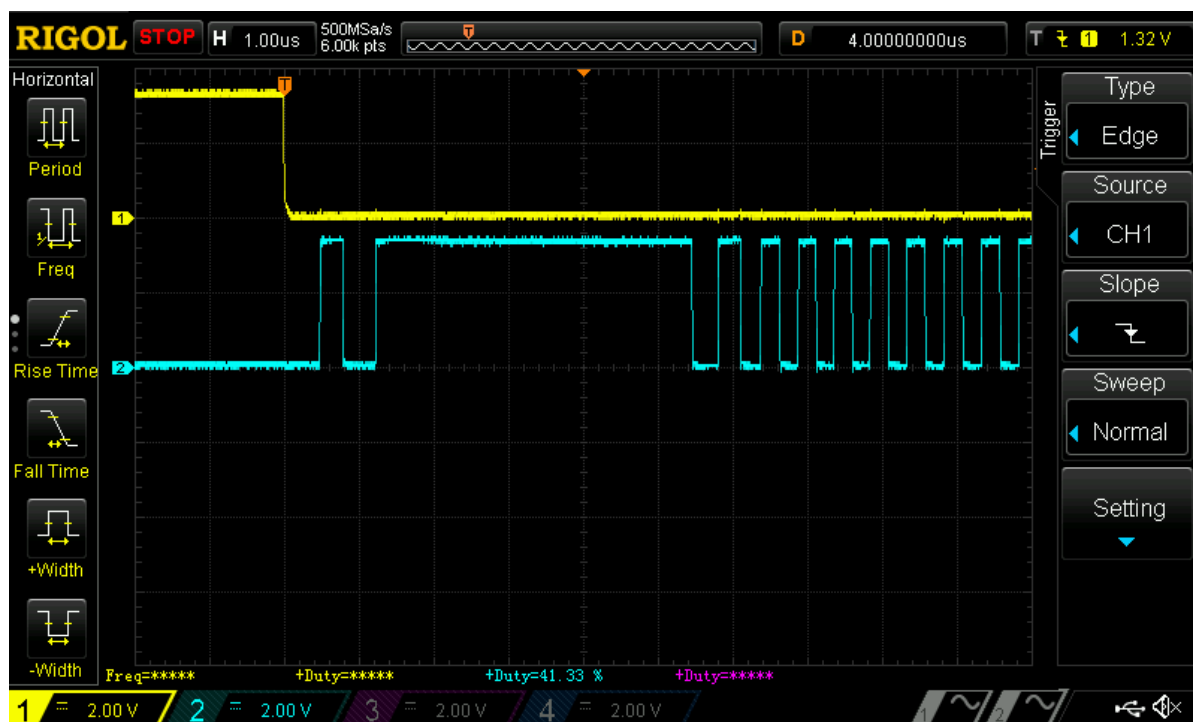
2 MHz OSC has an additional ~ 9 cycles settling period. Higher  $V_{DD}$  shows longer settling time.

Channel 1 – OSC Power Down; Channel 2 –OSC output

Such behavior will lead to substantial error in period calculations if the delay time is relatively small.

- Enable Fast Start-up option. Fast Start-up means forcing bias ready at the power-up instead of automatic enabling at OSC event. The standby current consumption difference between Fast start-up disabled and enabled is only an additional 300 nA.
- Use the “Force power on” OSC power control option to make the OSC operate at all times. However, this will cause increased constant current consumption.

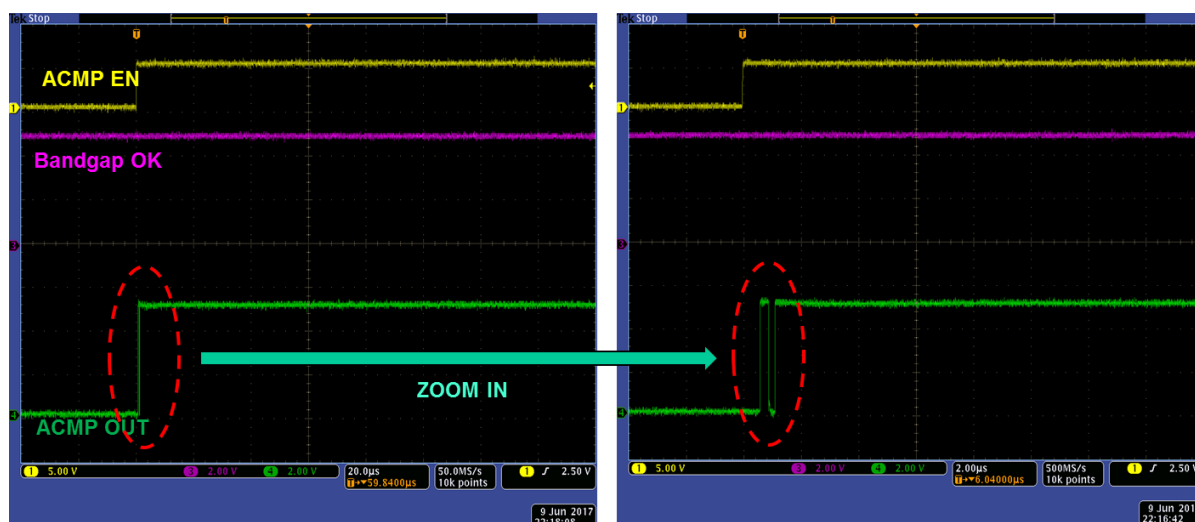
After power-up, if LDO is enabled earlier than ACMP, its output may generate a glitch.

$V_{DD} = 5.0\text{ V}$ , ACMP IN+ > IN-, one of LDOs enabled.

Because BG\_OK is already released by LDO, there is no gating signal. Depending on the ACMP VREF condition & the positive input value, it is possible for the ACMP to have a glitch. Subsequently, the other ACMP will not have an issue unless the customer repeats LDO enable first and ACMP later during power stable.

Use both edge delay on the output to filter out the glitch.

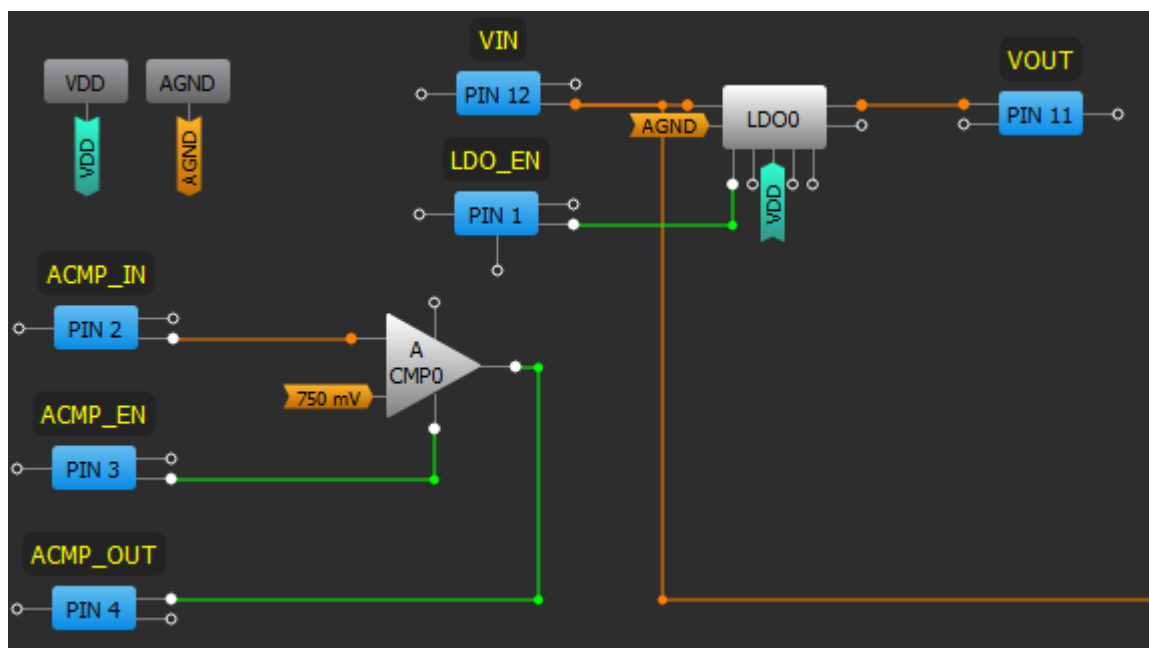
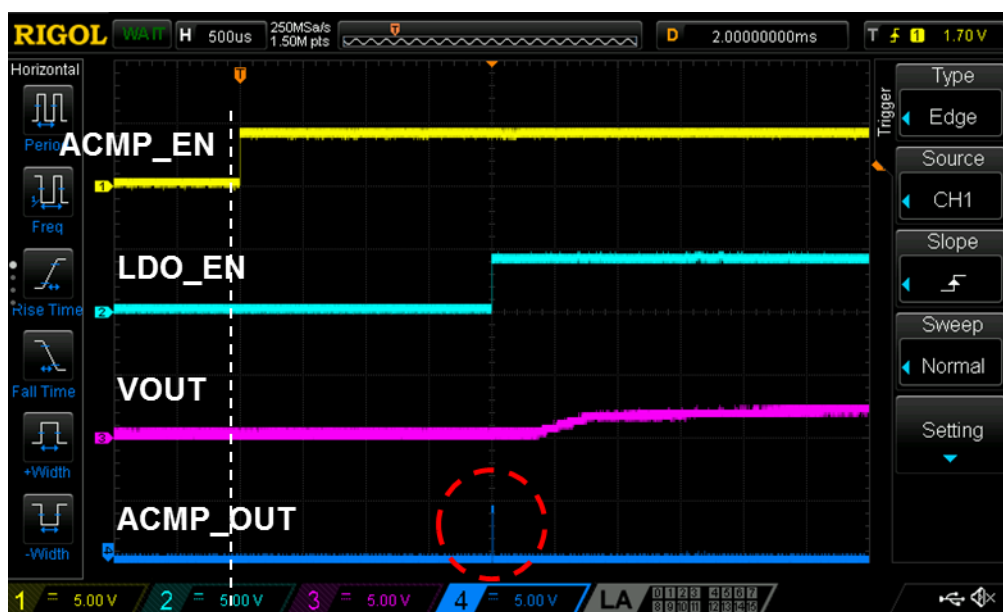
If an LDO's Low Power Mode is selected (for example tied to  $V_{DD}$ ) a glitch may appear on the ACMP's output after the first LDO is enabled. When the first LDO is turned on, the Low Power Mode switch causes a drop in the internal bandgap voltage that is used to derive the ACMP reference voltages.

- Use both edge delay on the output to filter out the glitch.
- Use some logic to avoid turning on Low Power Mode before enabling LDO and powering up the ACMP. Example is shown below.

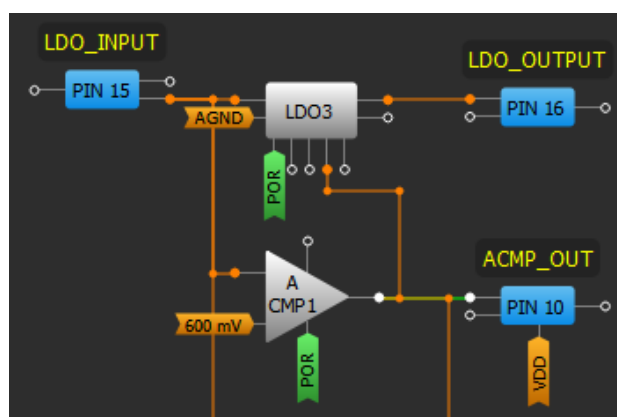
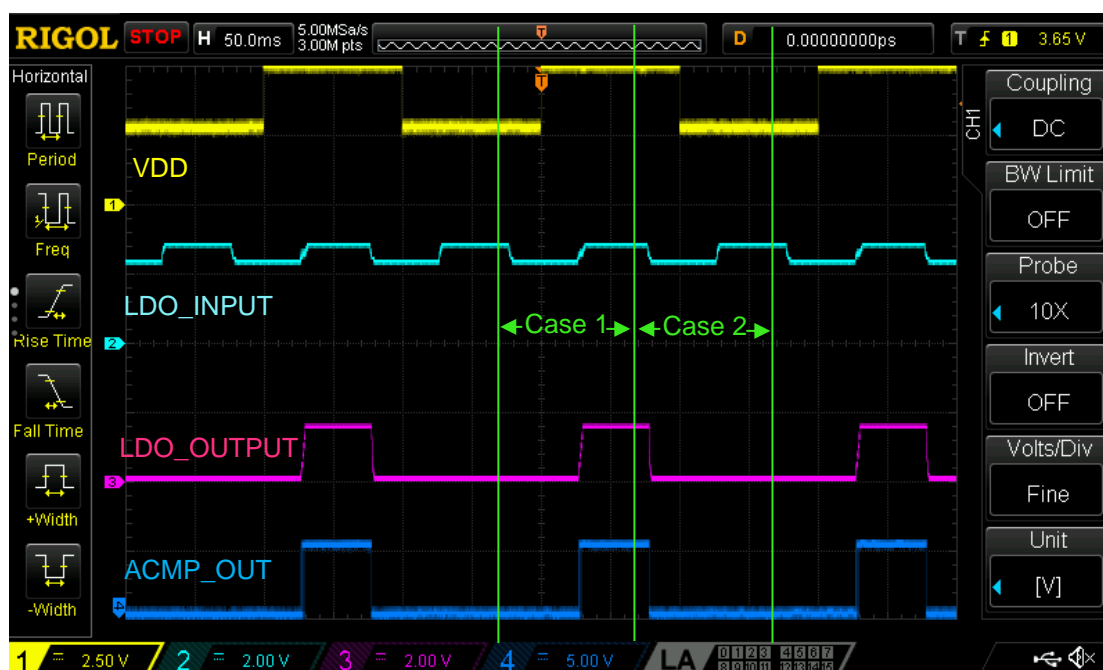
If an LDO's VIN pin (LDO\_INPUT) has an internal connection (depicted with an orange wire) to the ACMP's IN+ port, the ACMP's output may give an erroneous result with respect to the LDO's input voltage. The switch between the LDO's VIN pin and the ACMP's IN+ port is implemented using an NMOS-only based transmission gate with its gate controlled by logic supplied from V<sub>DD</sub>. As a result, this switch is unable to pass LDO input voltages that are close to V<sub>DD</sub>. This can result in the ACMP's IN+ port seeing a lower voltage than the actual voltage present at LDO\_INPUT. This lower input voltage may cause the output of the ACMP to behave unexpectedly.

If the LDO's UVLO feature is enabled, the ACMP's output will cause unexpected LDO behavior that results from the previously described transmission gate voltage drop.

Case 1: proper behavior at  $V_{DD} = 5\text{ V}$ .

With a 5 V  $V_{DD}$ , the NMOS transmission gate passes the 2.25 and 2.75 V LDO\_INPUT pin voltages to the ACMP's IN+ port. When the input voltage exceeds the 2.4 V IN- threshold of the ACMP, the LDO is enabled.

Case 2: erroneous behavior at  $V_{DD} = 2.75\text{ V}$ .

When the  $V_{DD}$  is reduced to 2.75 V, the NMOS transmission gate is unable to pass LDO\_INPUT's full magnitude to the ACMP's IN+ port. Since the IN+ port of the ACMP doesn't exceed the 2.4 V IN- threshold, the ACMP's output stays low and keeps the LDO disabled.

If the GreenPAK's  $V_{DD}$  is always powered up before the LDO's VIN input, you can externally short the LDO's VIN to another dedicated analog input pin for the desired ACMP.

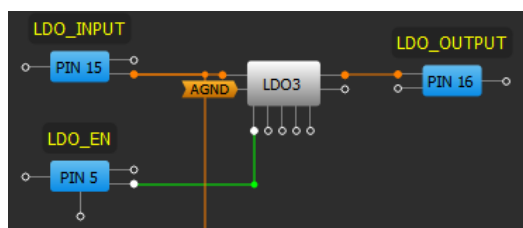
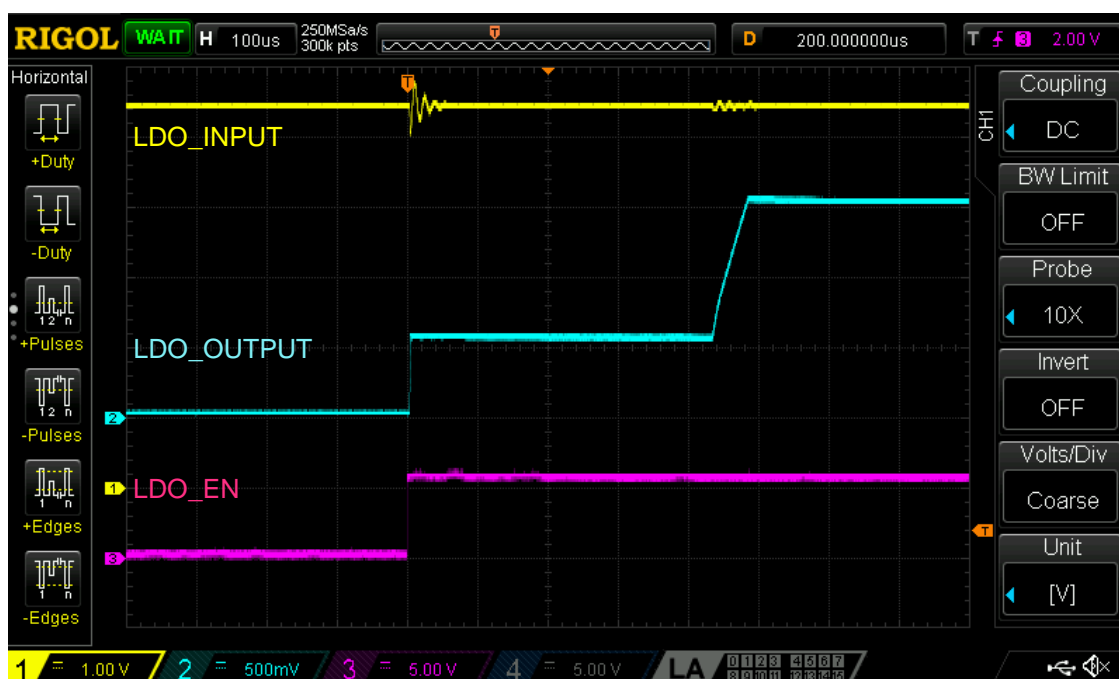
When a GreenPAK's first LDO is enabled, the LDO's VOUT will step to a non-zero voltage during its 500  $\mu\text{s}$  wait time. The magnitude of this step is directly proportional to the LDO's VIN and the GreenPAK's  $V_{DD}$ . With a large LDO input voltage and  $V_{DD}$ , this step can exceed 500 mV.

$V_{DD} = 5.5\text{ V}$ , LDO\_INPUT = 5.5 V, all other LDOs disabled.

If your GreenPAK design has an unused LDO, you can reduce the magnitude of this voltage step by keeping an unused LDO enabled in high power mode.

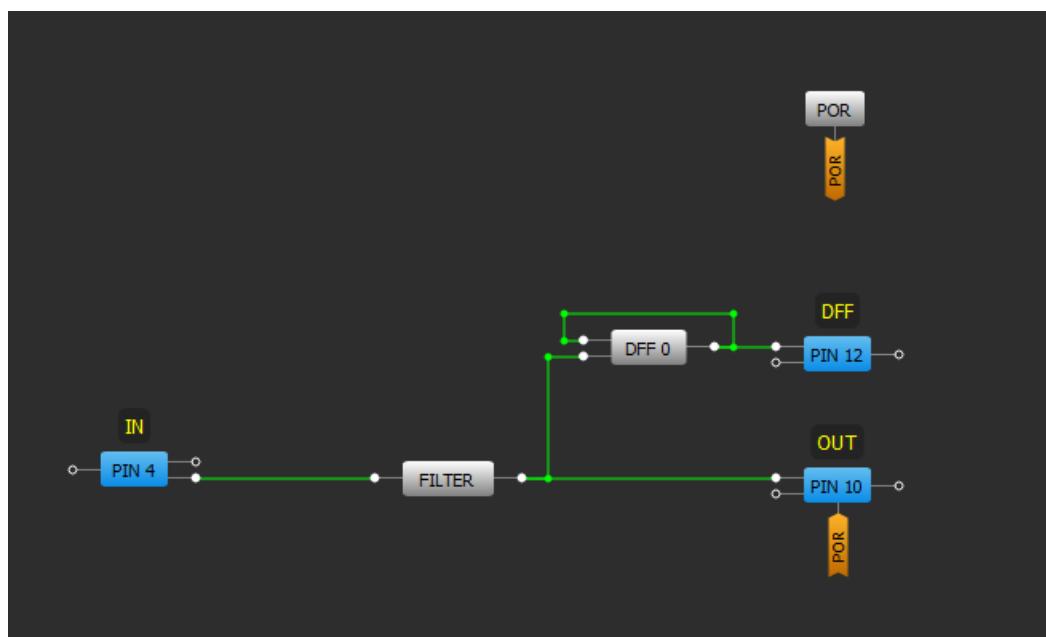
If the FILTER cell's input signal contains multiple consecutive pulses within short time intervals, the FILTER cell may not filter the input pulses as expected. The errant behavior applies only to repeated input pulses and depends on both their frequency and duty cycle.

Channel 1 (yellow/top line) – PIN#4 (IN).

Channel 2 (light blue/2nd line) – PIN#10 (OUT).

Channel 3 (magenta /3rd line) – PIN#12 (DFF).

Currently, there is no workaround for this issue. The FILTER block correctly filters isolated glitches, but it shouldn't be used to filter repetitive, high frequency input signals.

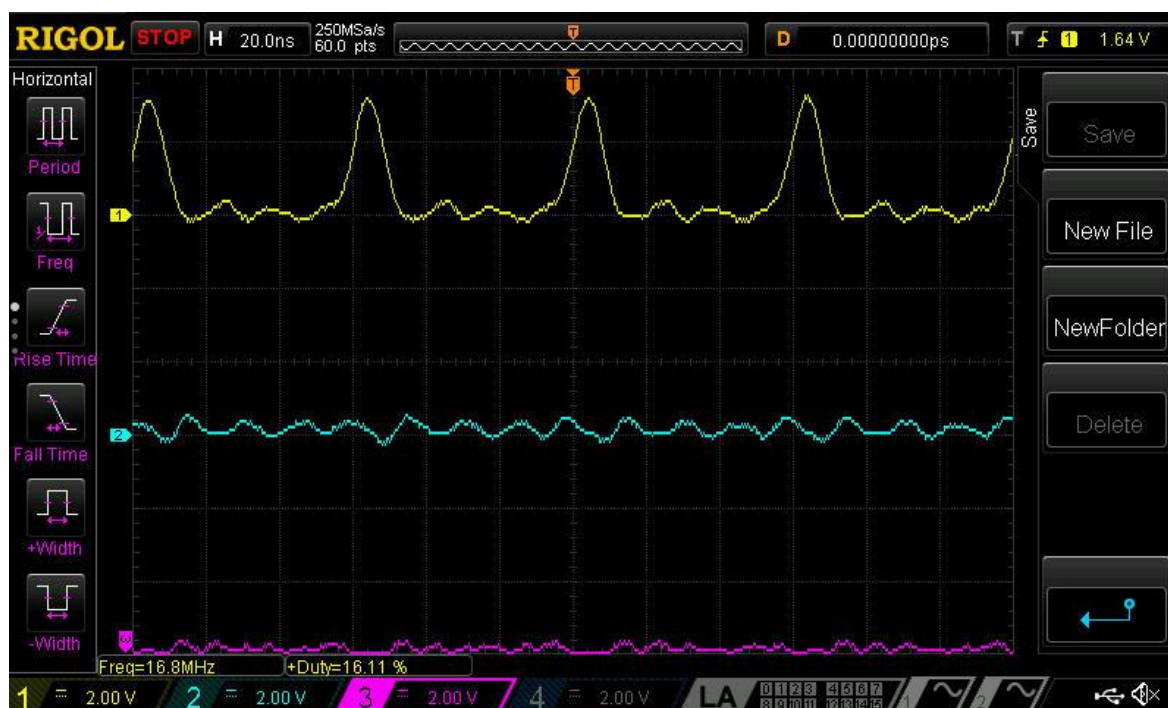
1. Period is 60 ns. Pulse width is 10 ns, DC = 16.7 % (correct functionality).

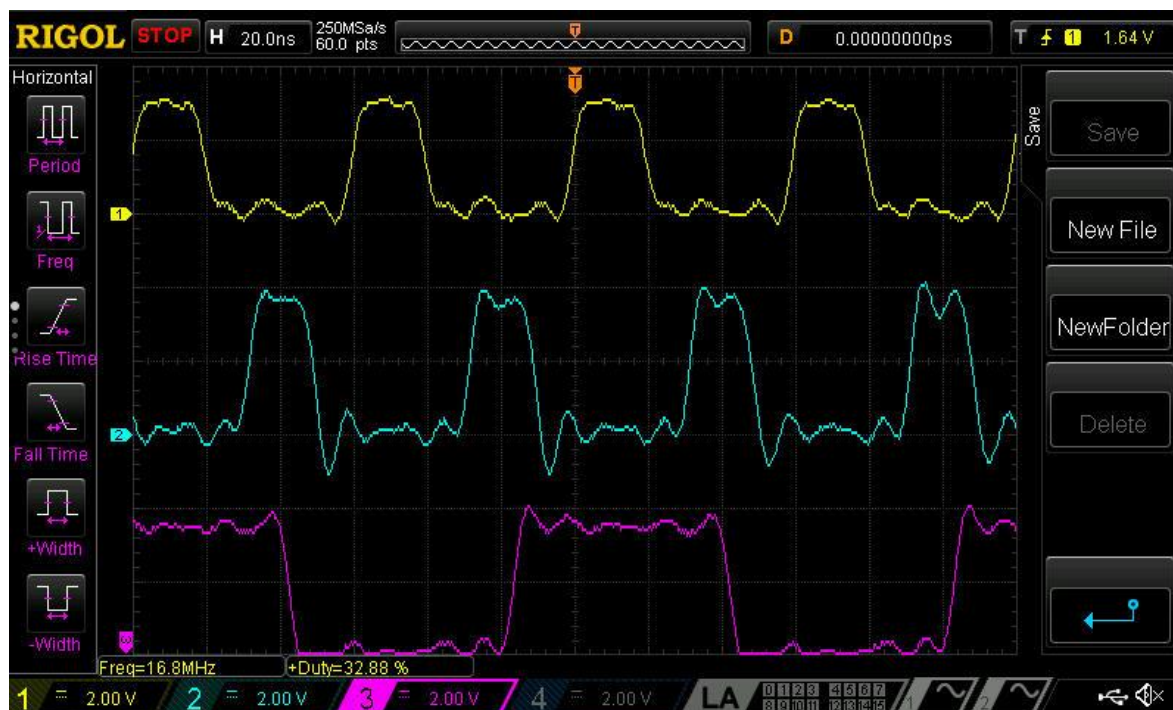
2. Period is 60 ns. Pulse width is 20 ns, DC = 33.3 % (incorrect functionality).

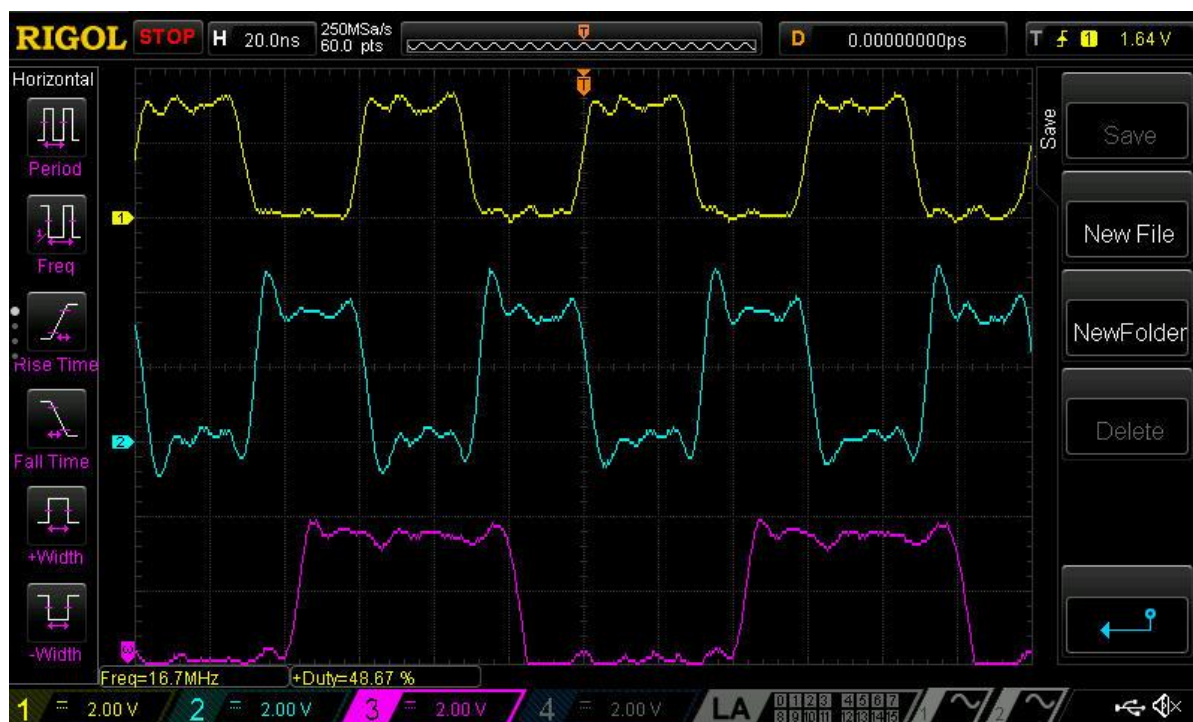
3. Period is 60 ns. Pulse width is 30 ns, DC = 50 % (incorrect functionality).

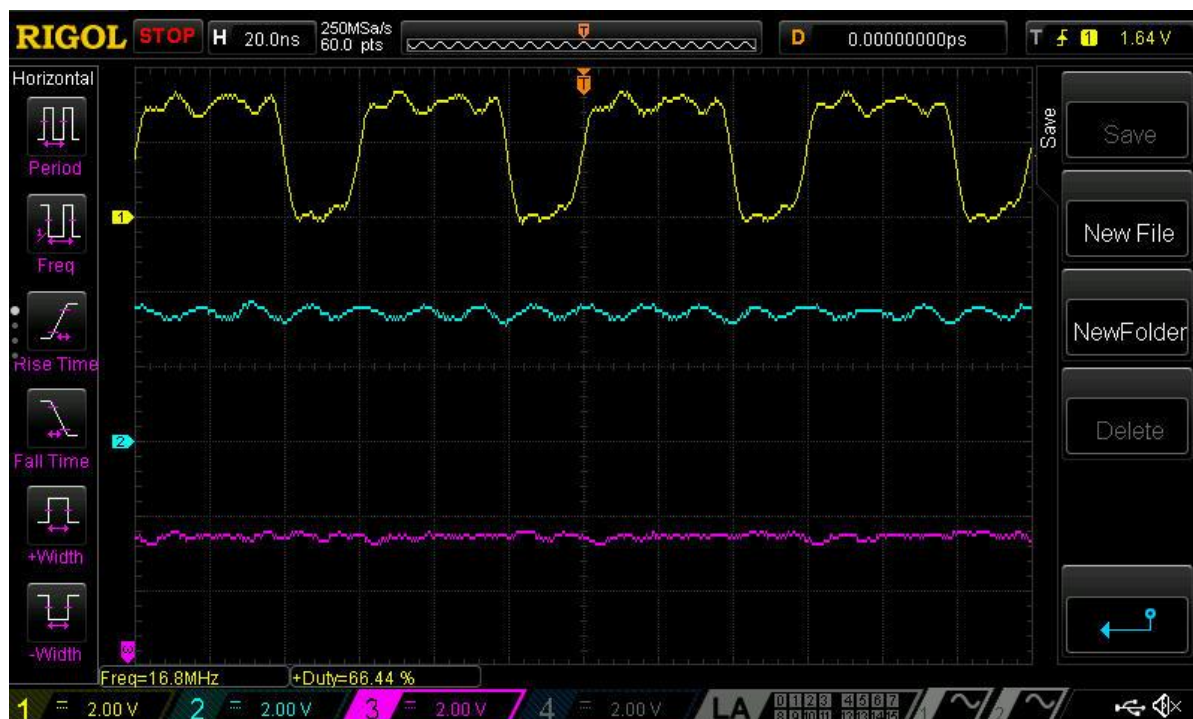
4. Period is 60 ns. Pulse width is 40 ns, DC = 66.67 % (correct functionality).

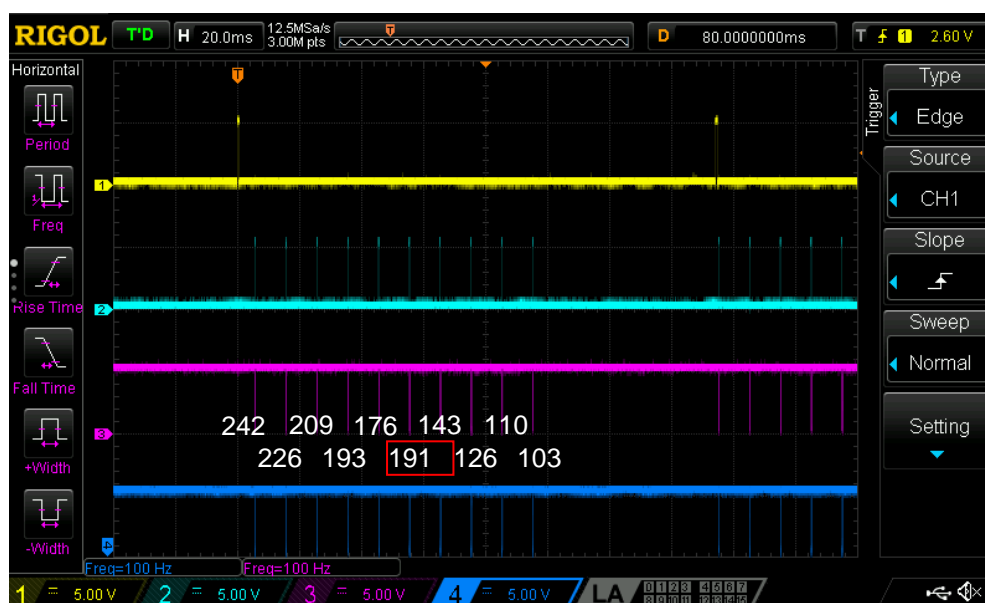
Asynchronous interaction between the CNT/DLY clock input and the I<sup>2</sup>C latch signal (generated by an I<sup>2</sup>C read command of the CNT/DLY block's count value) can result in an incorrect I<sup>2</sup>C data read. The CNT/DLY block will count accurately, but the count value transferred into the block's I<sup>2</sup>C read register might be loaded incompletely if the I<sup>2</sup>C latch signal and the clock input occur at about the same time.

The example data capture below shows ten periodic I<sup>2</sup>C reads of CNT2/DLY2 configured to count down at about 16 clocks per read. The sixth read sample erroneously shows a value greater than that of the fifth. The seventh sample reads as if the previous I<sup>2</sup>C error never occurred - the difference from the fifth sample (176) to the seventh (143) is 33 clocks or 16 clocks + 17 clocks as expected.

Channel 1 (yellow/top line) – PIN#2 (CNT2/DLY2 Out).  
 Channel 2 (light blue/2nd line) – PIN#1 (I<sup>2</sup>C Read Triggers).  
 Channel 3 (magenta /3rd line) – PIN#8 (I<sup>2</sup>C SCL).  
 Channel 3 (dark blue /4th line) – PIN#9 (I<sup>2</sup>C SDA).

If the possibility of incorrect I<sup>2</sup>C data reads can't be accommodated for by external software checks, one can guarantee proper operation by stopping the CNT/DLY block's clock during I<sup>2</sup>C reads through one of the following methods: by disabling the oscillator block, by reconfiguring the CNT/DLY block's clock source, or by gating an external clock using a LUT (Look-up Table) in the signal matrix. After disabling the CNT/DLY block's clock, the count registers can be read without error. Please note that this workaround will add the I<sup>2</sup>C read and processing time to the counter's overall clock period.

The best workaround depends on the resource constraints of the application. If the oscillator block doesn't clock other logic elements within the design, a matrix output can be used to manually power down the oscillators for the I<sup>2</sup>C read. When the CNT/DLY block's clock source is routed internally from the oscillator block, I<sup>2</sup>C commands can temporarily reconfigure the CNT/DLY block's clock source registers to select "Ext. CLK. (From Matrix)." This action will disable the clock by connecting it to ground. If the CNT/DLY block is clocked from the signal matrix, a LUT can be used to gate the clock during an I<sup>2</sup>C read.

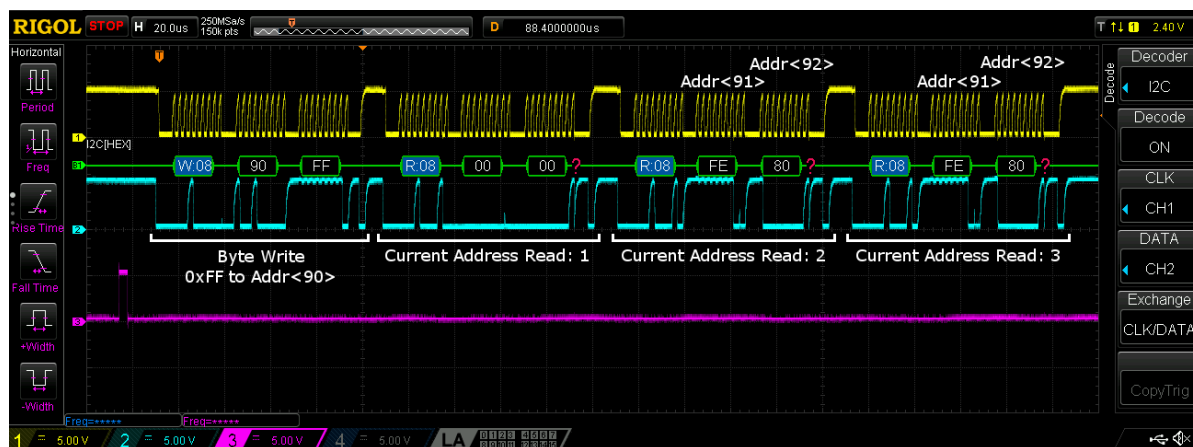
The first “Current Address Read” or “Sequential Read” command following an I<sup>2</sup>C “Byte Write” or a “Sequential Write” command will produce incorrect data. Additional read commands will return the expected data. See the waveform below for more information.

Channel 1 (yellow/top line) – PIN#8 (SCL).

Channel 2 (light blue/2nd line) – PIN#9 (SDA).

Channel 3 (magenta/3rd line) – I<sup>2</sup>C Software Trigger.

Note: In the GreenPAK test design, Addr<91> and Addr<92> expect FE and 80 respectively.

If possible, use the “Random Read” command as described in the datasheet for SLG46580. This command will output the correct data.

If you expect consecutive reads of the same register, we recommend sending a “Random Read” command to the register preceding the register of interest. After the “Random Read” command finishes, the chip’s register pointer will increment to the desired register and the following “Current

Address Read” or “Sequential Read” commands will produce the correct data. Note that the “Current Address Read” and “Sequential Read” commands don’t increment the GreenPAK’s register pointer.

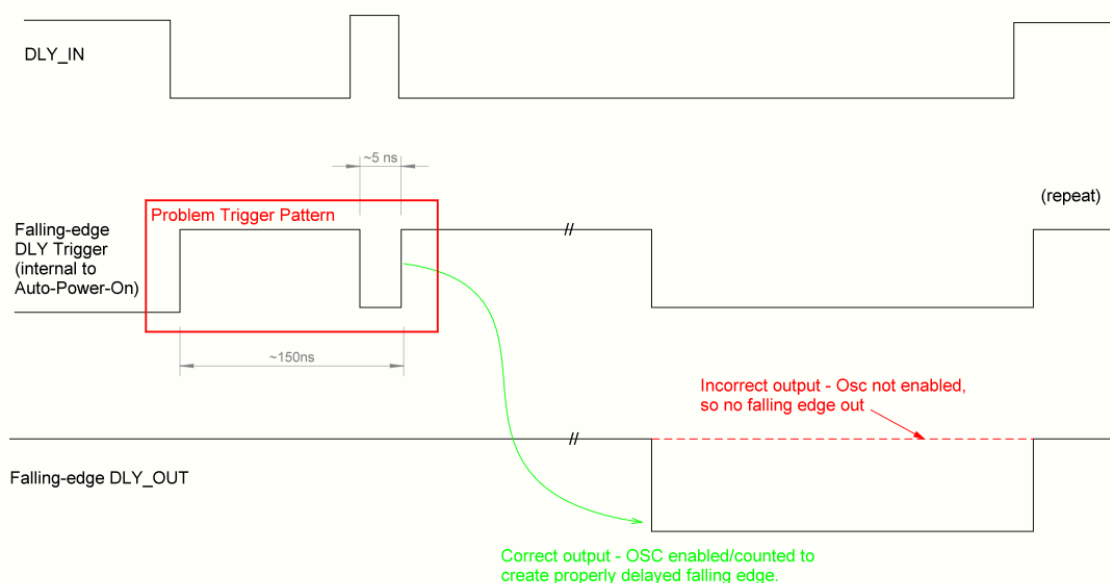
Figure 1: Problem Trigger Pattern

For this chip, the Auto Power On circuitry of the 25 kHz/2 MHz generators contains a circuit errata, which can potentially fail to power on the OSC for a specific pattern and timing of the OR of all related DLY trigger signals. The pattern is shown in Figure 1 (boxed in red) and consists of a relatively longer pulse (~145 ns) followed by a shorter (~5 ns) glitch of opposite polarity.

1. Use signal conditioning circuits to prevent glitch on DLY inputs < 200 ns. Examples:
  - a. ACMP with Hysteresis
  - b. External RC in front of Digital Input with Schmitt Trigger
  - c. Filter cell.
2. Set OSC power mode to Force Power On mode instead of Auto Power On.
3. Use different oscillator, such as 25 MHz Ring OSC, which does not have Auto Power On issue.

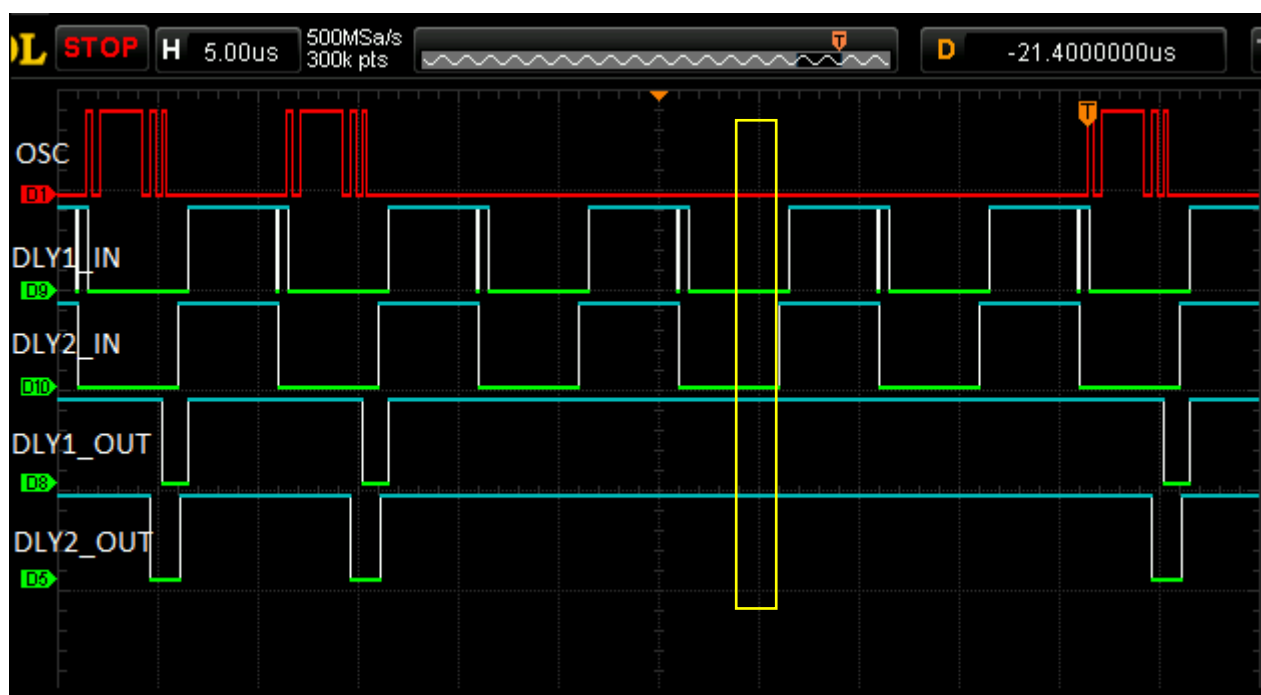
Figure 3: Errata Capture (Zoom Out)

Figure 3 shows a series of DLY output events are missing, where the OSC is correspondingly not triggering when it was supposed to. Figure 4 is a zoom in of the boxed region from Figure 3. The total glitch/chatter time was measured in this case at 152 ns. By using the composite OR of the two delay channels, we can asynchronously strobe with tiny frequency variations, and so tune the timing to induce this errata. Note that the error is not persistent – the system is recovered when all DLYs are returned to inactive state, such as when input of falling edge DLY goes high, thus canceling delay, or after DLY out finishes.

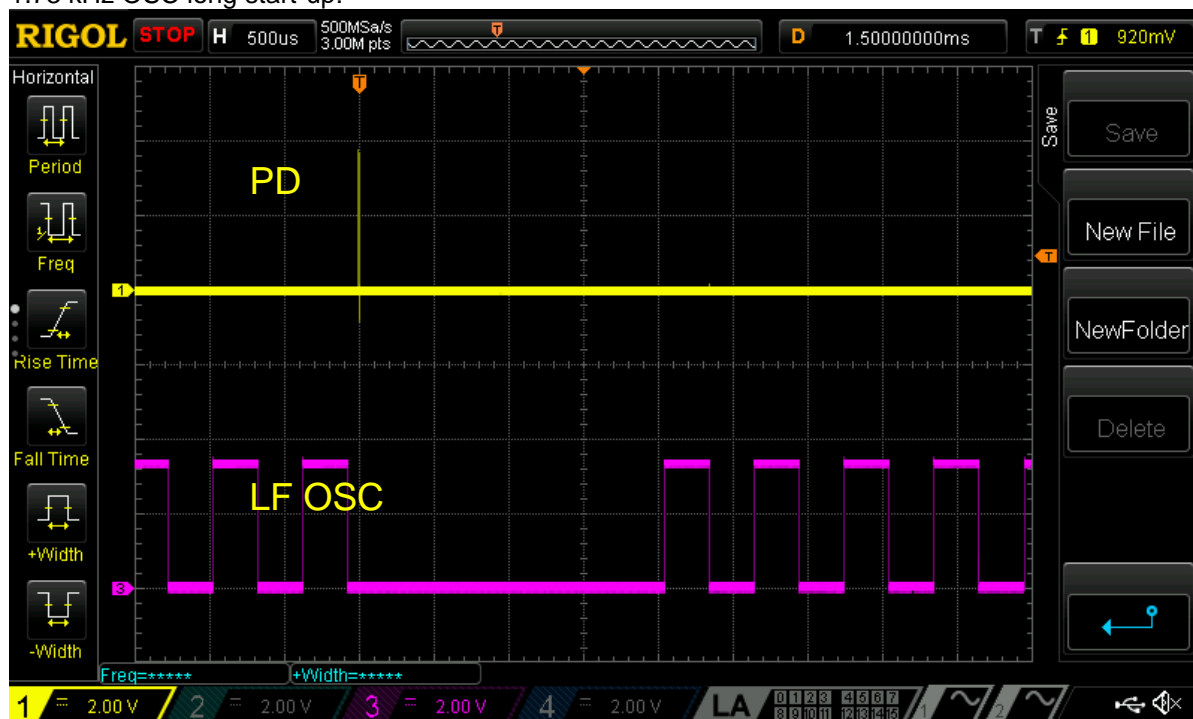
If a pulse with a duration of less than ~40 ns is applied to the PWR DOWN input of an oscillator, the oscillator outputs remain stuck for milliseconds.

1.73 kHz OSC long start-up:

Change Fast start-up setting to Enable or omit applying glitches at PWR DOWN input in OSC.

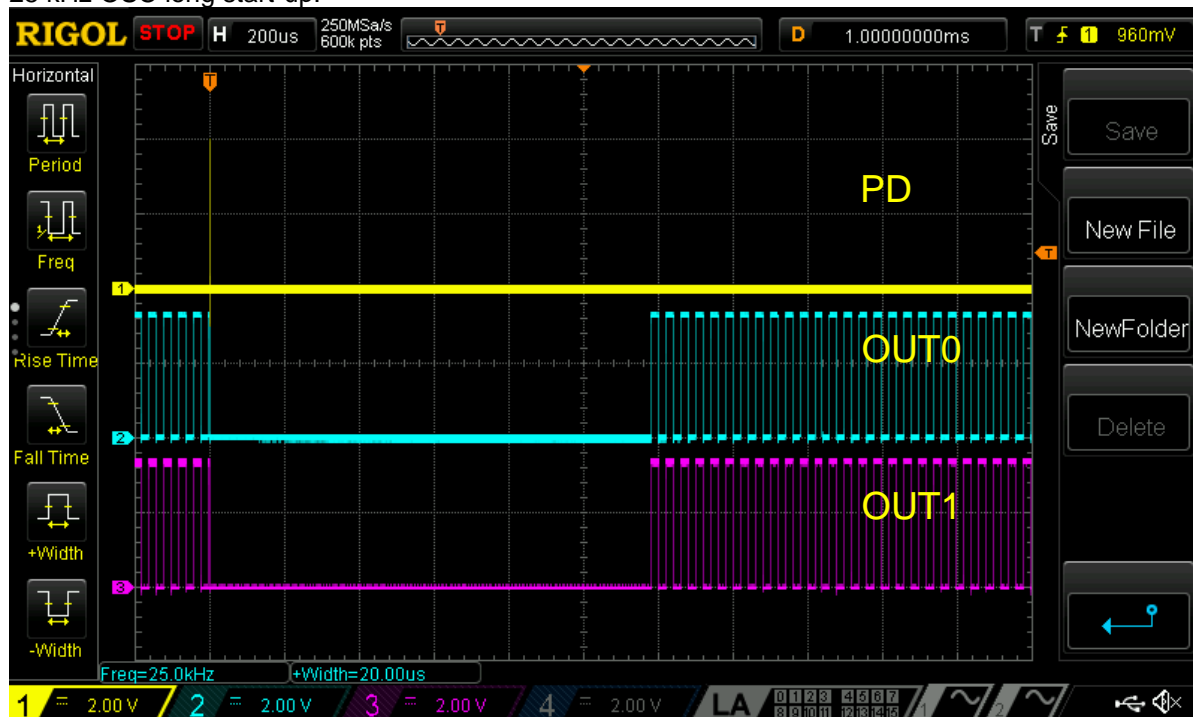
25 kHz OSC long start-up:

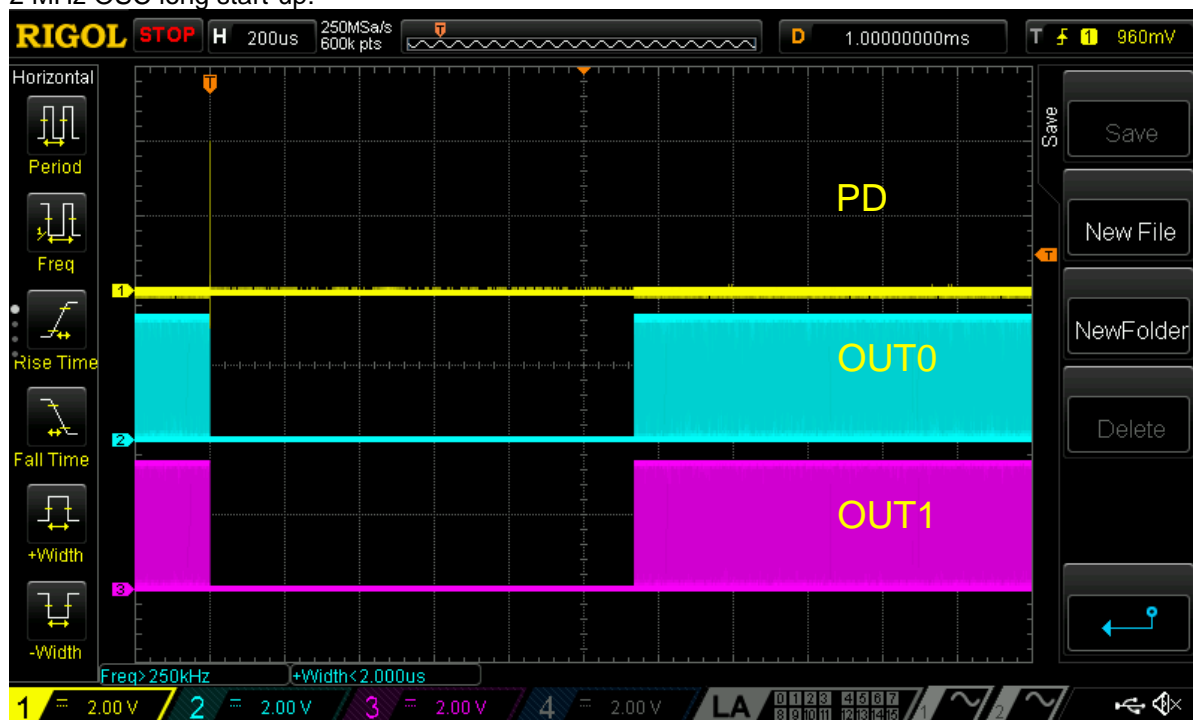
2 MHz OSC long start-up:
