SLG46582 Errata

CE-GP-002

This document contains the known errata for SLG46582 and the recommended workarounds.

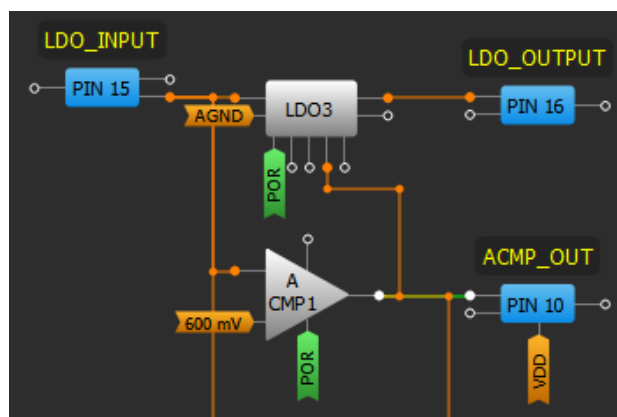
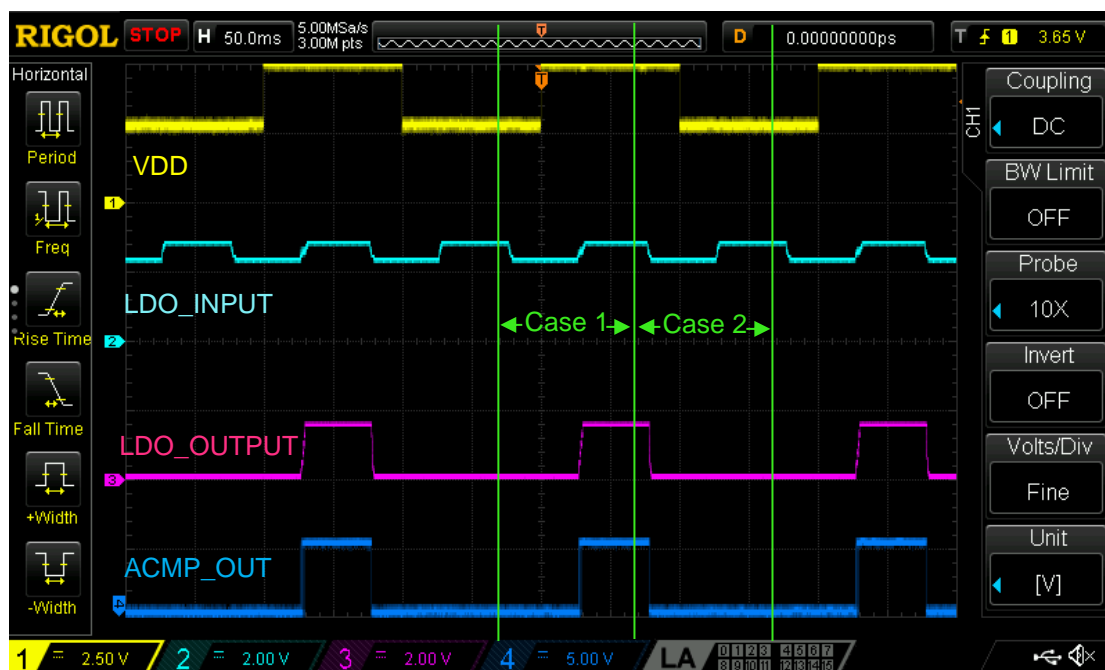
If an LDO's VIN pin (LDO_INPUT) has an internal connection (depicted with an orange wire) to the ACMP's IN+ port, the ACMP's output may give an erroneous result with respect to the LDO's input voltage. The switch between the LDO's VIN pin and the ACMP's IN+ port is implemented using an NMOS-only based transmission gate with its gate controlled by logic supplied from V_{DD} . As a result, this switch is unable to pass LDO input voltages that are close to V_{DD} . This can result in the ACMP's IN+ port seeing a lower voltage than the actual voltage present at LDO_INPUT. This lower input voltage may cause the output of the ACMP to behave unexpectedly.

If the LDO's UVLO feature is enabled, the ACMP's output will cause unexpected LDO behavior that results from the previously described transmission gate voltage drop.

Case 1: proper behavior at $V_{DD} = 5\text{ V}$.

With a 5 V V_{DD} , the NMOS transmission gate passes the 2.25 and 2.75 V LDO_INPUT pin voltages to the ACMP's IN+ port. When the input voltage exceeds the 2.4 V IN- threshold of the ACMP, the LDO is enabled.

Case 2: erroneous behavior at $V_{DD} = 2.75\text{ V}$.

When the V_{DD} is reduced to 2.75 V, the NMOS transmission gate is unable to pass LDO_INPUT's full magnitude to the ACMP's IN+ port. Since the IN+ port of the ACMP doesn't exceed the 2.4 V IN- threshold, the ACMP's output stays low and keeps the LDO disabled.

If the GreenPAK's V_{DD} is always powered up before the LDO's VIN input, you can externally short the LDO's VIN to another dedicated analog input pin for the desired ACMP.

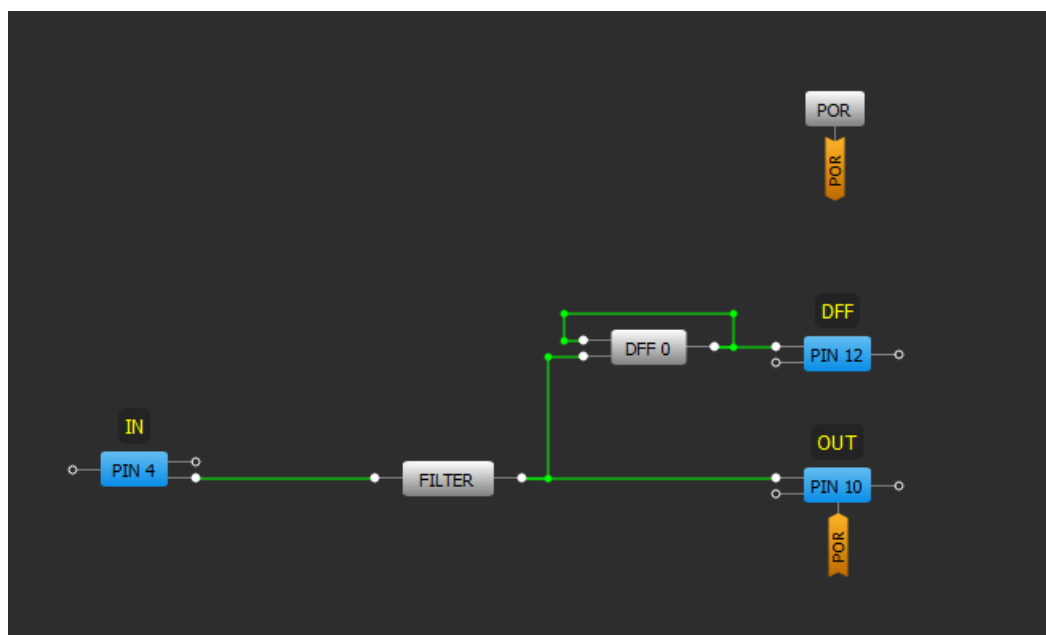
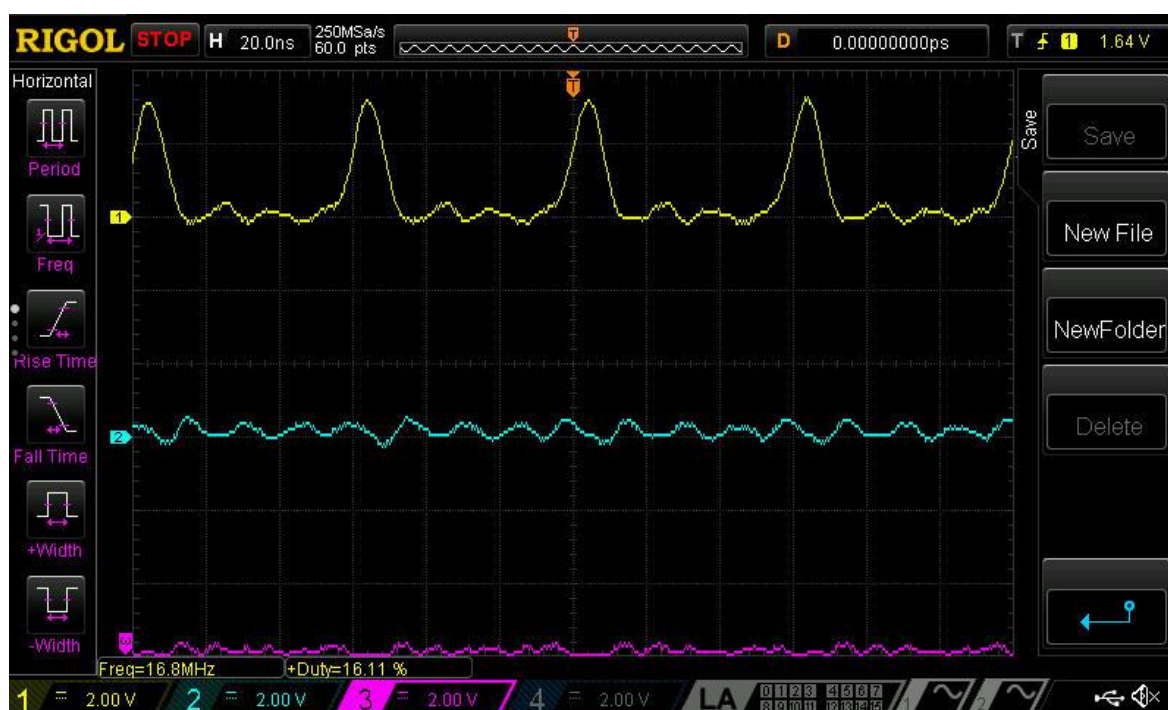
If the FILTER cell's input signal contains multiple consecutive pulses within short time intervals, the FILTER cell may not filter the input pulses as expected. The errant behavior applies only to repeated input pulses and depends on both their frequency and duty cycle.

1. Period is 60 ns. Pulse width is 10 ns, DC = 16.7 % (correct functionality).

Currently, there is no workaround for this issue. The FILTER block correctly filters isolated glitches, but it shouldn't be used to filter repetitive, high frequency input signals.

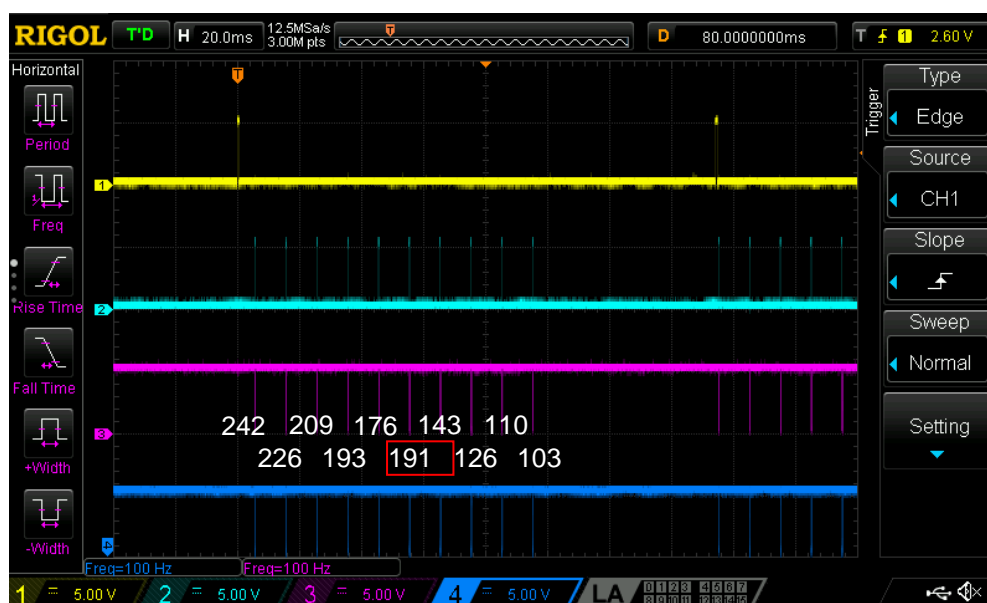
Asynchronous interaction between the CNT/DLY clock input and the I²C latch signal (generated by an I²C read command of the CNT/DLY block's count value) can result in an incorrect I²C data read. The CNT/DLY block will count accurately, but the count value transferred into the block's I²C read register might be loaded incompletely if the I²C latch signal and the clock input occur at about the same time.

The example data capture below shows ten periodic I²C reads of CNT2/DLY2 configured to count down at about 16 clocks per read. The sixth read sample erroneously shows a value greater than that of the fifth. The seventh sample reads as if the previous I²C error never occurred - the difference from the fifth sample (176) to the seventh (143) is 33 clocks or 16 clocks + 17 clocks as expected.

Channel 1 (yellow/top line) – PIN#2 (CNT2/DLY2 Out).
 Channel 2 (light blue/2nd line) – PIN#1 (I²C Read Triggers).
 Channel 3 (magenta /3rd line) – PIN#8 (I²C SCL).
 Channel 3 (dark blue /4th line) – PIN#9 (I²C SDA).

If the possibility of incorrect I²C data reads can't be accommodated for by external software checks, one can guarantee proper operation by stopping the CNT/DLY block's clock during I²C reads through one of the following methods: by disabling the oscillator block, by reconfiguring the CNT/DLY block's clock source, or by gating an external clock using a LUT (Look-up Table) in the signal matrix. After disabling the CNT/DLY block's clock, the count registers can be read without error. Please note that this workaround will add the I²C read and processing time to the counter's overall clock period.

The best workaround depends on the resource constraints of the application. If the oscillator block doesn't clock other logic elements within the design, a matrix output can be used to manually power down the oscillators for the I²C read. When the CNT/DLY block's clock source is routed internally from the oscillator block, I²C commands can temporarily reconfigure the CNT/DLY block's clock source registers to select "Ext. CLK. (From Matrix)." This action will disable the clock by connecting it to ground. If the CNT/DLY block is clocked from the signal matrix, a LUT can be used to gate the clock during an I²C read.

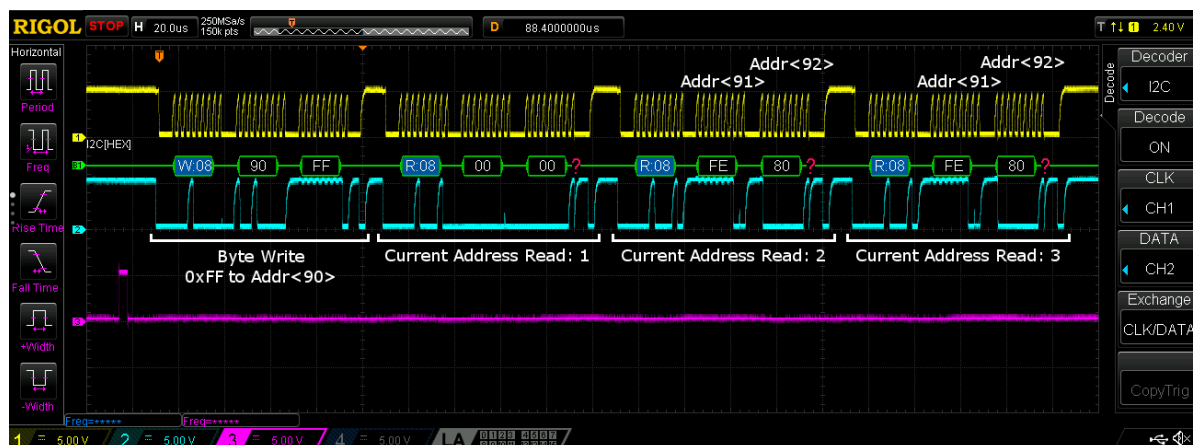
The first “Current Address Read” or “Sequential Read” command following an I²C “Byte Write” or a “Sequential Write” command will produce incorrect data. Additional read commands will return the expected data. See the waveform below for more information.

Channel 1 (yellow/top line) – PIN#8 (SCL).

Channel 2 (light blue/2nd line) – PIN#9 (SDA).

Channel 3 (magenta/3rd line) – I²C Software Trigger.

Note: In the GreenPAK test design, Addr<91> and Addr<92> expect FE and 80 respectively.

If possible, use the “Random Read” command as described in the datasheet for SLG46580. This command will output the correct data.

If you expect consecutive reads of the same register, we recommend sending a “Random Read” command to the register preceding the register of interest. After the “Random Read” command finishes, the chip’s register pointer will increment to the desired register and the following “Current

Address Read” or “Sequential Read” commands will produce the correct data. Note that the “Current Address Read” and “Sequential Read” commands don’t increment the GreenPAK’s register pointer.

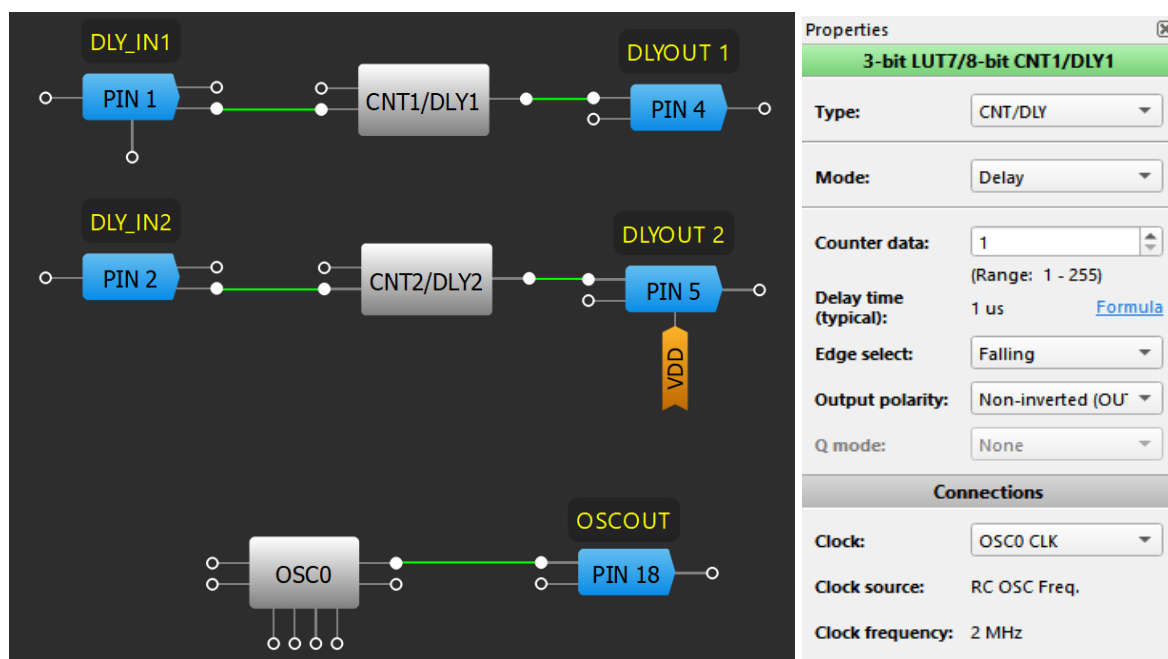
Figure 2: Test Circuit

The error is difficult to capture as the timing must be exact within ns, and short (ns) pulses are difficult to generate glitch precise enough to induce the problem. GPIO naturally filter out ns pulses, so for purposes of errata capture, two simultaneous falling-edge DLY circuits (as shown in Figure 2) were used. By lining up two delays precisely at a particular timing relationship, we can use the internal Auto Power On (OR logic) to generate the glitch pattern necessary to cause the error.

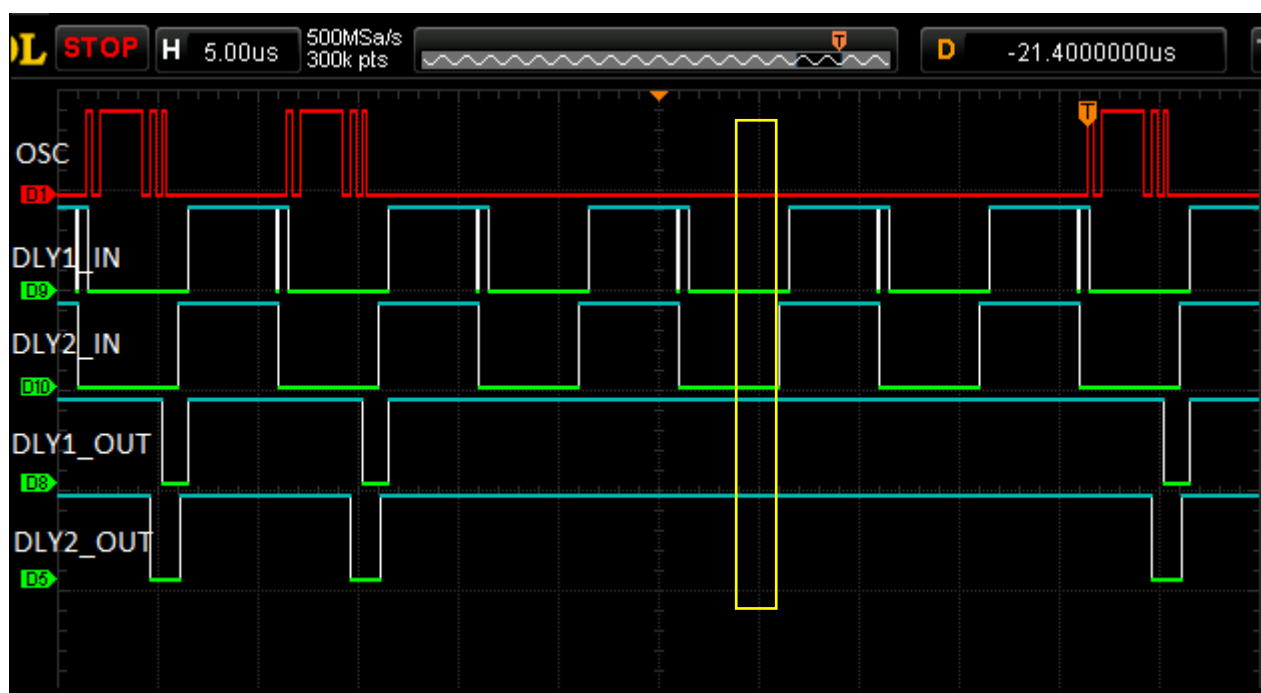
Figure 3: Errata Capture (Zoom Out)

Figure 3 shows a series of DLY output events are missing, where the OSC is correspondingly not triggering when it was supposed to. Figure 4 is a zoom in of the boxed region from Figure 3. The total glitch/chatter time was measured in this case at 152 ns. By using the composite OR of the two delay channels, we can asynchronously strobe with tiny frequency variations, and so tune the timing to induce this errata. Note that the error is not persistent – the system is recovered when all DLYs are returned to inactive state, such as when input of falling edge DLY goes high, thus canceling delay, or after DLY out finishes.

1. Use signal conditioning circuits to prevent glitch on DLY inputs < 200 ns. Examples:
 - a. ACMP with Hysteresis
 - b. External RC in front of Digital Input with Schmitt Trigger
 - c. Filter cell.
2. Set OSC power mode to Force Power On mode instead of Auto Power On.
3. Use different oscillator, such as 25 MHz Ring OSC, which does not have Auto Power On issue.

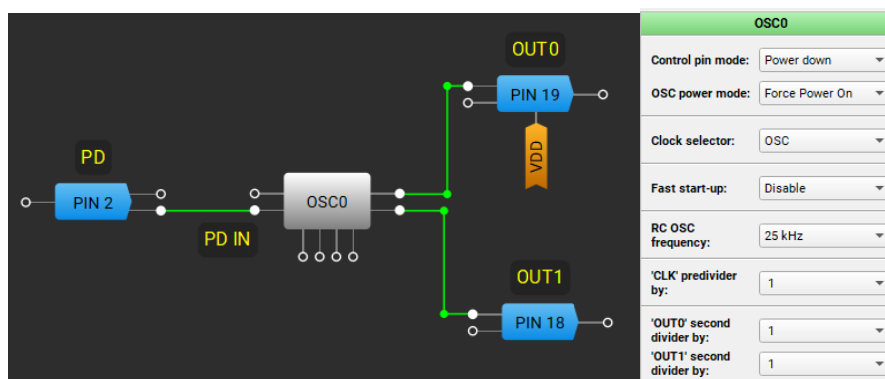
Short pulse of less than ~40ns is applied to PWR DOWN OSC.

Change Fast start-up setting to Enable or omit applying glitches at PWR DOWN input in OSC.

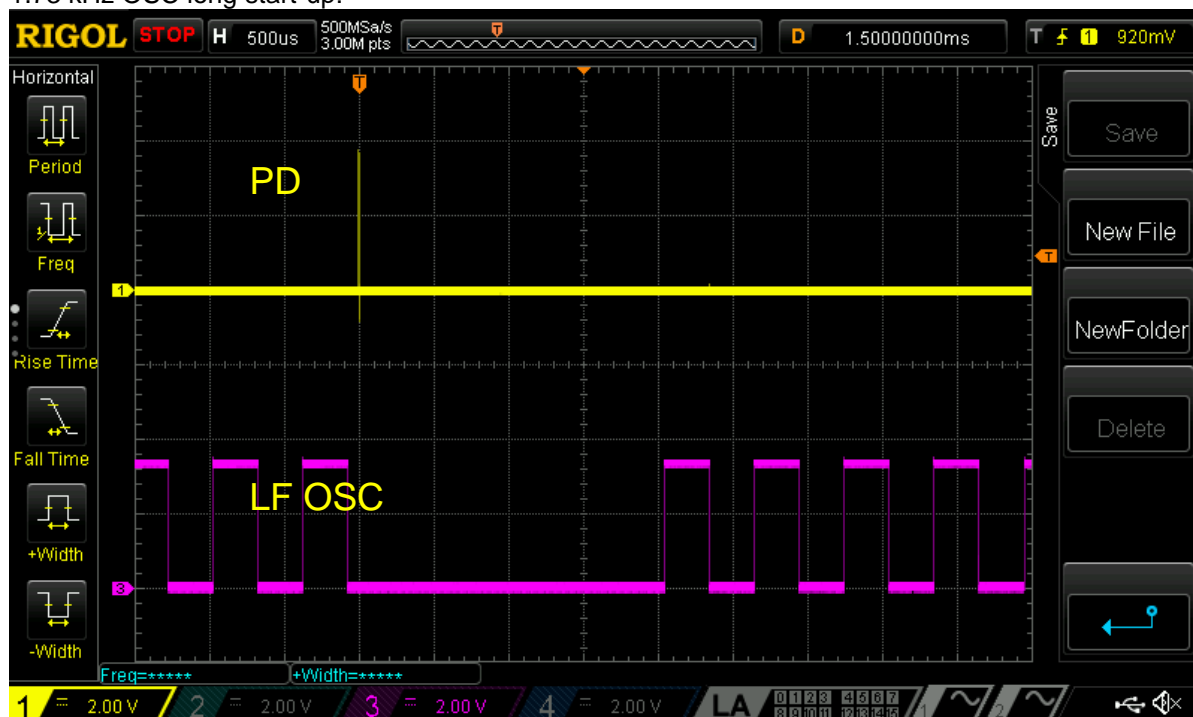
If a pulse with a duration of less than ~40 ns is applied to the PWR DOWN input of an oscillator, the oscillator outputs remain stuck for milliseconds.

1.73 kHz OSC long start-up:

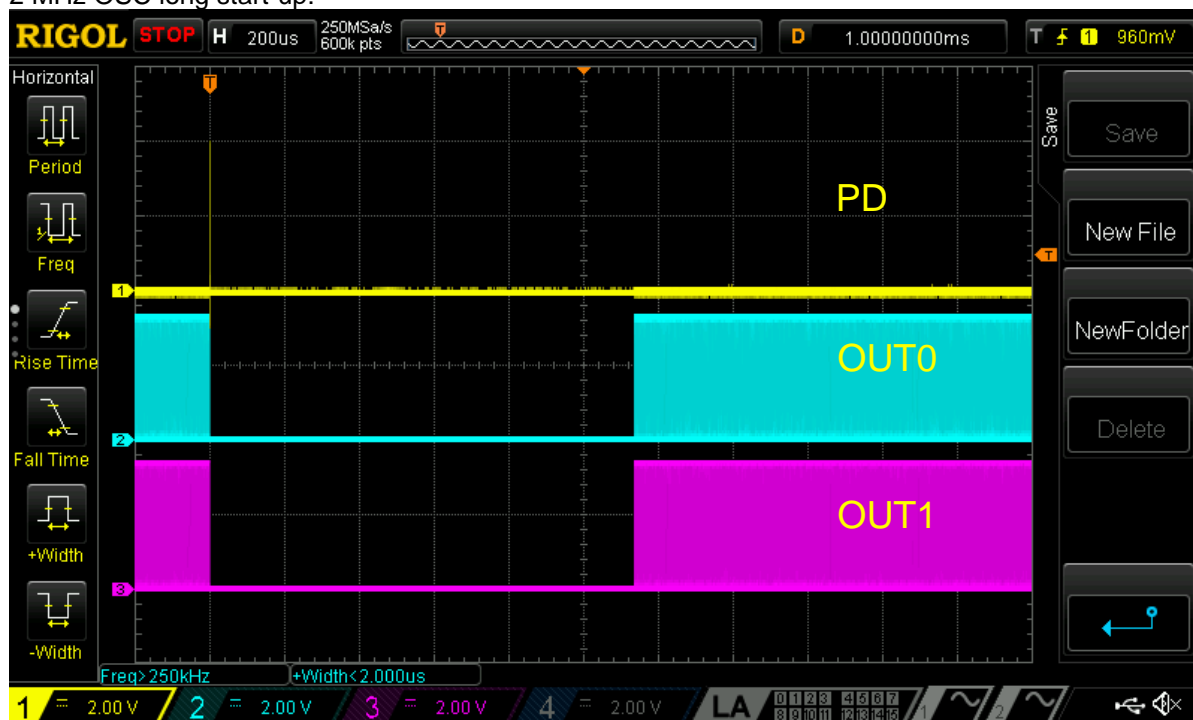
2 MHz OSC long start-up:
