SLG46585 Errata

CE-GP-002

This document contains the known errata for SLG46585 and the recommended workarounds.

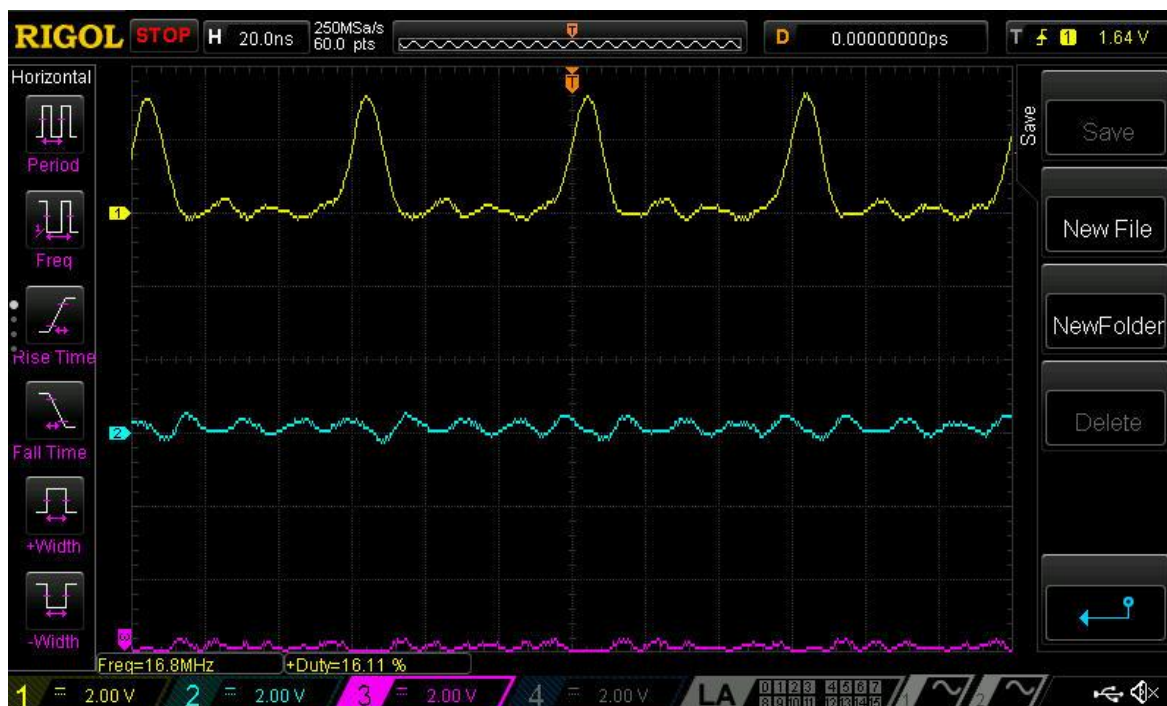
If the FILTER cell's input signal contains multiple consecutive pulses within short time intervals, the FILTER cell may not filter the input pulses as expected. The errant behavior applies only to repeated input pulses and depends on both their frequency and duty cycle.

1. Period is 60 ns. Pulse width is 10 ns, DC = 16.7 % (correct functionality).

Currently, there is no workaround for this issue. The FILTER block correctly filters isolated glitches, but it shouldn't be used to filter repetitive, high frequency input signals.

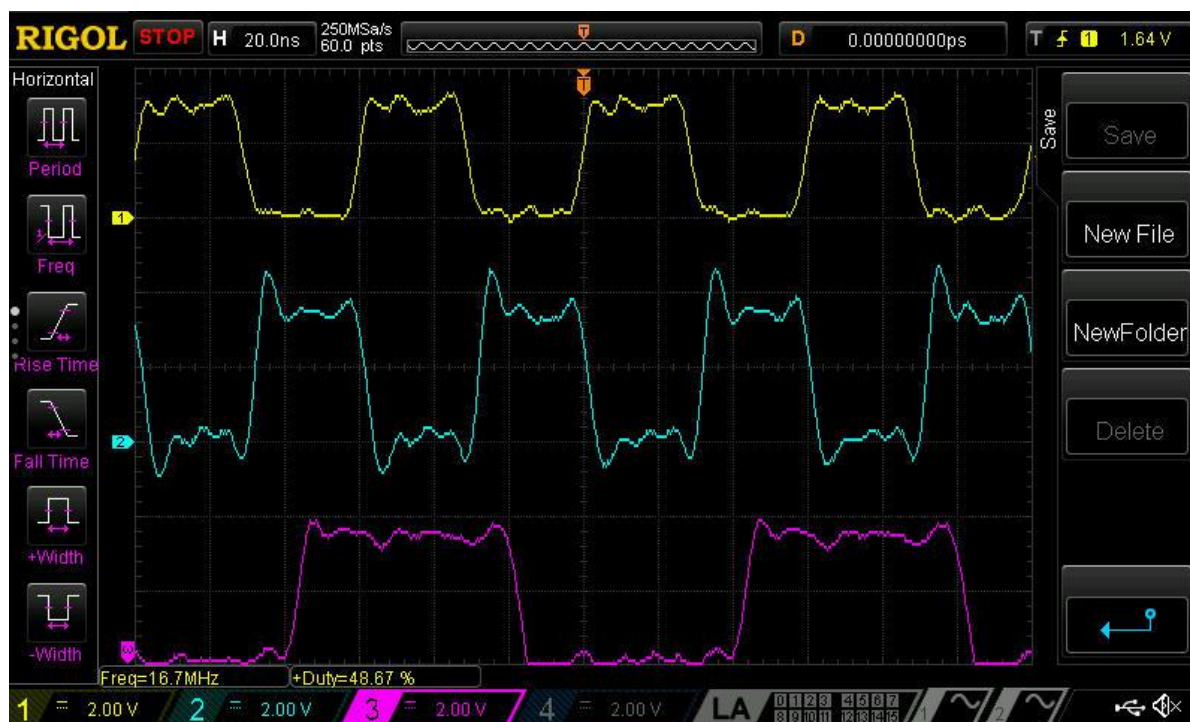
3. Period is 60 ns. Pulse width is 30 ns, DC = 50 % (incorrect functionality).

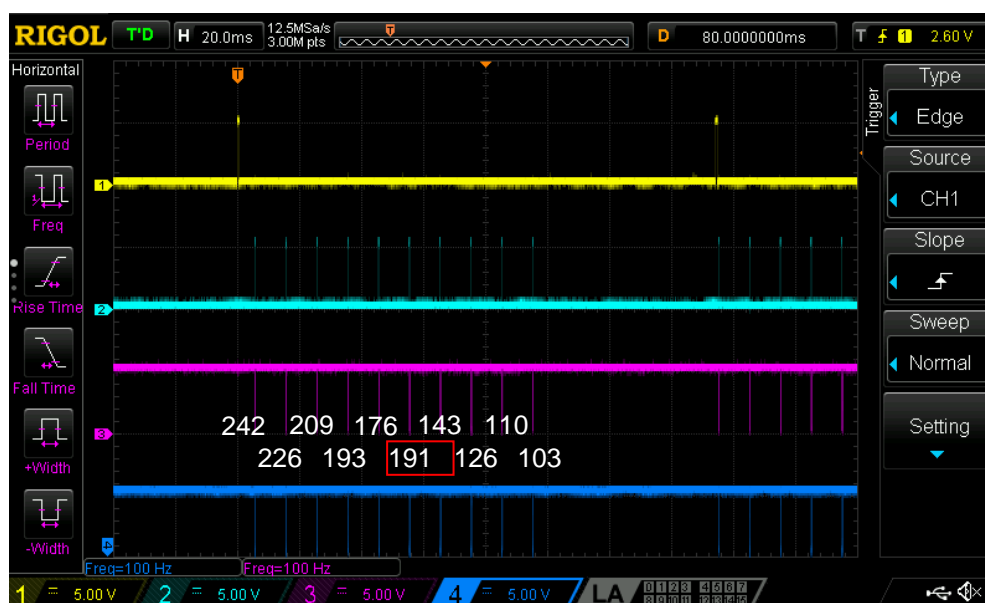
Asynchronous interaction between the CNT/DLY clock input and the I²C latch signal (generated by an I²C read command of the CNT/DLY block's count value) can result in an incorrect I²C data read. The CNT/DLY block will count accurately, but the count value transferred into the block's I²C read register might be loaded incompletely if the I²C latch signal and the clock input occur at about the same time.

The example data capture below shows ten periodic I²C reads of CNT2/DLY2 configured to count down at about 16 clocks per read. The sixth read sample erroneously shows a value greater than that of the fifth. The seventh sample reads as if the previous I²C error never occurred - the difference from the fifth sample (176) to the seventh (143) is 33 clocks or 16 clocks + 17 clocks as expected.

If the possibility of incorrect I²C data reads can't be accommodated for by external software checks, one can guarantee proper operation by stopping the CNT/DLY block's clock during I²C reads through one of the following methods: by disabling the oscillator block, by reconfiguring the CNT/DLY block's clock source, or by gating an external clock using a LUT (Look-up Table) in the signal matrix. After disabling the CNT/DLY block's clock, the count registers can be read without error. Please note that this workaround will add the I²C read and processing time to the counter's overall clock period.

The best workaround depends on the resource constraints of the application. If the oscillator block doesn't clock other logic elements within the design, a matrix output can be used to manually power down the oscillators for the I²C read. When the CNT/DLY block's clock source is routed internally from the oscillator block, I²C commands can temporarily reconfigure the CNT/DLY block's clock source registers to select "Ext. CLK. (From Matrix)." This action will disable the clock by connecting it to ground. If the CNT/DLY block is clocked from the signal matrix, a LUT can be used to gate the clock during an I²C read.

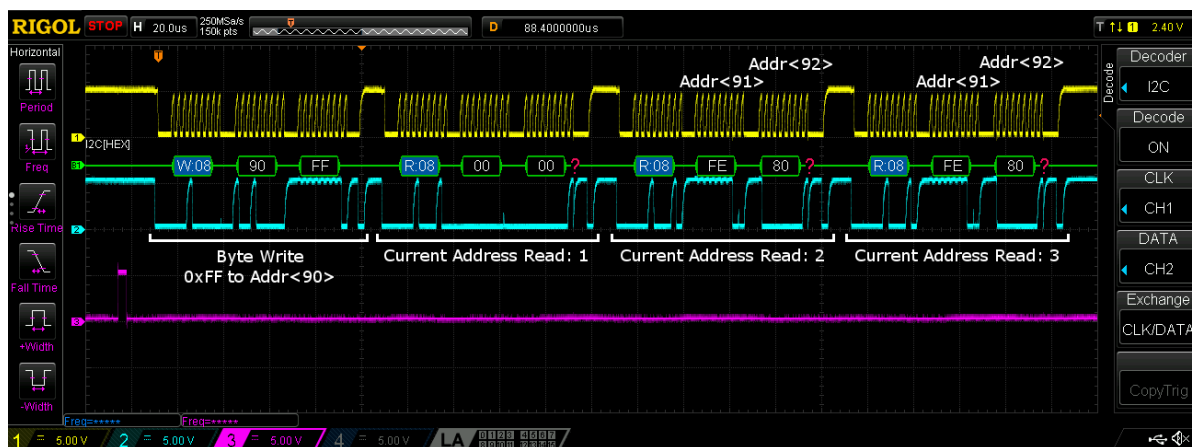
The first “Current Address Read” or “Sequential Read” command following an I²C “Byte Write” or a “Sequential Write” command will produce incorrect data. Additional read commands will return the expected data. See the waveform below for more information.

Note: In the GreenPAK test design, Addr<91> and Addr<92> expect FE and 80 respectively.

If possible, use the “Random Read” command as described in the datasheet for SLG46580. This command will output the correct data.

If you expect consecutive reads of the same register, we recommend sending a “Random Read” command to the register preceding the register of interest. After the “Random Read” command finishes, the chip’s register pointer will increment to the desired register and the following “Current

Address Read” or “Sequential Read” commands will produce the correct data. Note that the “Current Address Read” and “Sequential Read” commands don’t increment the GreenPAK’s register pointer.

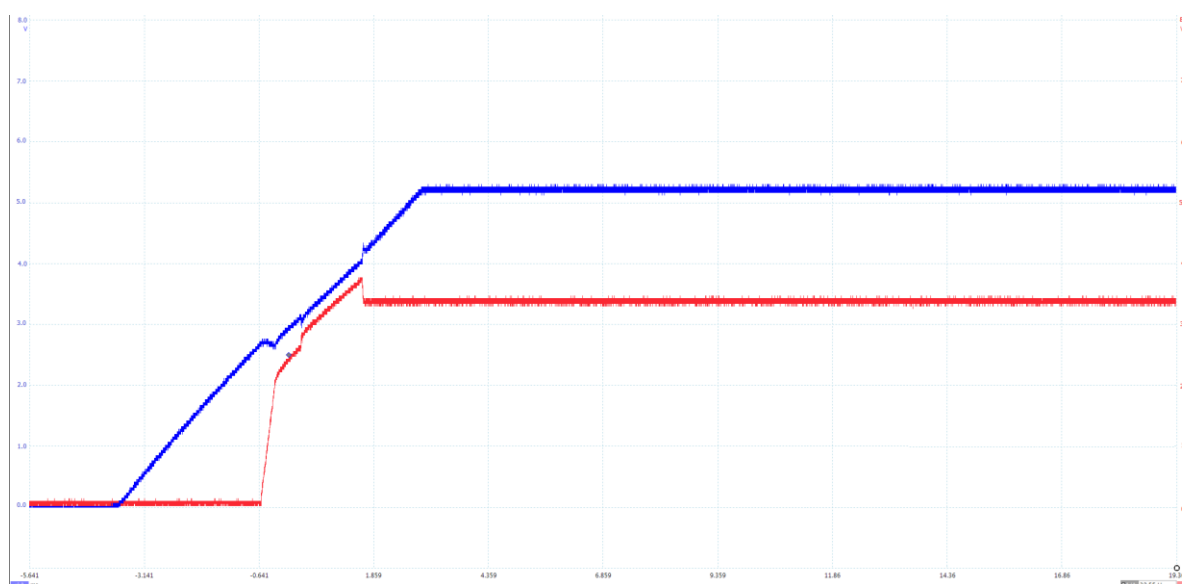
The maximum DC_VOUT to DC_VIN duty cycle ratio is 80 % for fsw=1.5 MHz and 75 % for fsw=2 MHz (See Table 20 in Datasheet section 5.11 parameter Maximum Duty Cycle). This voltage glitch issue only occurs if the DC_VOUT to DC_VIN ratio exceeds this maximum, meaning DC_VIN does not have enough headroom above DC_VOUT.

For DC_VOUT selections 1.2 V, 1.5 V, and 1.8 V, the UVLO can block the ON/OFF signal from enabling the DC/DC Buck Converter until DC_VIN is greater than 2.3 V. However, for selections 2.5 V, 3.0 V, and 3.3 V, which are greater than the UVLO threshold, there is no protection against enabling the DC/DC while the DC_VIN does not satisfy the Maximum Duty Cycle ratio specified above.

This glitch can be seen in an application where there is a slow DC_VIN/VDD ramp and the DC/DC’s enable signal is tied to DC_VIN/VDD, as shown in the example capture below.

The example capture below shows DC_VIN/VDD ramping from 0 V to 5.5 V at 1 V/ms. The output voltage is set to 3.3 V.

Use an ACMP to detect when DC_VIN is greater than DC_VOUT divided by Maximum Duty Cycle, and then AND the ACMP output with the ON/OFF signal.

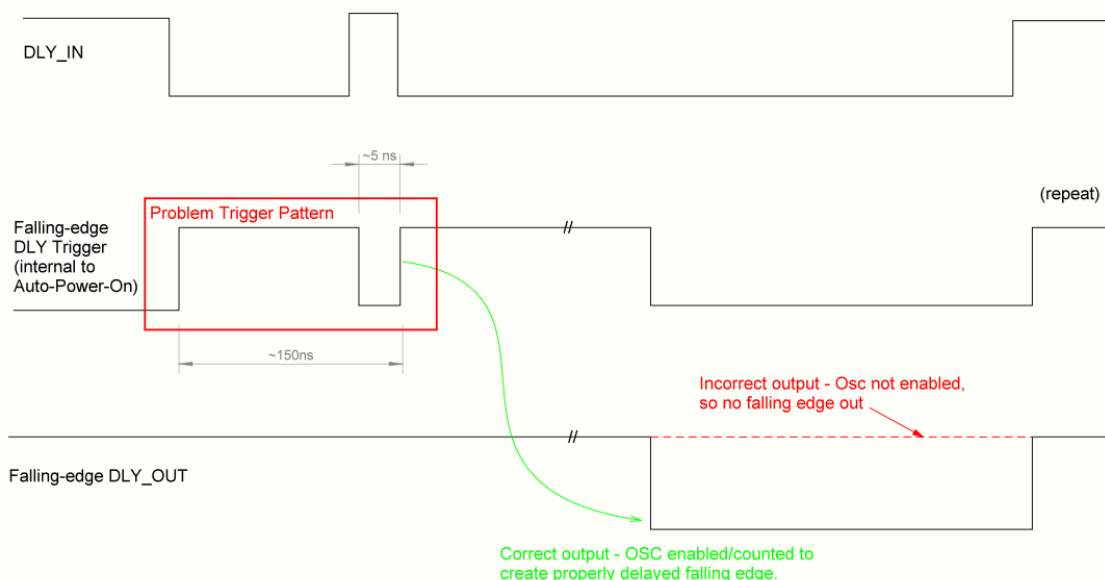
Figure 1: Problem Trigger Pattern

For this chip, the Auto Power On circuitry of the 25 kHz/2 MHz generators contains a circuit errata, which can potentially fail to power on the OSC for a specific pattern and timing of the OR of all related DLY trigger signals. The pattern is shown in Figure 1 (boxed in red) and consists of a relatively longer pulse (~145 ns) followed by a shorter (~5 ns) glitch of opposite polarity.

1. Use signal conditioning circuits to prevent glitch on DLY inputs < 200 ns. Examples:

- a. ACMP with Hysteresis
 - b. External RC in front of Digital Input with Schmitt Trigger
 - c. Filter cell.
2. Set OSC power mode to Force Power On mode instead of Auto Power On.
 3. Use different oscillator, such as 25 MHz Ring OSC, which does not have Auto Power On issue.

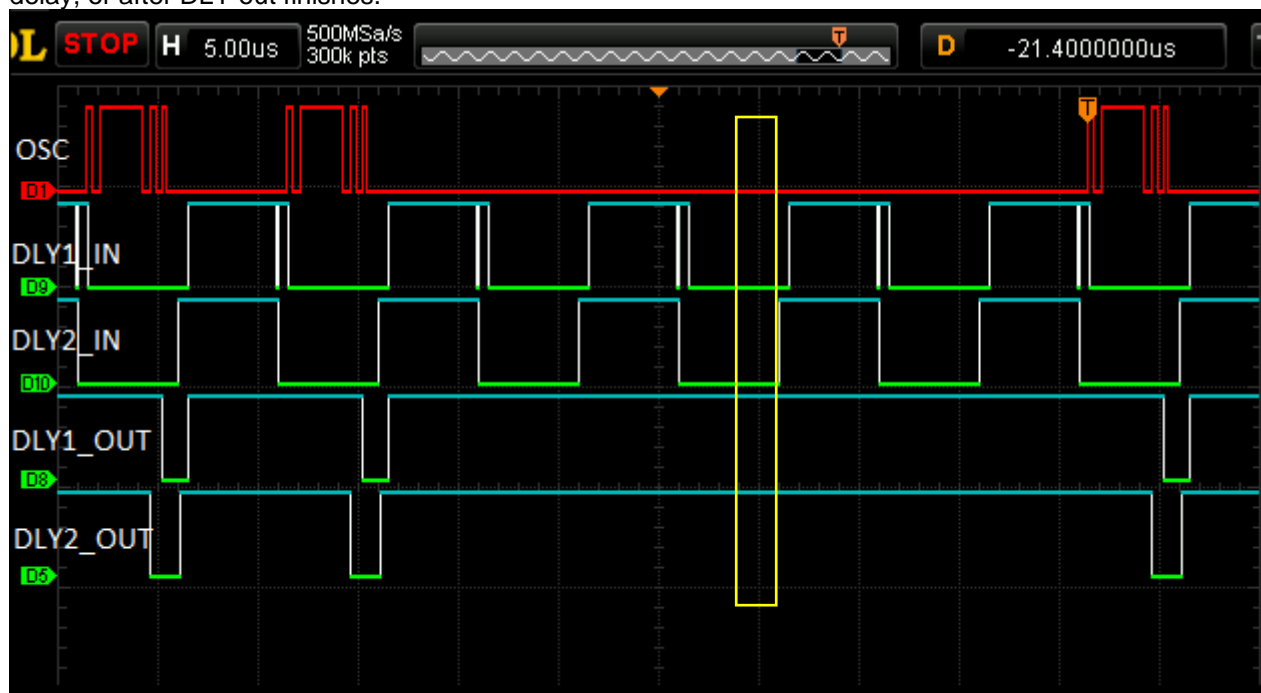
Figure 3: Errata Capture (Zoom Out)

Figure 3 shows a series of DLY output events are missing, where the OSC is correspondingly not triggering when it was supposed to. Figure 4 is a zoom in of the boxed region from Figure 3. The total glitch/chatter time was measured in this case at 152 ns. By using the composite OR of the two delay channels, we can asynchronously strobe with tiny frequency variations, and so tune the timing to induce this errata. Note that the error is not persistent – the system is recovered when all DLYs are returned to inactive state, such as when input of falling edge DLY goes high, thus canceling delay, or after DLY out finishes.

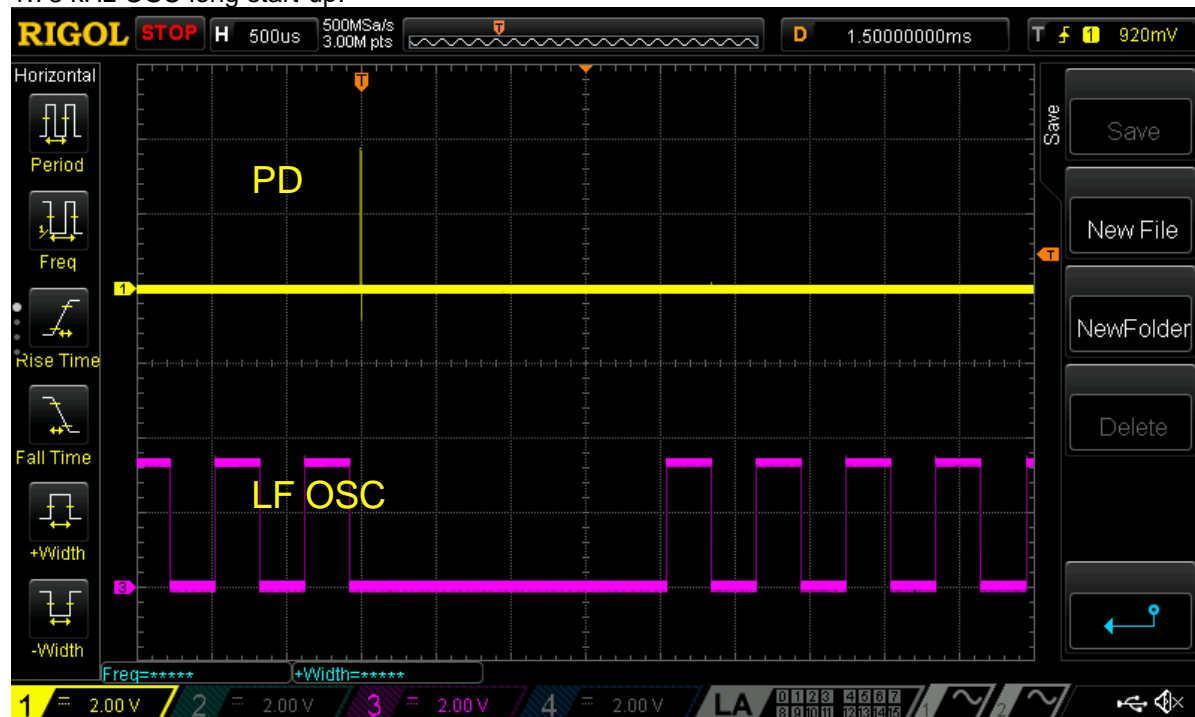
1.73 kHz OSC long start-up:

If a pulse with a duration of less than ~40 ns is applied to the PWR DOWN input of an oscillator, the oscillator outputs remain stuck for milliseconds. The issue is observed for all available oscillators.

Change Fast start-up setting to Enable or omit applying glitches at PWR DOWN input in OSC.

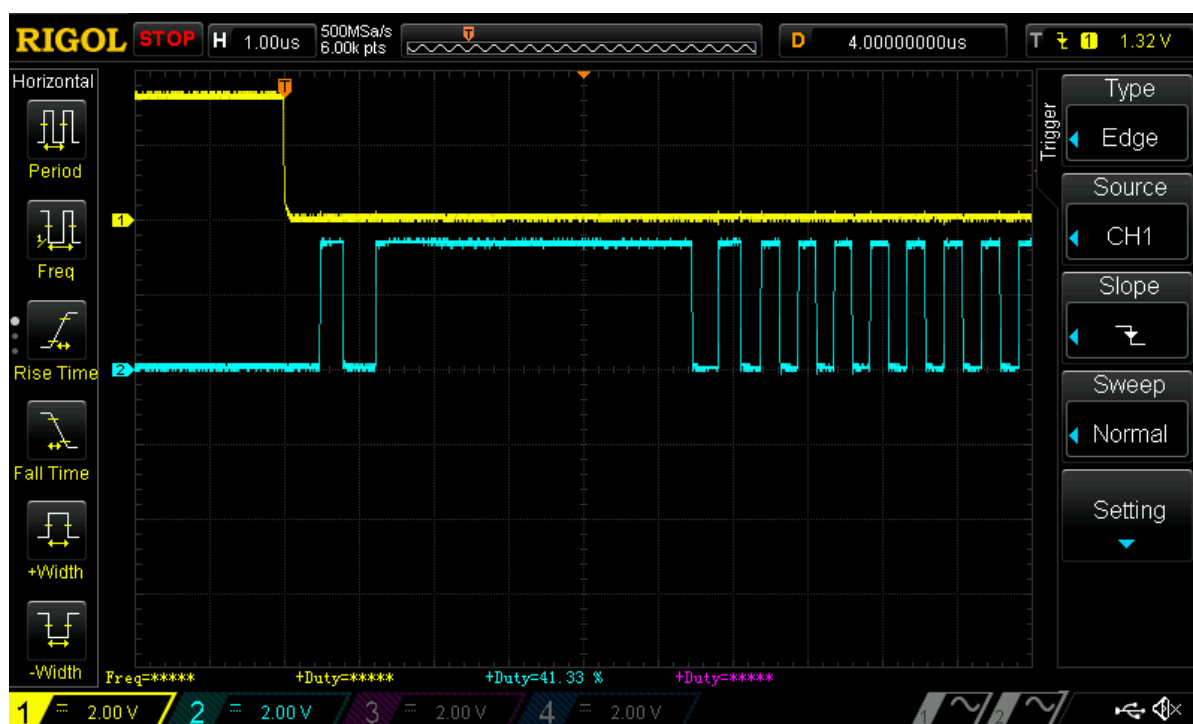
Figure 5. Channel 1 – OSC Power Down; Channel 2 –OSC output

2 MHz OSC has an additional ~ 9 cycles settling period. Higher V_{DD} shows longer settling time.

Such behavior will lead to substantial error in period calculations if the delay time is relatively small.

Enable Fast Start-up option. Fast Start-up means forcing bias ready at the power-up instead of automatic enabling at OSC event. The standby current consumption difference between Fast start-up disabled and enabled is only an additional 300 nA.

Use the “Force power on” OSC power control option to make the OSC operate at all times. However, this will cause increased constant current consumption.
