## SLG46620-EV Errata Note

This document contains the known errata for SLG46620-EV and the recommended workarounds.

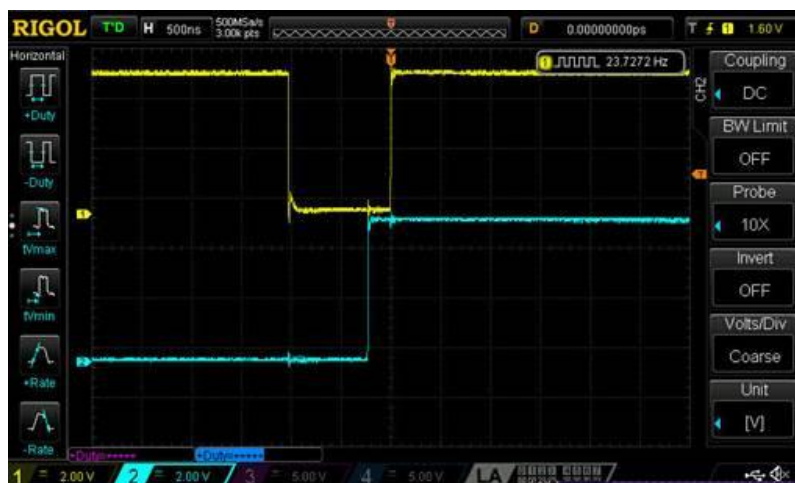
The output of the ACMP incorrectly goes low even when IN+ is greater than IN- if the RING OSC is active when the WS signal rises.

Channel 1 – ACMP out

Channel 2 – WS\_OUT

Avoid using the RING OSC with the WS Controller, or add a filtering block on the ACMP output to filter out the glitch.

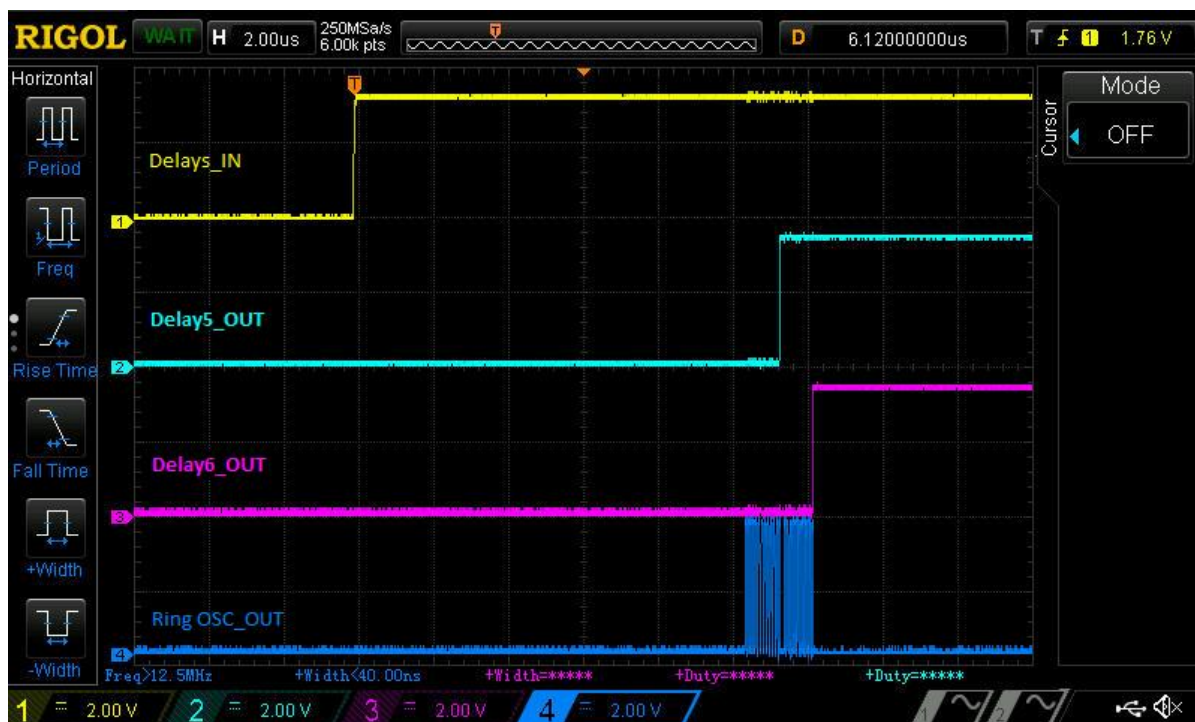
A similar situation can occur while using two connected delays (all edge detect types except for a pair “Rising edge DLY – Falling edge DLY”).

In the following example, Delay5 and Delay6 are configured in the same way. However, Delay5 time is 11.4us instead of expected 0.4us (Delay5 time).

- Set Ring OSC power mode to “Force Power On”
- or, Set Turn on by register option in BG (Band Gap) block as “Enable”

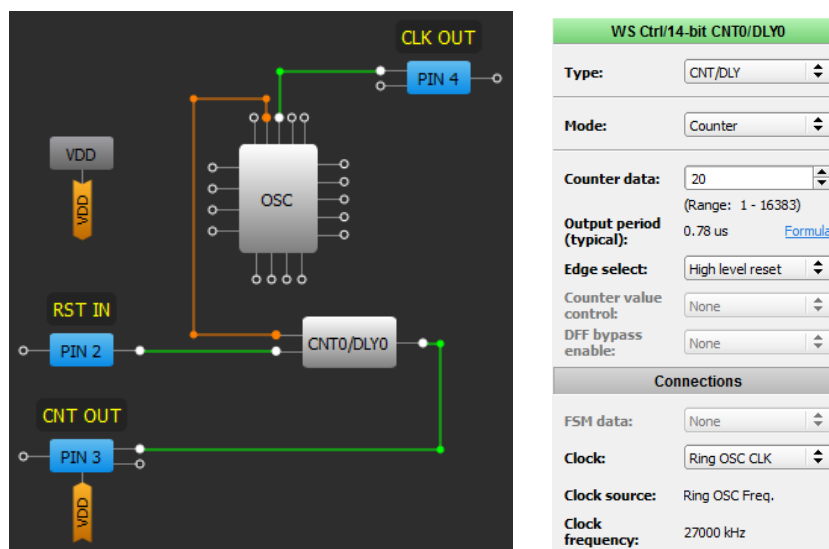
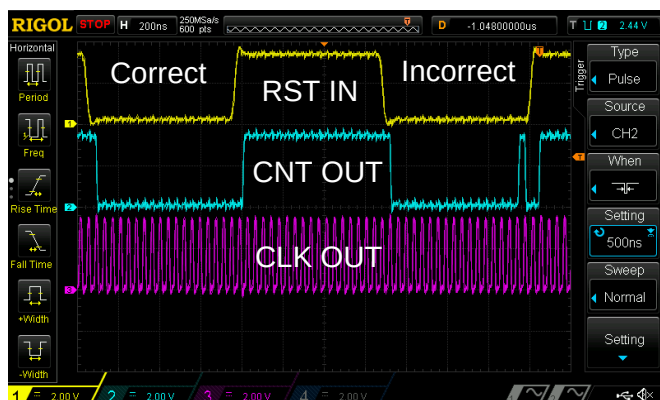
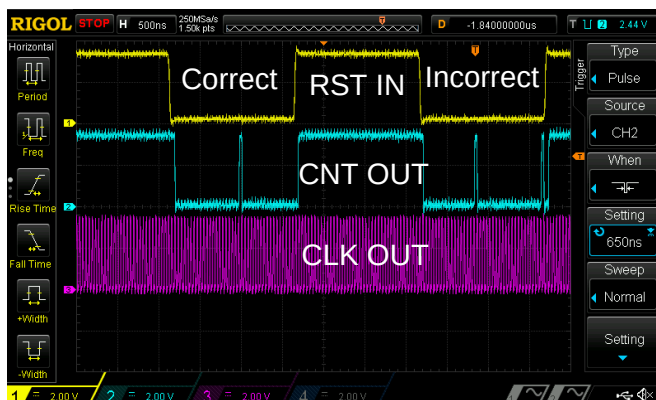
If the Counter Reset occurs at a time very close to a rising edge of the clock signal during clock signal generation (for example OSC operation), there is a possibility that the Counter Data of the Counter is reset incorrectly and the counter end signal (HIGH pulse) may appear faster than expected. This phenomena appears more frequently the higher the clock frequency is.

Synchronize RESET input of the Counter with its CLK using 2 DFF cells as shown in the image below.

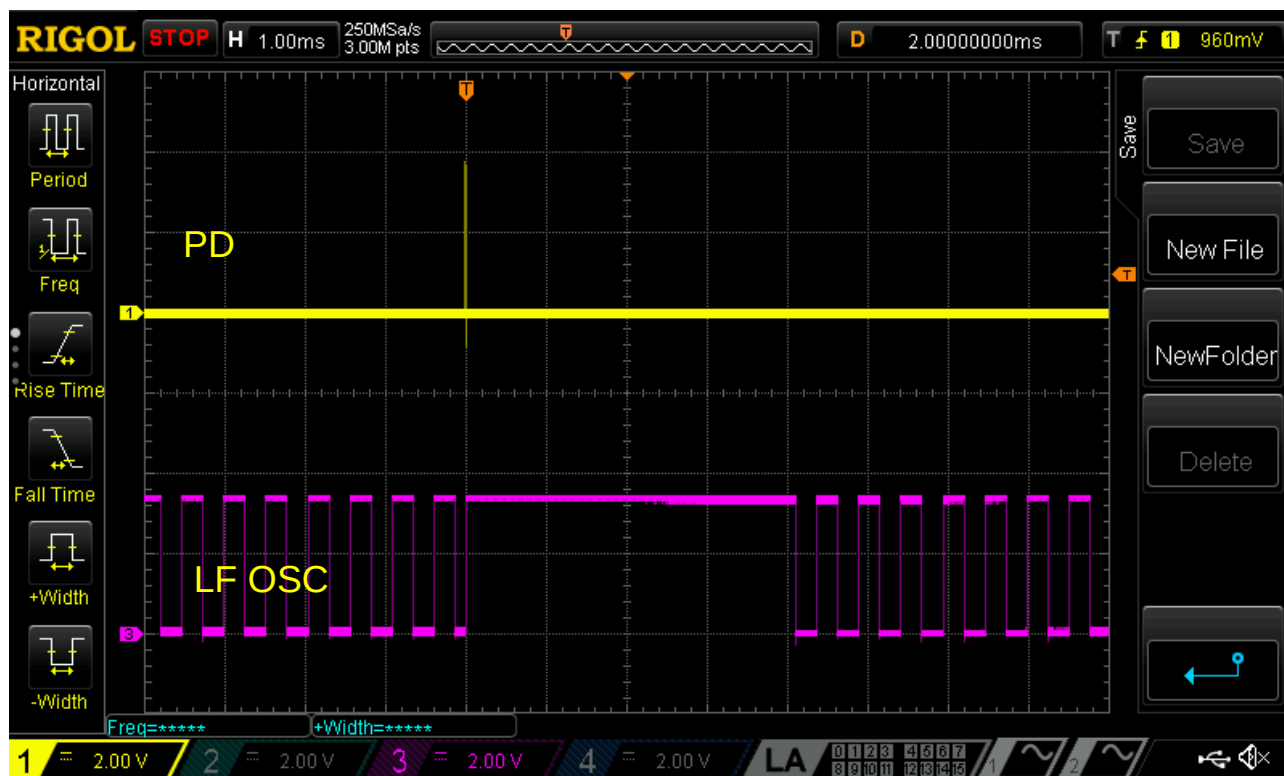
1.9 kHz OSC long start-up

If a pulse with a duration of less than ~40 ns is applied to the PWR DOWN input of the oscillator, the oscillator outputs remain stuck for milliseconds, as shown in Figure 16 and Figure 17. The issue is observed for all available oscillators.

Avoid applying glitches to the PWR DOWN input of an OSC.
