## SLG46620-A

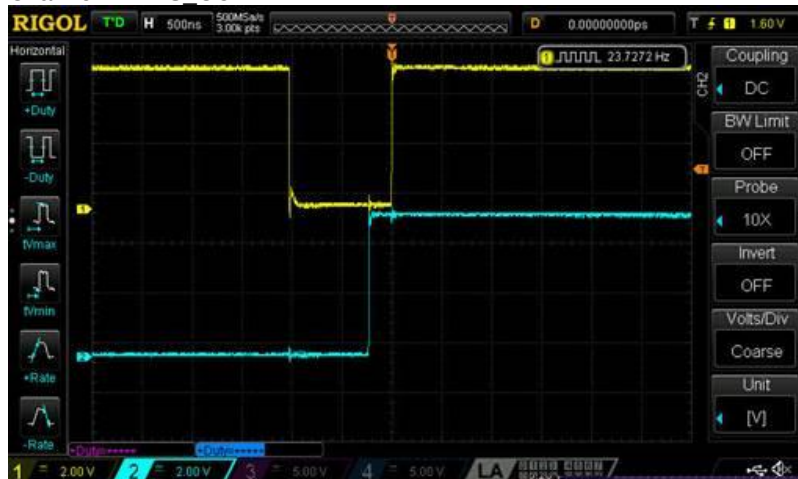
The output of the ACMP incorrectly goes low even when IN+ is greater than IN- if the RING OSC is active when the WS signal rises

Channel 1 – ACMP out

Channel 2 – WS OUT

- Avoid using the RING OSC with the WS Controller, or add a filtering block on the ACMP output to filter out the glitch.

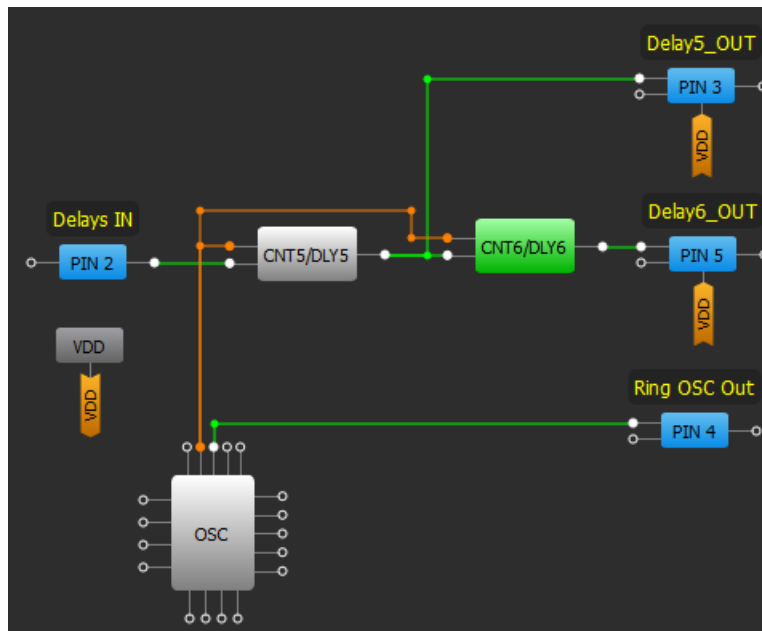
A similar situation can occur while using two connected delays (all edge detect types except for a pair “Rising edge DLY – Falling edge DLY”).

In the following example, Delay5 and Delay6 are configured in the same way. However, Delay5 time is 11.4us instead of expected 0.4us (Delay5 time).

- Set Ring OSC power mode to “Force Power On”
- or, Set Turn on by register option in BG (Band Gap) block as “Enable”

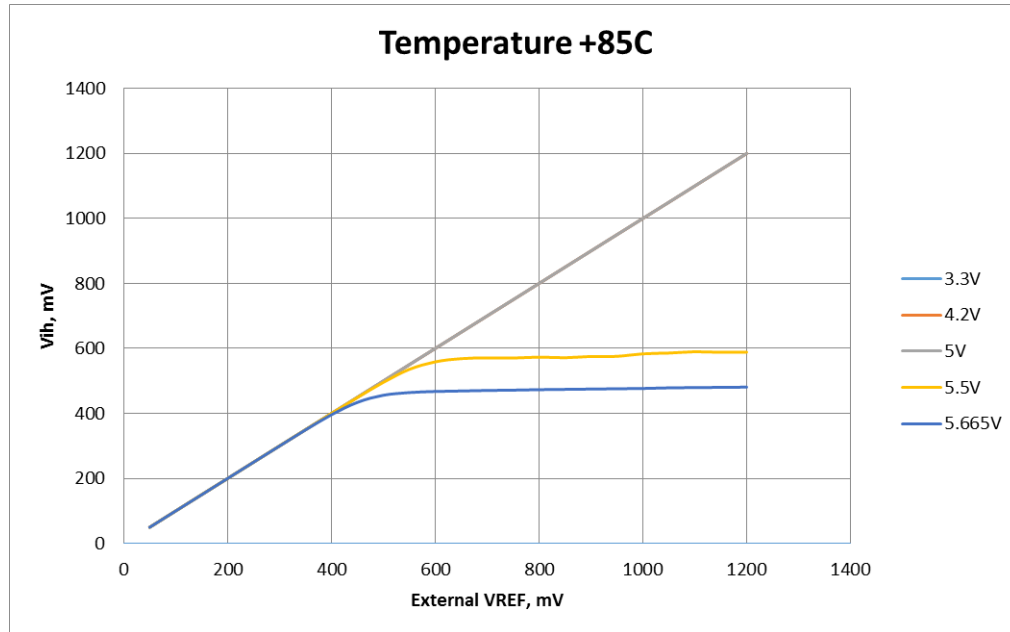
When using external Vref source, the ACMP comparison may happen at wrong threshold if the external Vref voltage is higher than a particular value (please see figure below) at high VDD values (> 5V) and high temperature.

- Avoid using ACMPs in such conditions.

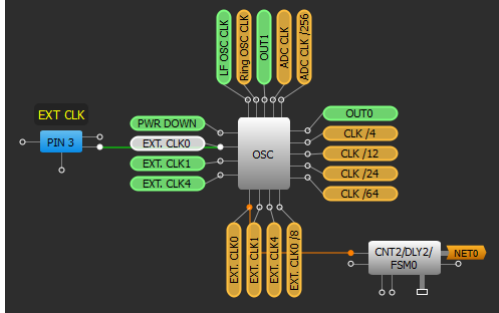
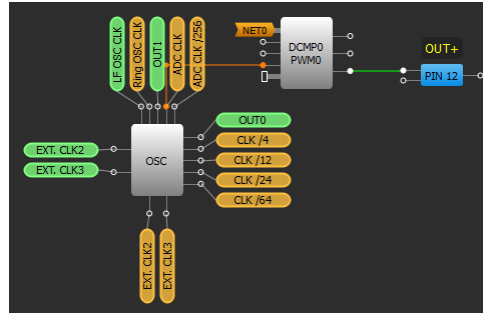
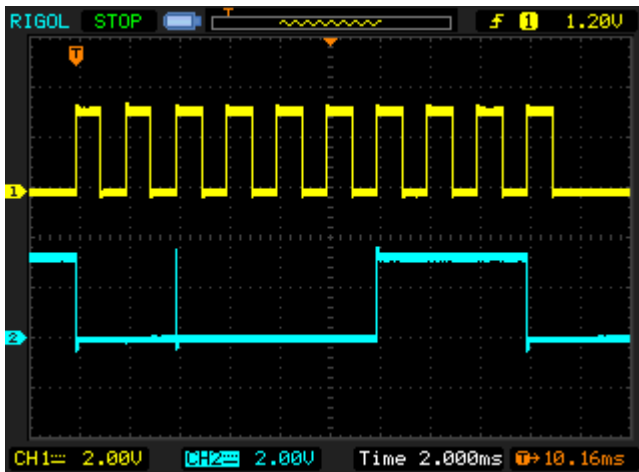
DCMP's OUT+ output may have a glitch when the input data is changed. This issue appears more frequently the higher DCMP clock is.

For example, DCMP IN+ sources from FSM0 and IN- from Register0. DCMP is clocked from the Ring OSC.

- Synchronize the data source clock with the DCMP clock source using 2 DFF cells as shown in the images below.

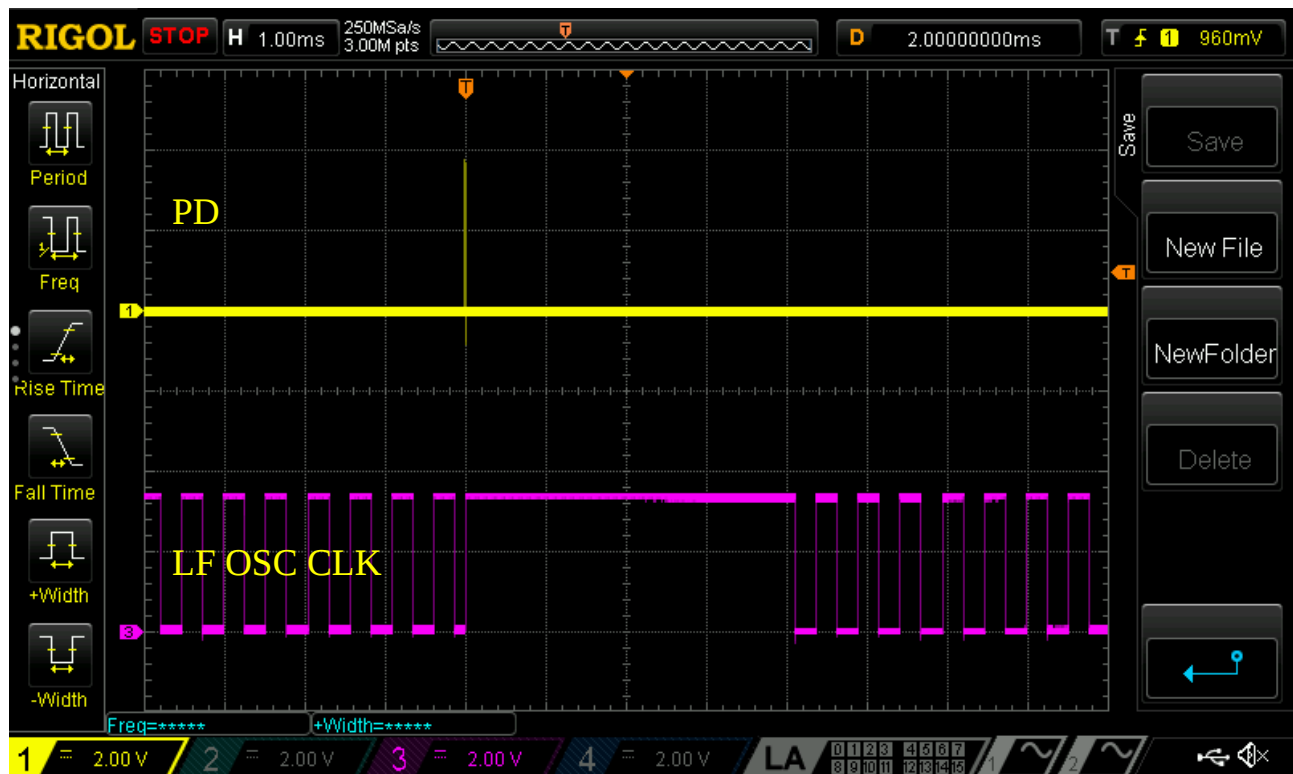
1.9 kHz OSC long start-up:

The issue is observed for all available oscillators.

Avoid applying glitches to the PWR DOWN input of an OSC.
