## ISSUE 1: Long Settling Time for Ring OSC

## SLG46621

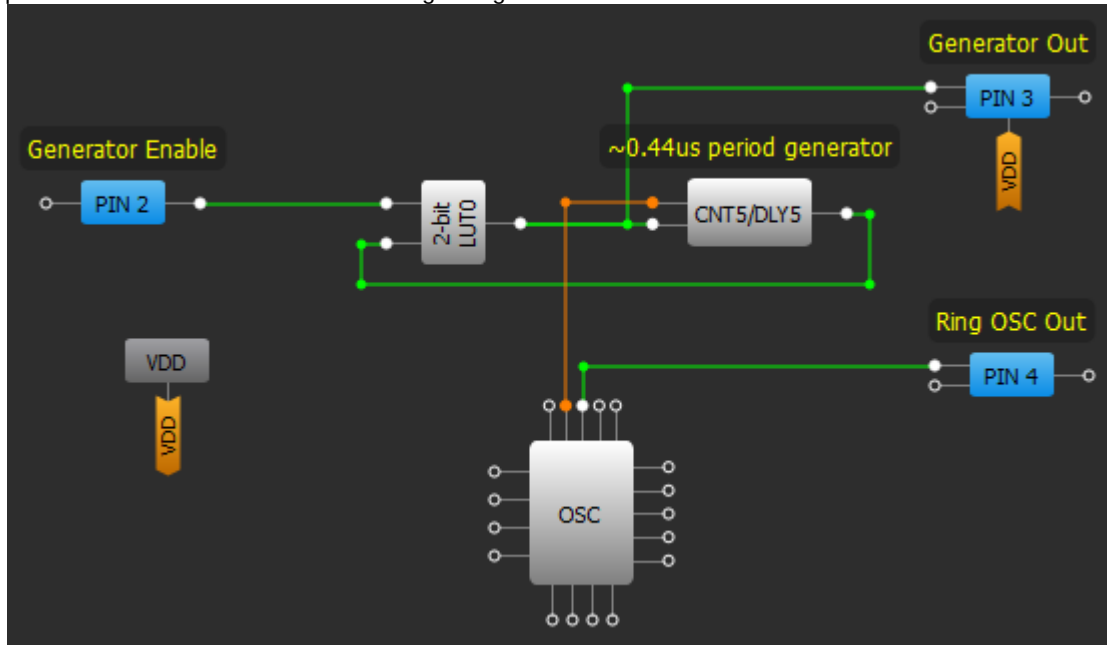
The Ring OSC has a longer settling time when configured as Auto Power On in the designs that have a very short Ring OSC disable time. An example of this issue is shown in the following configuration:

- Set Ring OSC power mode to “Force Power On”
- or, Set Turn on by register option in BG (Band Gap) block as “Enable”

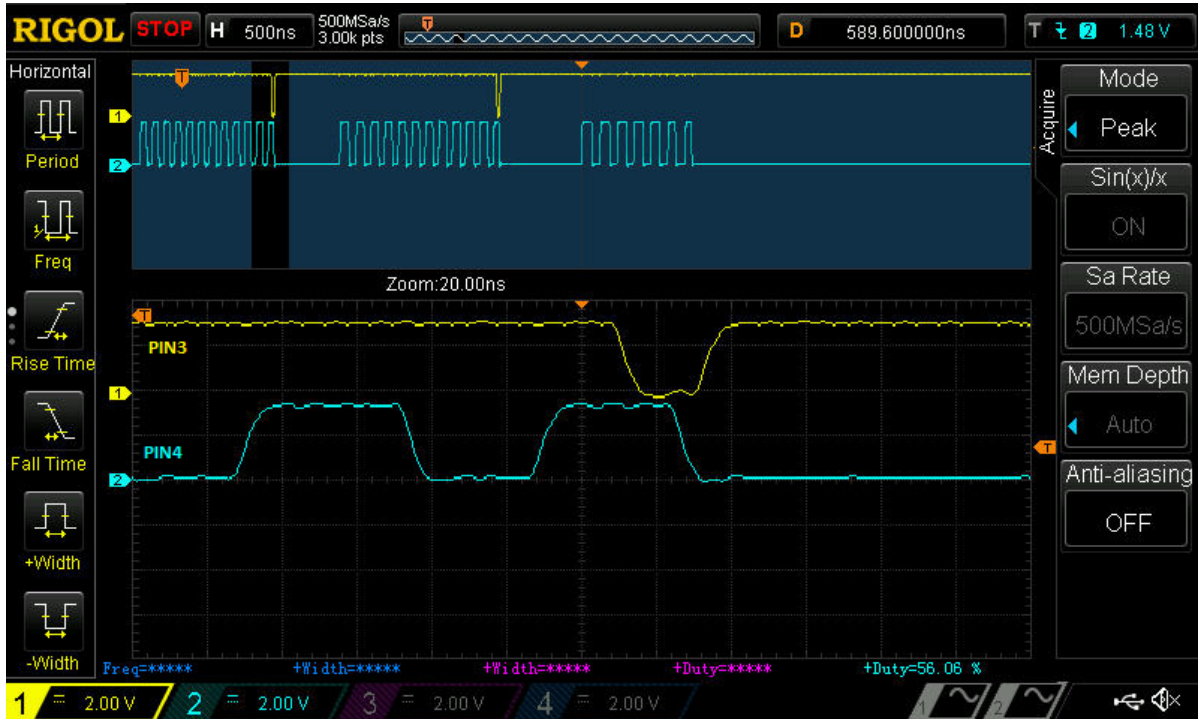
The configuration shown above generates a periodical signal with a frequency defined by the Delay cell and started by a high signal on PIN2. The issue becomes apparent in a longer settling time when the scheme generates short pulses (Delay is configured as a rising edge delay only). See waveform below.

Channel 1 – 2-bit LUT0 output; Channel 2 – Ring OSC output

Such behavior will lead to substantial error in period calculations if the delay time is relatively small.

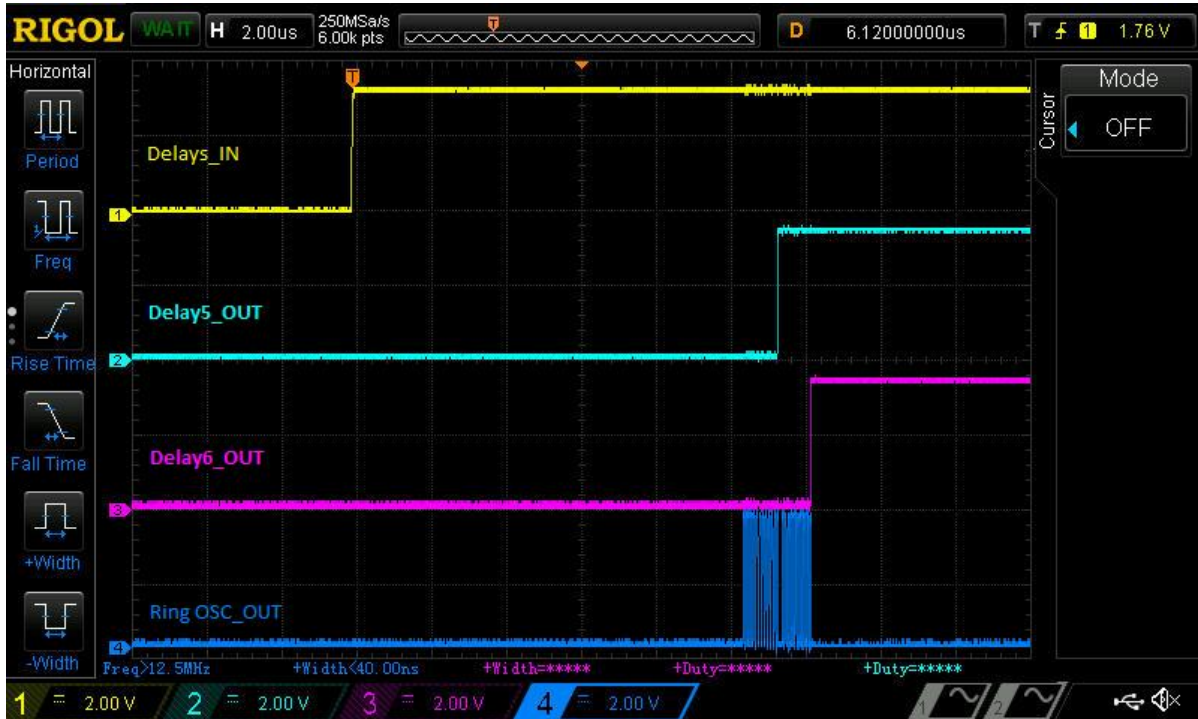
A similar situation can occur when using two connected delays (all edge detect types except when pairing “Rising edge DLY – Falling edge DLY”).

In the following example, Delay5 and Delay6 are configured in the same way. However, Delay5 time is 11.4us instead of expected 0.4us (Delay5 time).

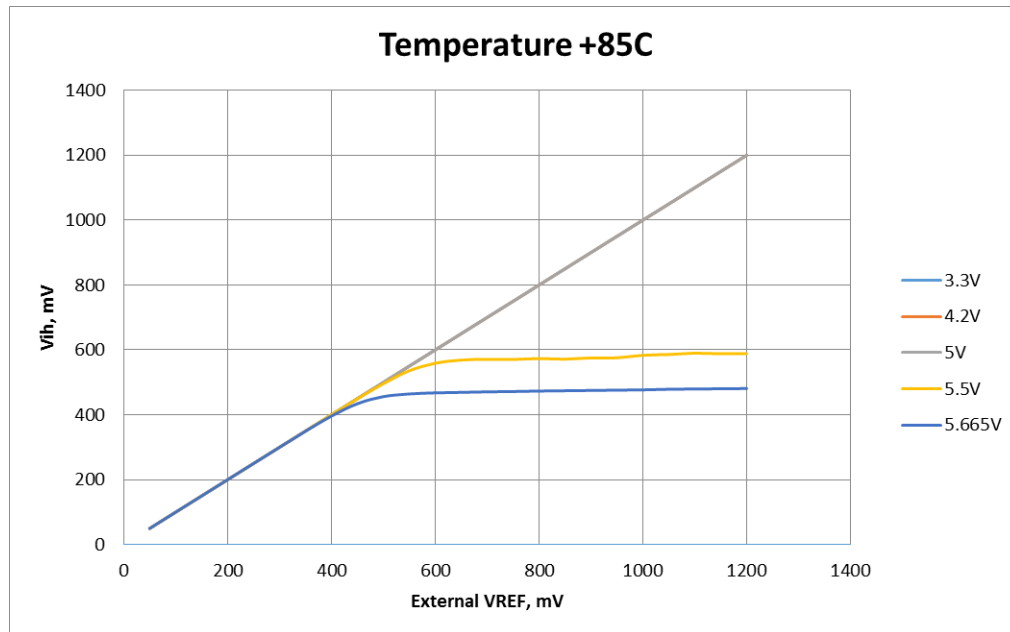
When using an external Vref source, the ACMP comparison may happen at the wrong threshold if the external Vref voltage is higher than a particular value (please see figure below) at high VDD values ( $> 5V$ ) and high temperature.

- Avoid using ACMPs in such conditions.

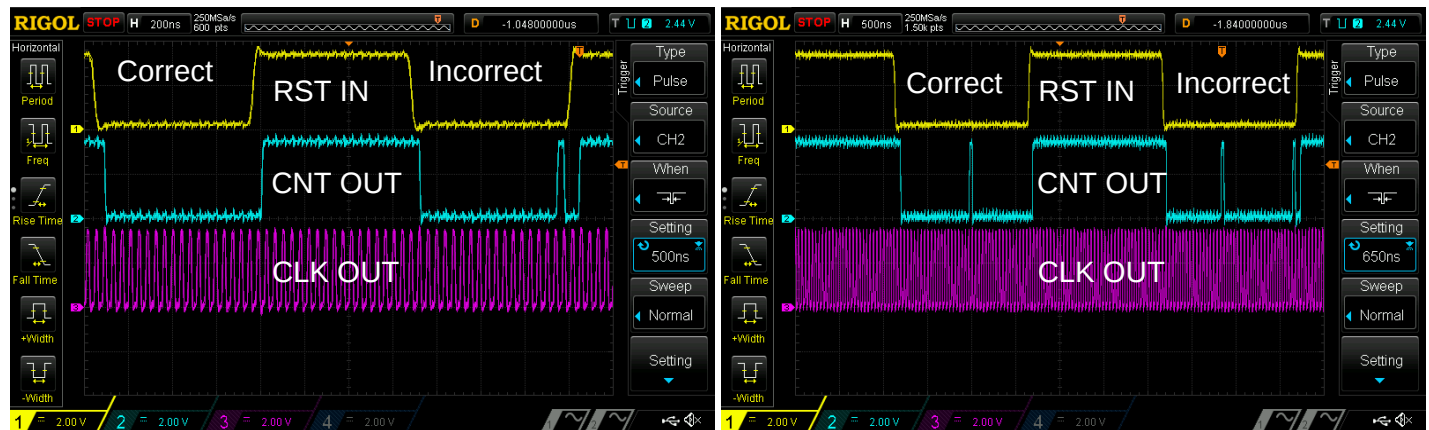
If the Counter Reset occurs at a time very close to a rising edge of the clock signal during clock signal generation (for example OSC operation), there is a possibility that the Counter Data of the Counter is reset incorrectly and the counter end signal (HIGH pulse) may appear faster than expected. This phenomena appears more frequently the higher the clock frequency is.

- Synchronize the RESET input of the Counter with its CLK using 2 DFF cells as shown in the image below.

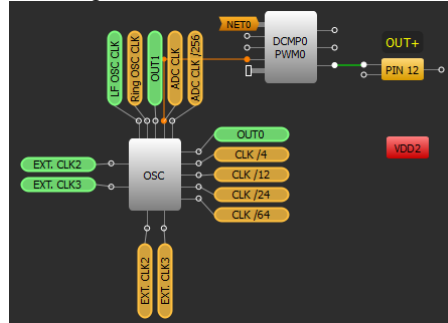
DCMP's OUT+ output may have a glitch when the input data is changed. This issue appears more frequently the higher DCMP clock is.

For example, DCMP IN+ sources from FSM0 and IN- from Register0. DCMP is clocked from the Ring OSC.

- Synchronize the data source clock with the DCMP clock source using 2 DFF cells as shown in the images below.

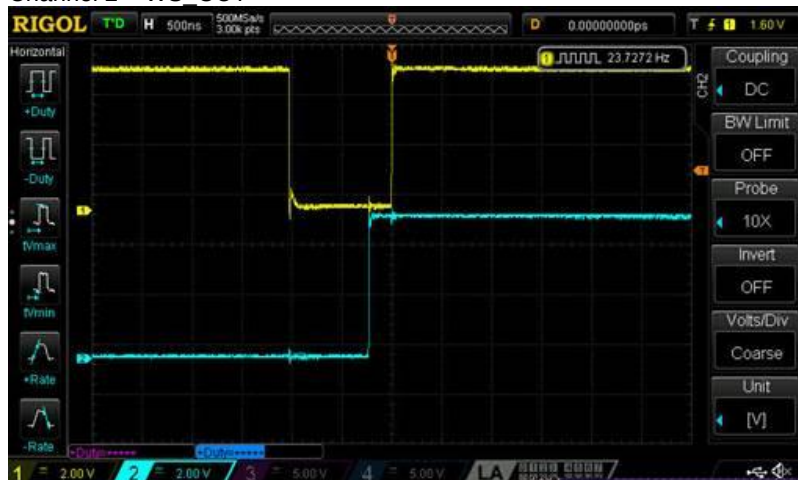
The output of the ACMP incorrectly goes low even when IN+ is greater than IN- if the RING OSC is active when the WS signal rises

Channel 1 – ACMP out

Channel 2 – WS\_OUT

Avoid using the RING OSC with the WS Controller, or add a filtering block on the ACMP output to filter out the glitch.
