## SLG47525/28 Errata Note

This document contains the known errata for SLG47525/28 and the recommended workarounds.

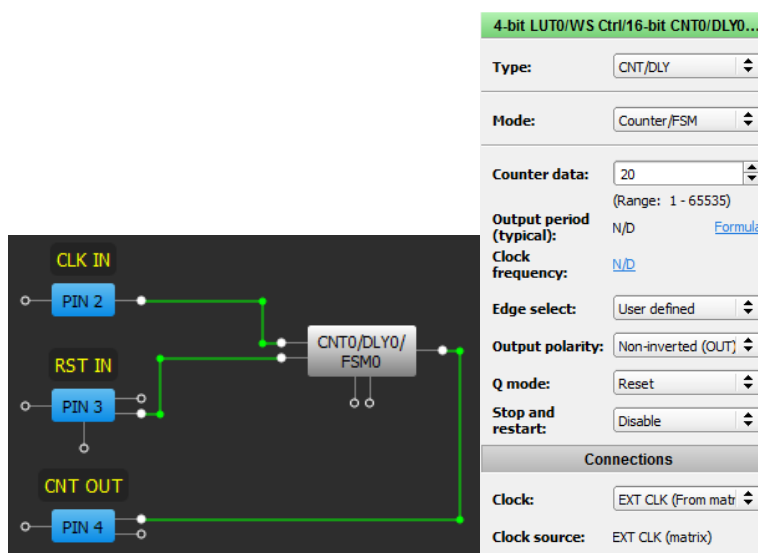
Figure 1

If the Counter Reset is asserted at the same time as a rising clock edge, it is possible that the Counter Data will be reset incorrectly and the counter output may appear faster than expected. This phenomenon appears more often as the clock frequency increases.

Synchronize RESET input of the Counter with its CLK using 2 DFF cells as shown on [Figure 3](#).

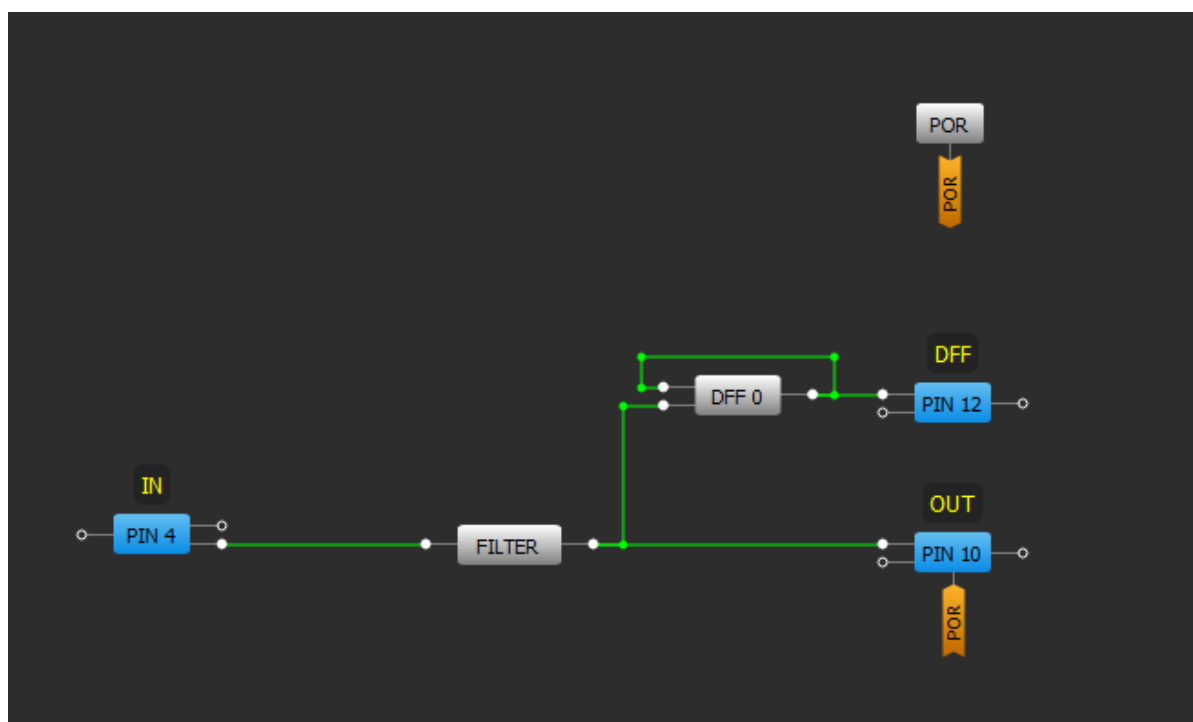
Figure 4

If clock type high frequency input comes in, the FILTER cell may not filter it out. There are several factors like input frequency, duty cycle, and LOW duration in such signal that may lead to its passing through FILTER block.

Currently there is no workaround for this issue. Filter block is good at filtering short spontaneous glitches. It is intended to be used in series connection before the delay cell to avoid its latching.

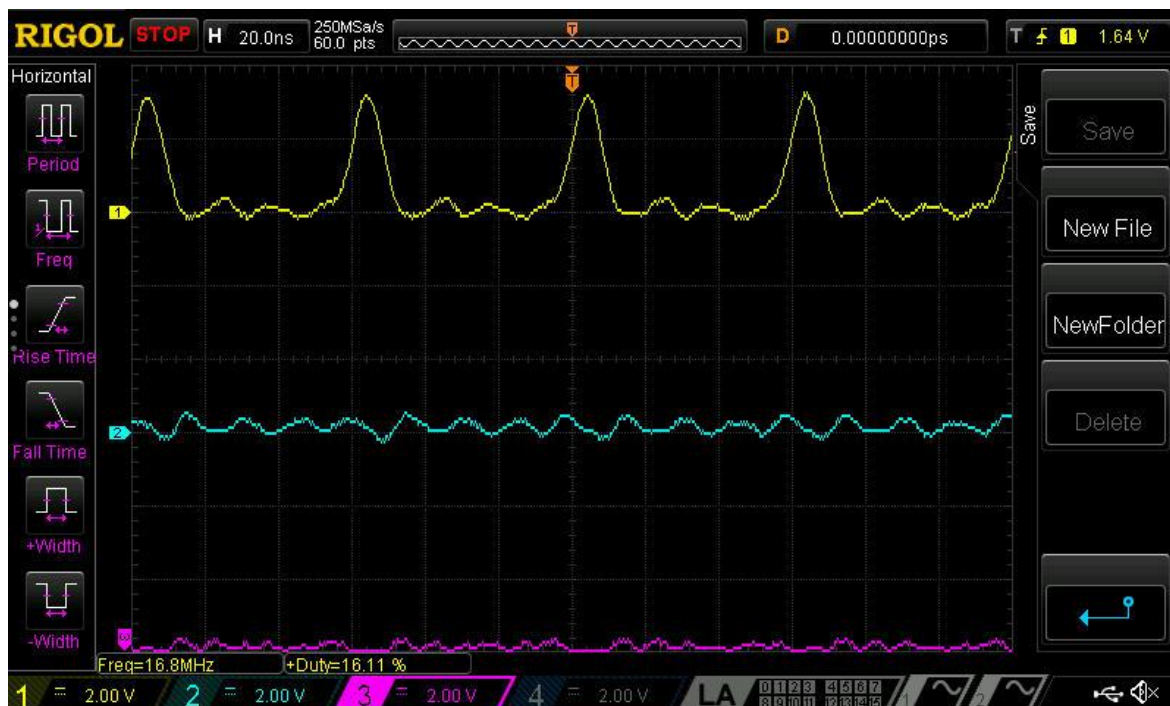
Figure 5

1. Period is 60 ns. Pulse width is 10 ns, DC = 16.7 % (correct functionality).

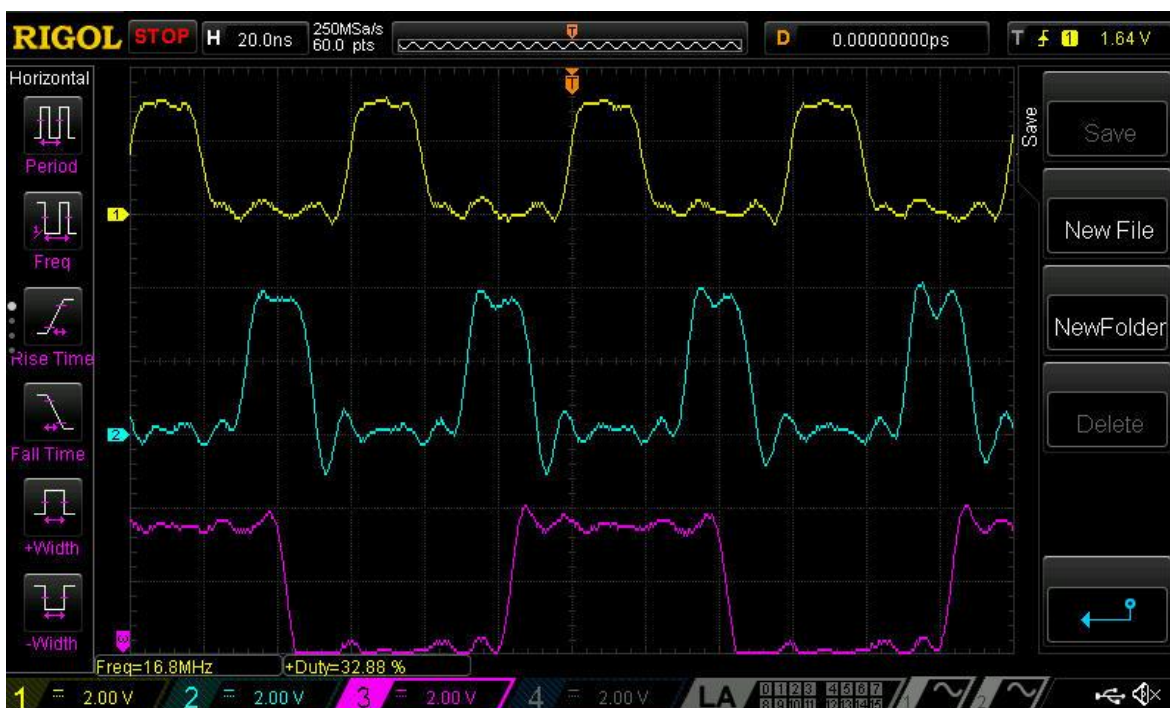
Figure 6

2. Period is 60 ns. Pulse width is 20 ns, DC = 33.3 % (incorrect functionality).

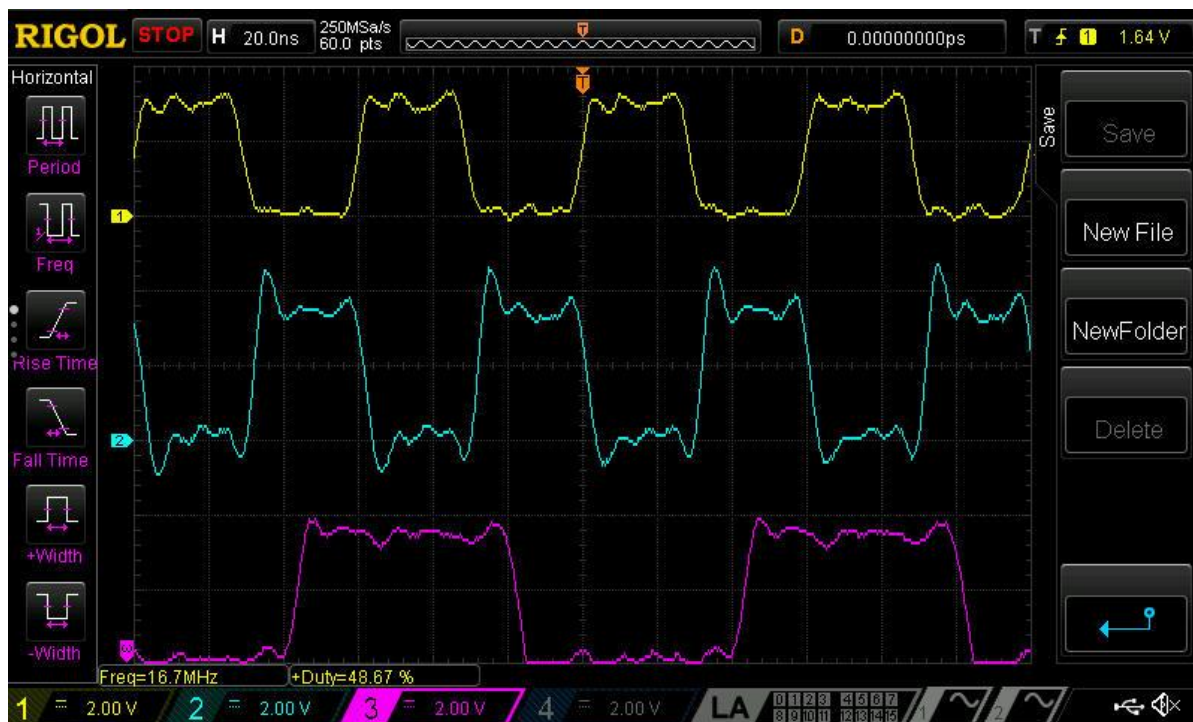
Figure 7

3. Period is 60 ns. Pulse width is 30 ns, DC = 50 % (incorrect functionality).

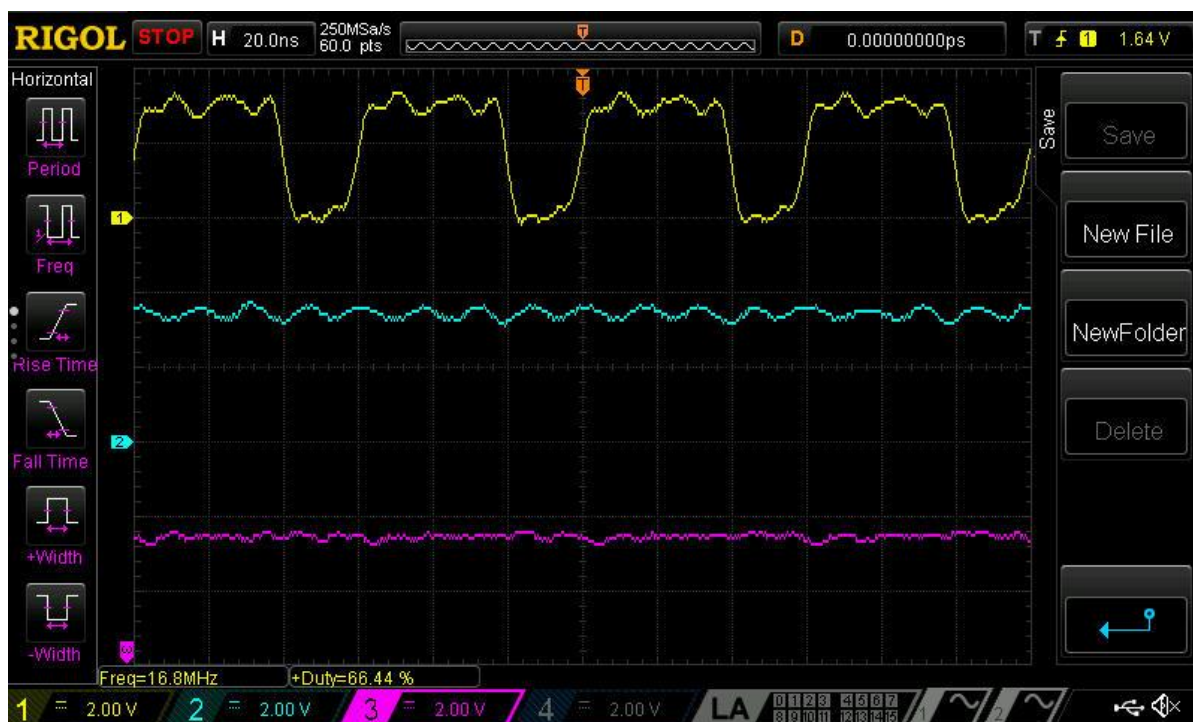
Figure 8

4. Period is 60 ns. Pulse width is 40 ns, DC = 66.67 % (correct functionality).

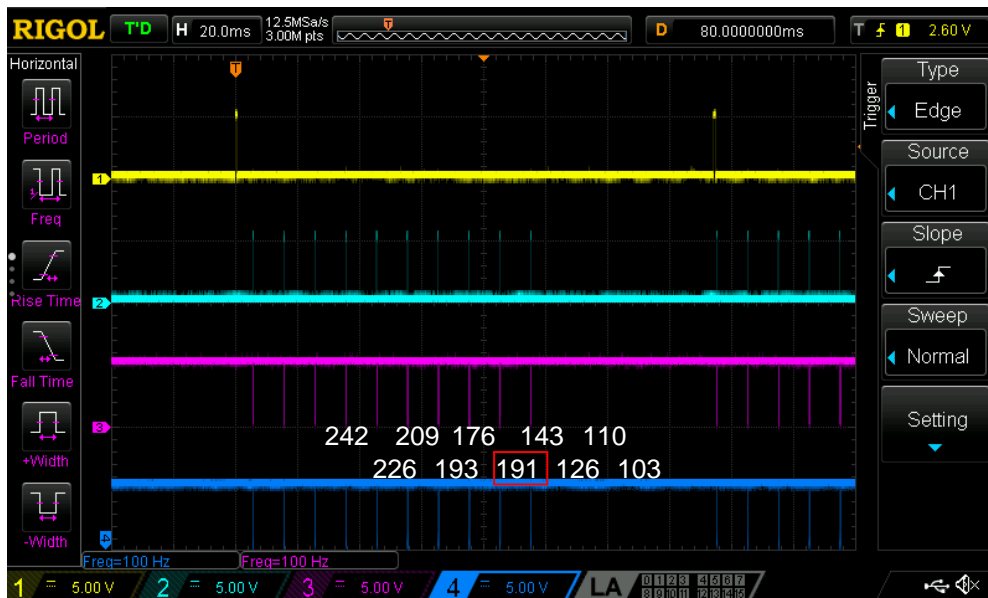
Asynchronous interaction between the CNT/DLY clock input and the I<sup>2</sup>C LATCH signal (generated by an I<sup>2</sup>C read command of the CNT/DLY block's count value) can result in an incorrect I<sup>2</sup>C data read. The CNT/DLY block will count accurately, but the count value transferred into the block's I<sup>2</sup>C read register might be loaded incompletely if the I<sup>2</sup>C LATCH signal and the clock input occur at about the same time.

The example data capture in Figure 9 shows ten periodic I<sup>2</sup>C reads of CNT2/DLY2 configured to count down at about 16 clocks per read. The sixth read sample erroneously shows a value greater than that of the fifth. The seventh sample reads as if the previous I<sup>2</sup>C error never occurred - the difference from the fifth sample (176) to the seventh (143) is 33 clocks or 16 clocks + 17 clocks as expected.

If the possibility of incorrect I<sup>2</sup>C data reads cannot be accommodated for by external software checks, one can guarantee proper operation by stopping the CNT/DLY block's clock during I<sup>2</sup>C reads through one of the following methods: by disabling the oscillator block, by reconfiguring the CNT/DLY block's clock source, or by gating an external clock using a LUT (Look Up Table) in the signal matrix. After disabling the CNT/DLY block's clock, the count registers can be read without error. Please note that this workaround will add the I<sup>2</sup>C read and processing time to the counter's overall clock period.

The best workaround depends on the resource constraints of the application. If the oscillator block does not clock other logic elements within the design, a matrix output can be used to manually power down the oscillators for the I<sup>2</sup>C read. When the CNT/DLY block's clock source is routed internally from the oscillator block, I<sup>2</sup>C commands can temporarily reconfigure the CNT/DLY block's clock source registers to select "Ext. CLK. (From Matrix)". This action will disable the clock by connecting it to ground. If the CNT/DLY block is clocked from the signal matrix, a LUT can be used to gate the clock during the I<sup>2</sup>C read.

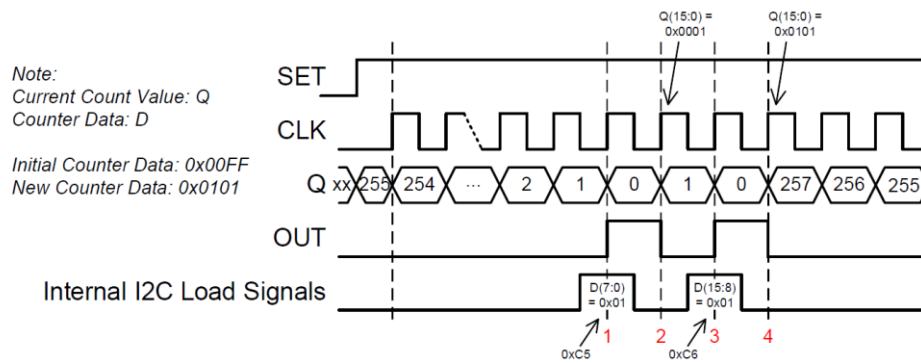
Figure 10. I<sup>2</sup>C Write of 16-Bit Counter Data Example

The timing diagram in [Figure 10](#) sets up a case where an improper output will be seen on the counter. In this example, the initial Counter Data value (D) is set up as 0x00FF. As you can see, the Current Count Value (Q) decrements from 255 down to 0 with rising edges on CLK. At time "1" denoted by a red number 1, an I<sup>2</sup>C command (not shown) has just been sent to the GreenPAK device to reconfigure the Counter Data value to 0x0101.

As previously mentioned, the 16-bit value is loaded from the I<sup>2</sup>C buffers to the Counter Data registers in 8-bit chunks. Right at time “1”, the LSB byte (0x01) is loaded into the Counter Data registers. This makes the Counter Data value temporarily equal to 0x0001. At time “2” between the internal I<sup>2</sup>C load signals, the counter receives a rising edge on its clock input. This causes the Current Count Value to underflow and to be loaded with the Counter Data value which is 0x0001. At time “3”, the MSB byte (0x01) is loaded into the Counter Data registers setting the Counter Data value to 0x0101. At time “4”, the Current Count Value underflows again and is set to the Counter Data value of 0x0101.

This behavior results in two output pulses on OUT when only one pulse is expected. Observing this behavior depends upon the asynchronous timing between the counter's clock and an I<sup>2</sup>C write command to the Counter Data registers. For some applications, the extra pulse on OUT can be ignored and the counter will self-correct after underflowing, overflowing, or being SET/RESET through the GreenPAK connection matrix.

For applications where the application processor needs to read the Current Count Value while the counter is clocking, disable the "Stop and Restart Bit." When this bit is disabled, the counter's clock will not be gated internally which avoids the loss of count values during  $T_{stop}$ . In order to guarantee the current count value after the I<sup>2</sup>C write to the Counter Data registers, the clock should be manually stopped for the I<sup>2</sup>C write or a SET/RESET command should be generated after the I<sup>2</sup>C write (Case 1).

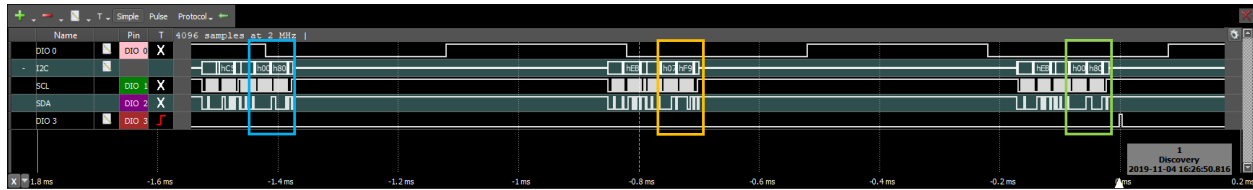
Figure 12. Counter Behavior

For the following condition, the Counter Data register contents are unexpectedly loaded into the counter's DFF chain. This behavior occurs when there is a falling edge on the counter block's clock input during the data return

portion of the I<sup>2</sup>C read of the Counter Data registers. Figure 12 shows this falling edge boxed in light blue followed by two I<sup>2</sup>C reads of the Current Count Value registers.

As you can see by the MCU data log below, the Current Count Value gradually increases from 0xF904 to 0xF907 but is unexpectedly reset to 0x8000. Please note that the colored HEX values in the MCU Log correspond to the boxed I<sup>2</sup>C read commands shown in the waveform above. As previously described, this reset occurs because there is a falling edge on the counter's clock input while the GreenPAK device is responding to the I<sup>2</sup>C read request to 0xC5 and 0xC6 (note that 0xC5/0xC6 are the Counter Data registers and 0xEB/0xEC are the Current Count Value registers for CNT0).

The reason that the counter is not set to 0x8000 on the I<sup>2</sup>C read immediately following the Counter Data query is because the counter requires two rising edges on its clock input to load the data from the Counter Data registers into the DFF chain. Note that all rising edges during  $T_{stop}$  will be gated internally by the "Stop and Restart" feature.

For systems that require I<sup>2</sup>C write access to the Counter Data registers while the counter is clocking, enable the “Stop and Restart Bit” (Case 2).

I<sup>2</sup>C Read of Counter Data: avoid reading Counter Data via I<sup>2</sup>C while the counter is being clocked.

Within the MCU, we recommend saving the Counter Data register configuration as a software variable so that the Counter Data register does not need to be read during counter operation.

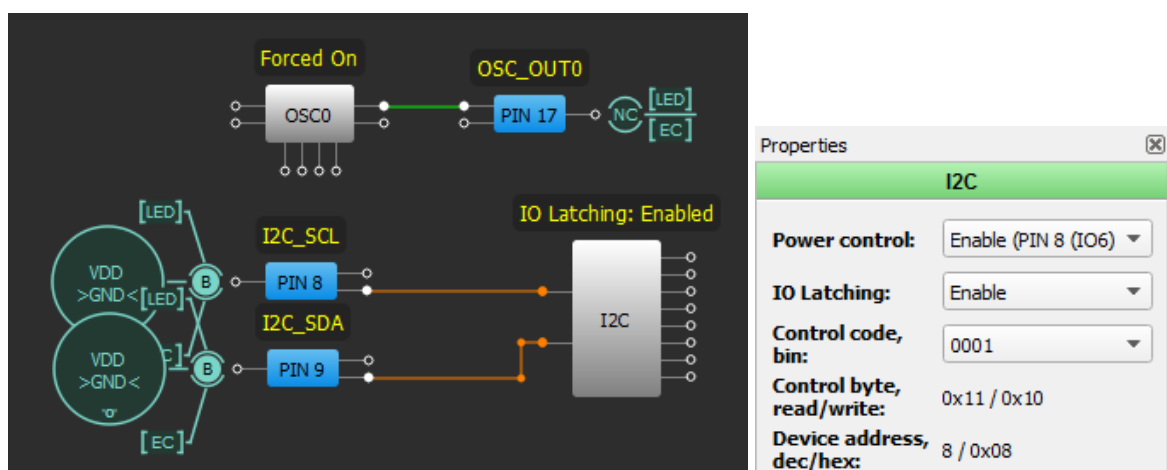
Figure 13

The GreenPAK device does not check for a matching I<sup>2</sup>C Slave address condition before triggering 'IO Latching'. A Start bit on the I<sup>2</sup>C bus will trigger IO Latching. A Start bit is when I2C\_SDA goes low first followed by I2C\_SCL going low after.

In the example in [Figure 13](#), we will be monitoring the OSC output, which is measured by a scope on Channel 3 via PIN17 (“OSC OUT0”). The I<sup>2</sup>C bus will be forced low to create a START bit.

Disable IO Latching in programmed OTP. This register is I<sup>2</sup>C-write locked during normal operation and therefore should be disabled in configuration file.

Do not share I<sup>2</sup>C bus with other devices and make sure the I<sup>2</sup>C bus is not powered down while the GreenPAK is still powered through V<sub>DD</sub>.

If the above cannot be satisfied, then consider using the SLG4658x devices, where this errata has been fixed.

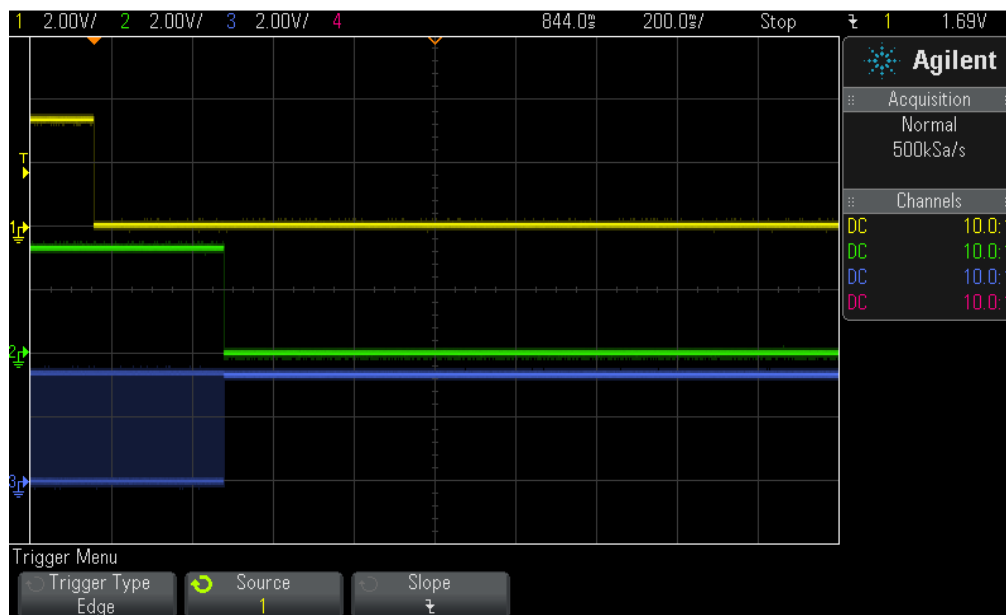
Figure 14

By toggling I2C\_SDA low and then I2C\_SCL low, the GreenPAK registers this as a start bit and latches all General Purpose Outputs such as PIN#17 (“OSC\_OUT0”). In Figure 14, notice that PIN#17 (OSC\_OUT0) stops toggling.

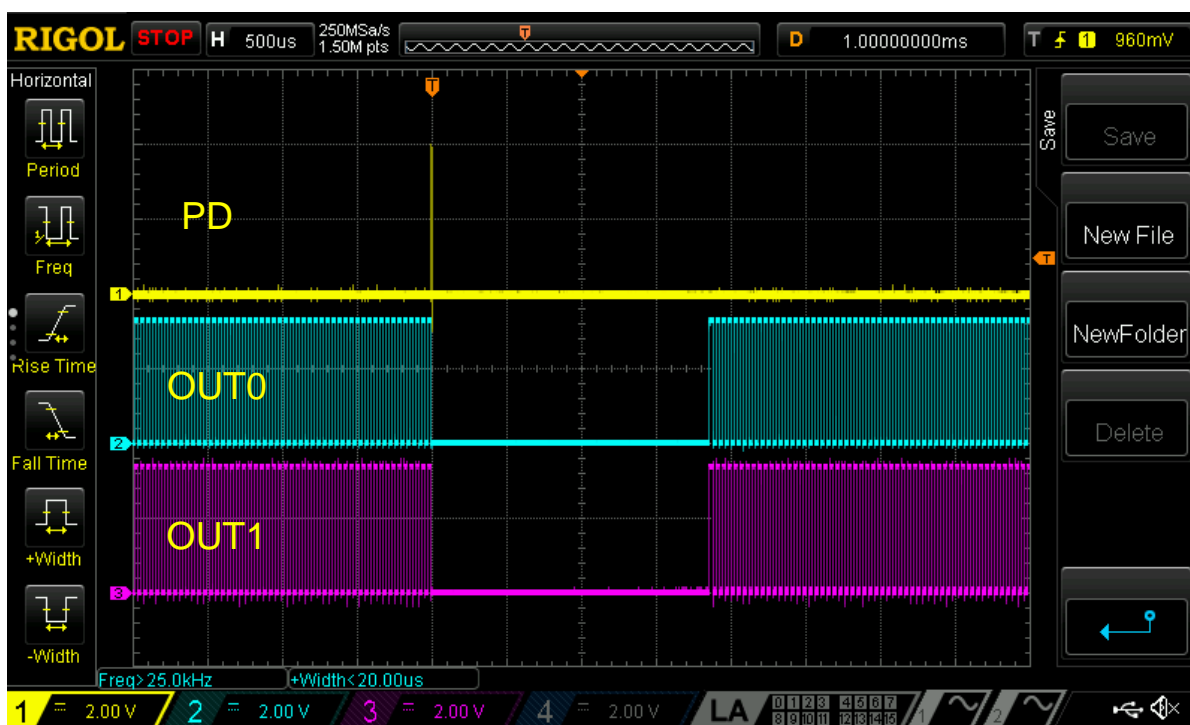
If a pulse with a duration of less than ~40 ns is applied to the PWR DOWN input of the oscillator, the oscillator outputs remain stuck for milliseconds, as shown in [Figure 16](#) and [Figure 17](#). The issue is observed for all available oscillators.

Figure 16. 25 kHz OSC Long Start-Up

Change Fast start-up setting to Enable or omit applying glitches at PWR DOWN input in OSC.

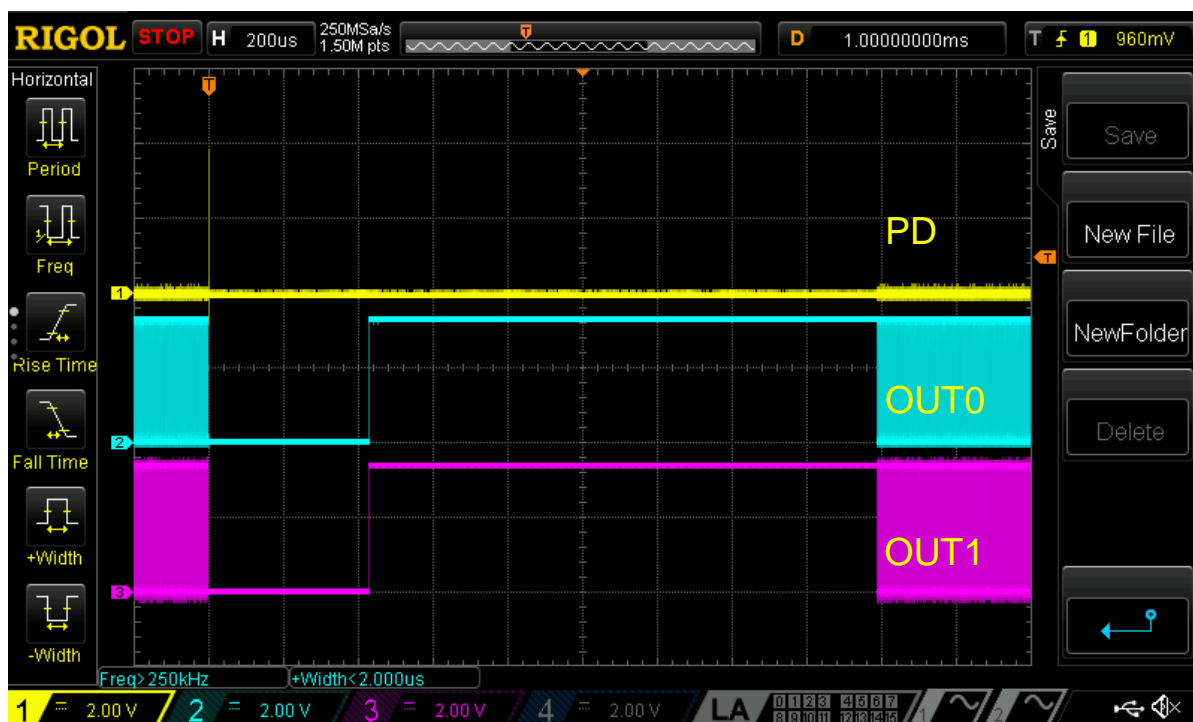
Figure 17. 2 MHz OSC Long Start-Up
