## SLG47525/28 Errata Note

This document contains the known errata for SLG47525/28 and the recommended workarounds.

Package(s)	14-pin STQFN (SLG47525): 2.0 mm x 2.2 mm x 0.55 mm, 0.4 mm pitch
	20-pin STQFN (SLG47528): 2.0 mm x 3.0 mm x 0.55 mm, 0.4 mm pitch

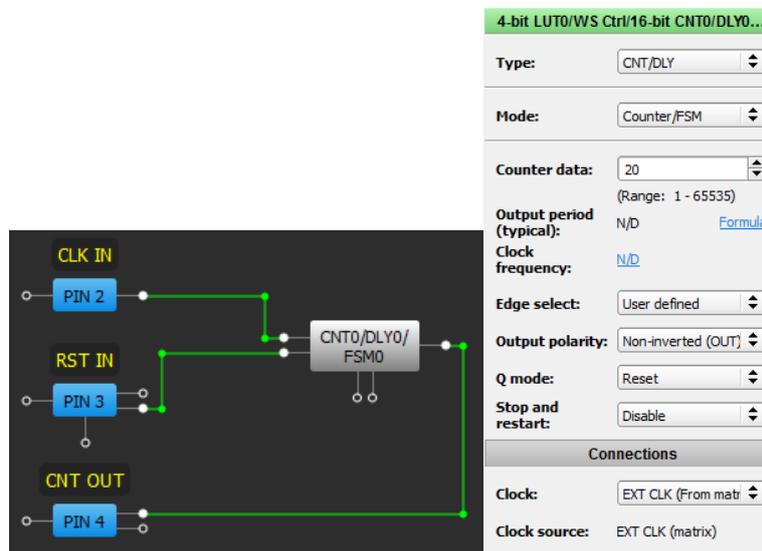
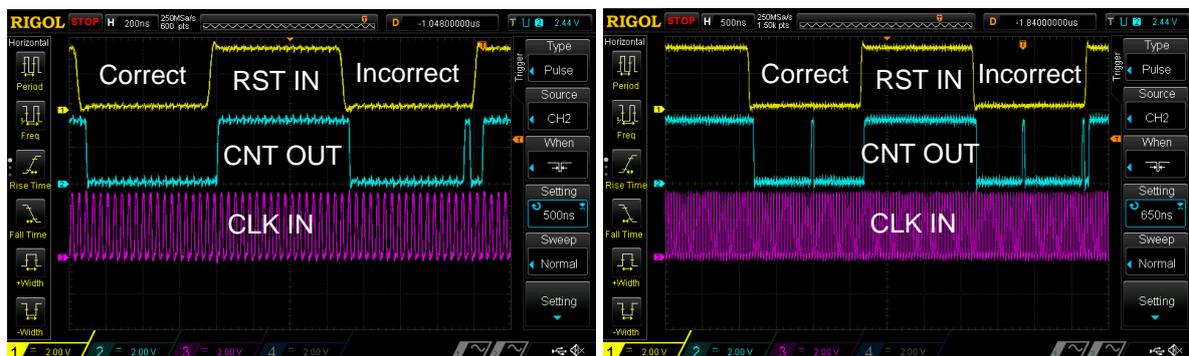
Figure 1

If the Counter Reset is asserted at the same time as a rising clock edge, it is possible that the Counter Data will be reset incorrectly and the counter output may appear faster than expected. This phenomenon appears more often as the clock frequency increases.

Synchronize RESET input of the Counter with its CLK using 2 DFF cells as shown on Figure 3.

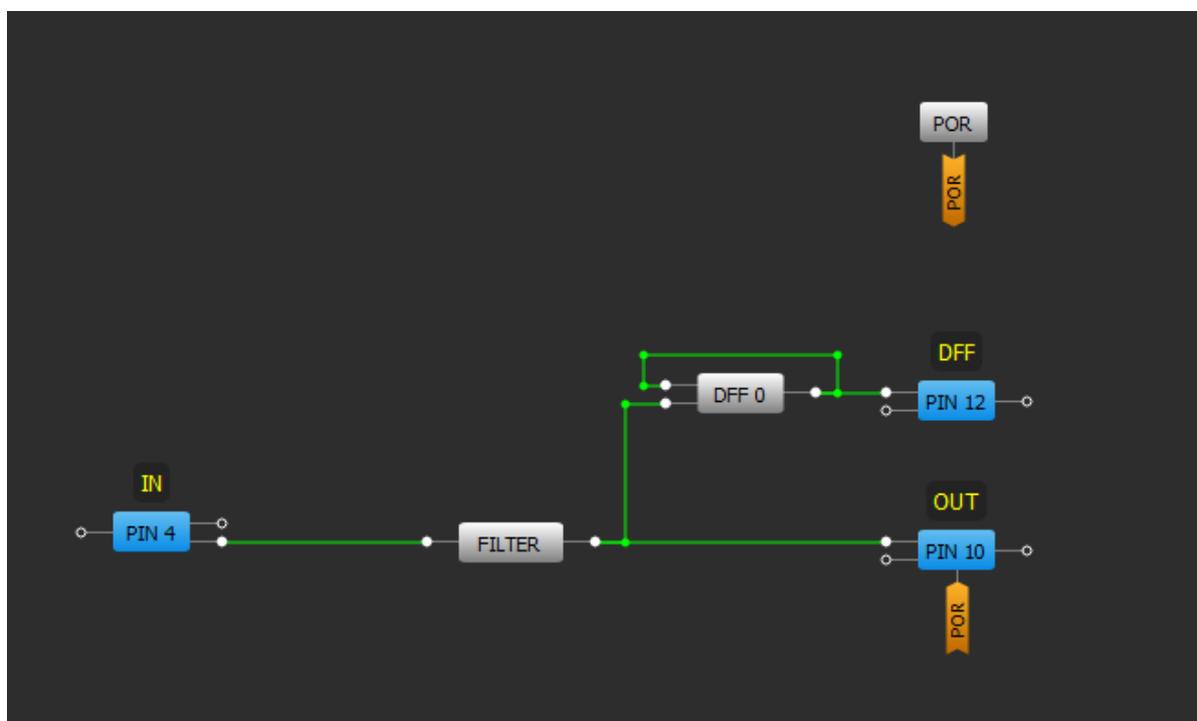
Figure 4

If clock type high frequency input comes in, the FILTER cell may not filter it out. There are several factors like input frequency, duty cycle, and LOW duration in such signal that may lead to its passing through FILTER block.

Currently there is no workaround for this issue. Filter block is good at filtering short spontaneous glitches. It is intended to be used in series connection before the delay cell to avoid its latching.

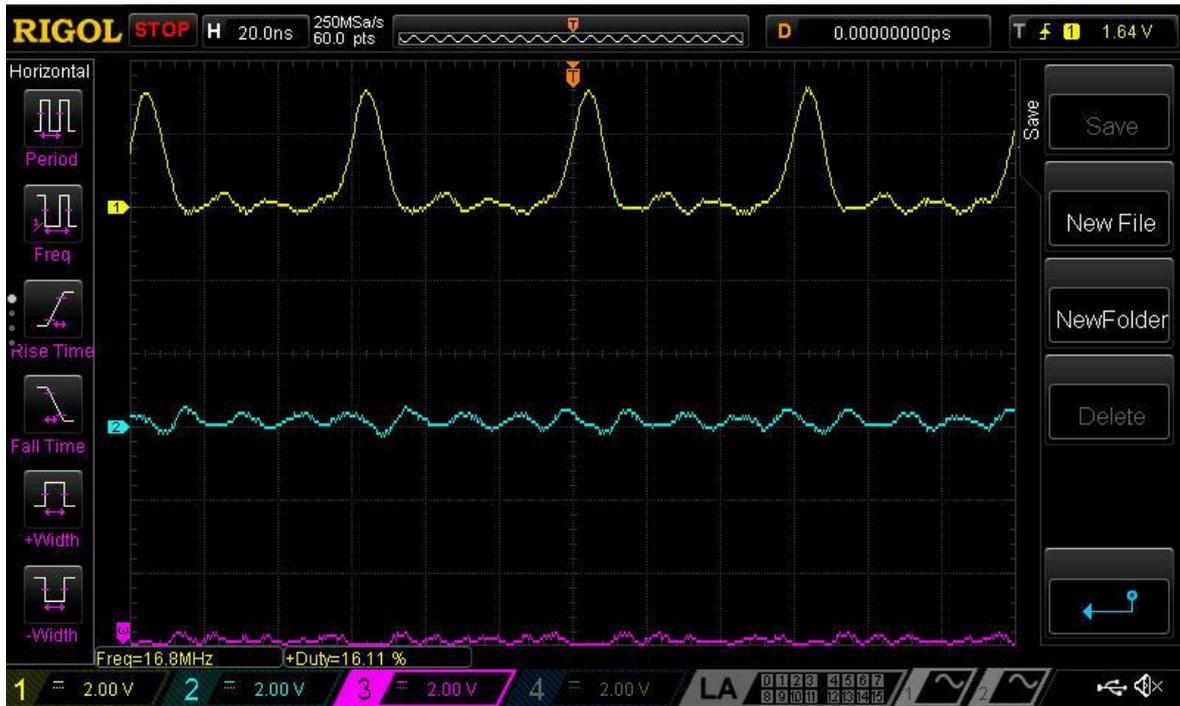
Figure 5

- 1. Period is 60 ns. Pulse width is 10 ns, DC = 16.7 % (correct functionality).

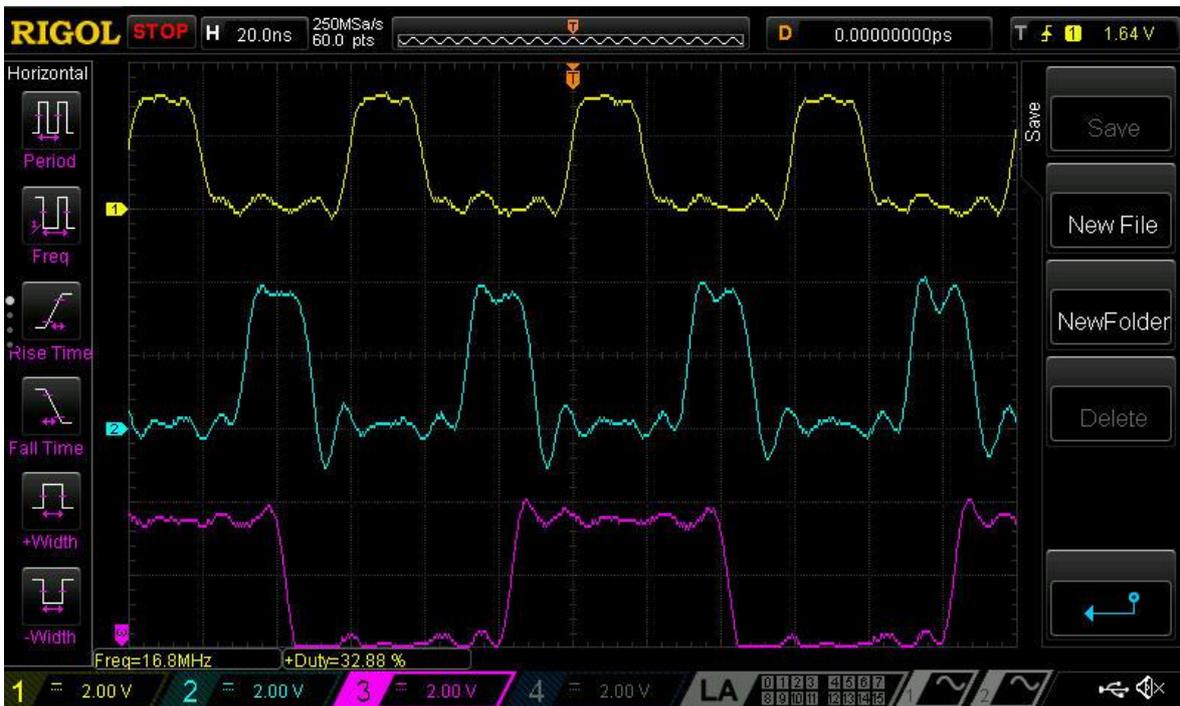
Figure 6

- 2. Period is 60 ns. Pulse width is 20 ns, DC = 33.3 % (incorrect functionality).

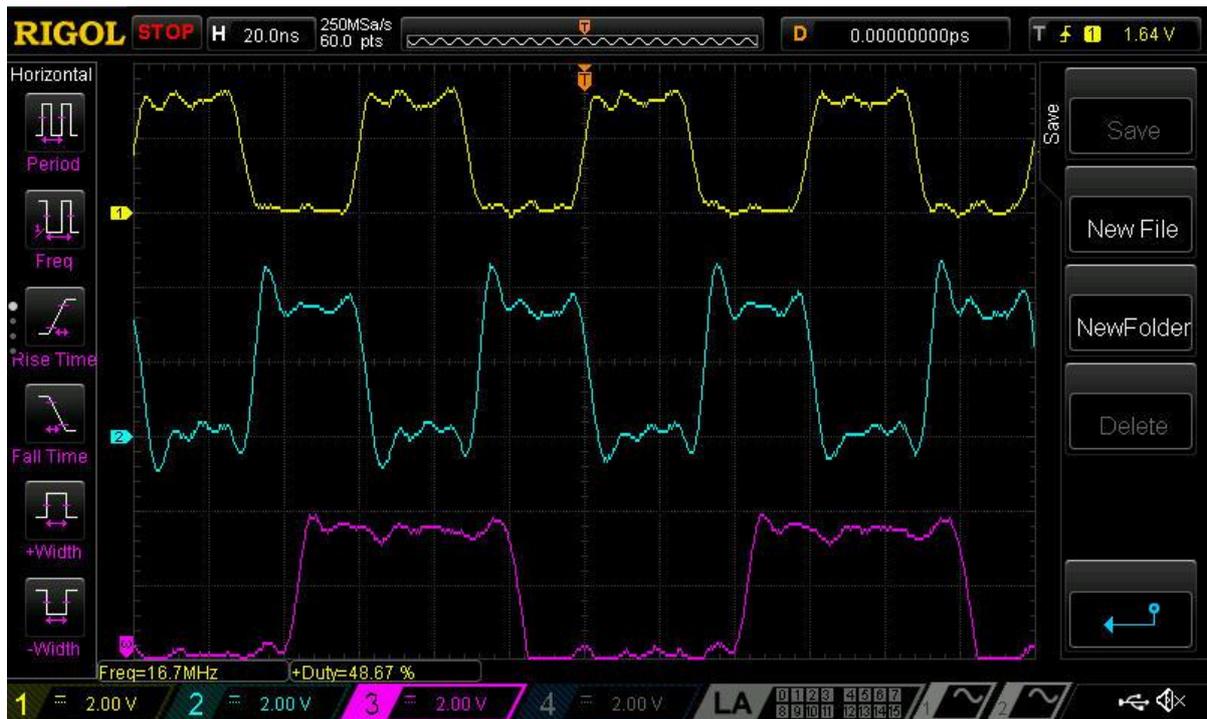
Figure 7

- Period is 60 ns. Pulse width is 30 ns, DC = 50 % (incorrect functionality).

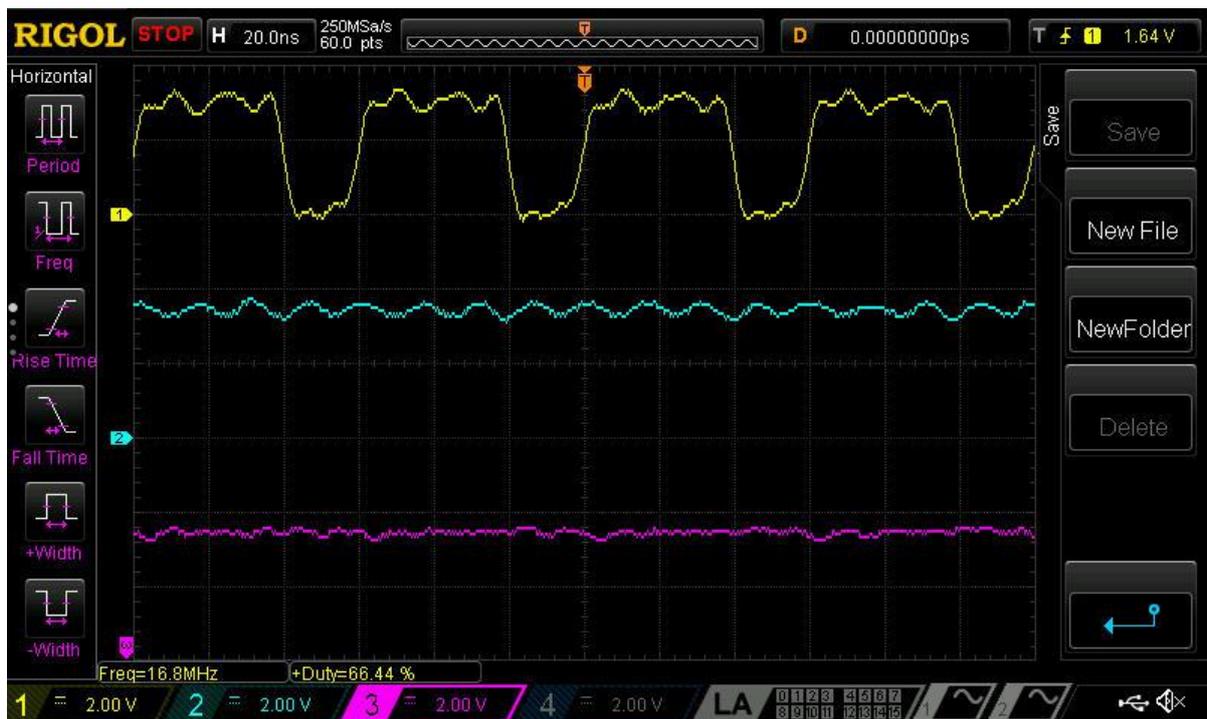
Figure 8

- Period is 60 ns. Pulse width is 40 ns, DC = 66.67 % (correct functionality).

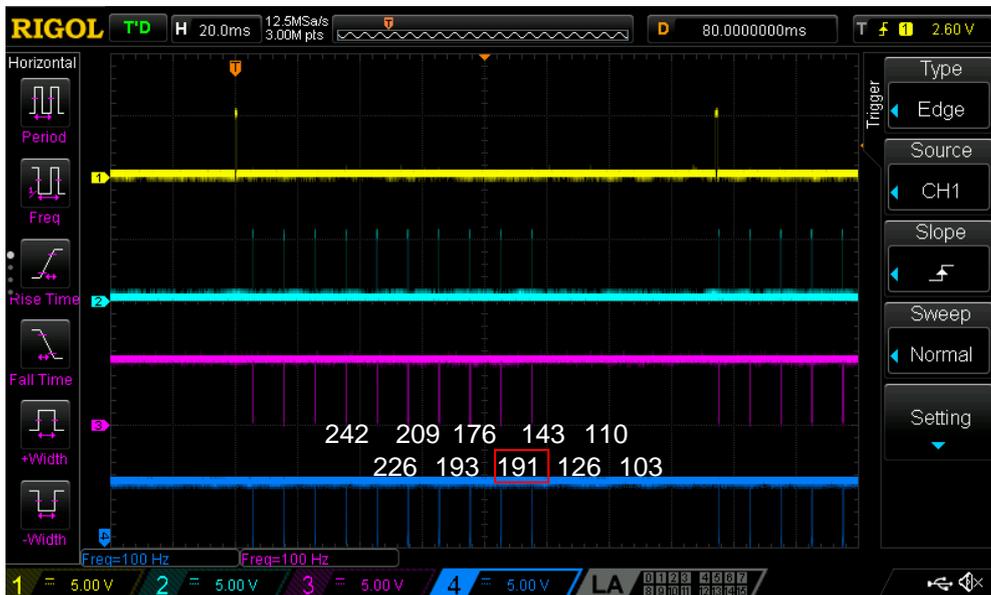
Asynchronous interaction between the CNT/DLY clock input and the I<sup>2</sup>C LATCH signal (generated by an I<sup>2</sup>C read command of the CNT/DLY block's count value) can result in an incorrect I<sup>2</sup>C data read. The CNT/DLY block will count accurately, but the count value transferred into the block's I<sup>2</sup>C read register might be loaded incompletely if the I<sup>2</sup>C LATCH signal and the clock input occur at about the same time.

The example data capture in Figure 9 shows ten periodic I<sup>2</sup>C reads of CNT2/DLY2 configured to count down at about 16 clocks per read. The sixth read sample erroneously shows a value greater than that of the fifth. The seventh sample reads as if the previous I<sup>2</sup>C error never occurred - the difference from the fifth sample (176) to the seventh (143) is 33 clocks or 16 clocks + 17 clocks as expected.

If the possibility of incorrect I<sup>2</sup>C data reads cannot be accommodated for by external software checks, one can guarantee proper operation by stopping the CNT/DLY block's clock during I<sup>2</sup>C reads through one of the following methods: by disabling the oscillator block, by reconfiguring the CNT/DLY block's clock source, or by gating an external clock using a LUT (Look Up Table) in the signal matrix. After disabling the CNT/DLY block's clock, the count registers can be read without error. Please note that this workaround will add the I<sup>2</sup>C read and processing time to the counter's overall clock period.

The best workaround depends on the resource constraints of the application. If the oscillator block does not clock other logic elements within the design, a matrix output can be used to manually power down the oscillators for the I<sup>2</sup>C read. When the CNT/DLY block's clock source is routed internally from the oscillator block, I<sup>2</sup>C commands can temporarily reconfigure the CNT/DLY block's clock source registers to select "Ext. CLK. (From Matrix)". This action will disable the clock by connecting it to ground. If the CNT/DLY block is clocked from the signal matrix, a LUT can be used to gate the clock during the I<sup>2</sup>C read.

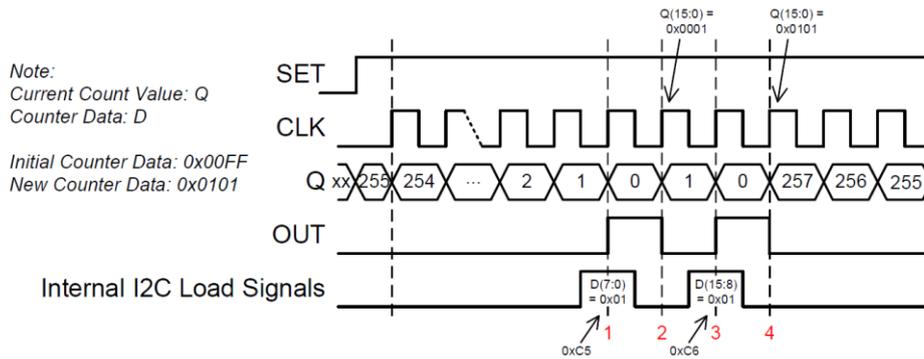
Figure 10. I<sup>2</sup>C Write of 16-Bit Counter Data Example

The timing diagram in [Figure 10](#) sets up a case where an improper output will be seen on the counter. In this example, the initial Counter Data value (D) is set up as 0x00FF. As you can see, the Current Count Value (Q) decrements from 255 down to 0 with rising edges on CLK. At time "1" denoted by a red number 1, an I<sup>2</sup>C command (not shown) has just been sent to the GreenPAK device to reconfigure the Counter Data value to 0x0101.

As previously mentioned, the 16-bit value is loaded from the I<sup>2</sup>C buffers to the Counter Data registers in 8-bit chunks. Right at time “1”, the LSB byte (0x01) is loaded into the Counter Data registers. This makes the Counter Data value temporarily equal to 0x0001. At time “2” between the internal I<sup>2</sup>C load signals, the counter receives a rising edge on its clock input. This causes the Current Count Value to underflow and to be loaded with the Counter Data value which is 0x0001. At time “3”, the MSB byte (0x01) is loaded into the Counter Data registers setting the Counter Data value to 0x0101. At time “4”, the Current Count Value underflows again and is set to the Counter Data value of 0x0101.

This behavior results in two output pulses on OUT when only one pulse is expected. Observing this behavior depends upon the asynchronous timing between the counter’s clock and an I<sup>2</sup>C write command to the Counter Data registers. For some applications, the extra pulse on OUT can be ignored and the counter will self-correct after underflowing, overflowing, or being SET/RESET through the GreenPAK connection matrix.

For applications where the application processor needs to read the Current Count Value while the counter is clocking, disable the “Stop and Restart Bit.” When this bit is disabled, the counter’s clock will not be gated internally which avoids the loss of count values during T<sub>stop</sub>. In order to guarantee the current count value after the I<sup>2</sup>C write to the Counter Data registers, the clock should be manually stopped for the I<sup>2</sup>C write or a SET/RESET command should be generated after the I<sup>2</sup>C write (Case 1).

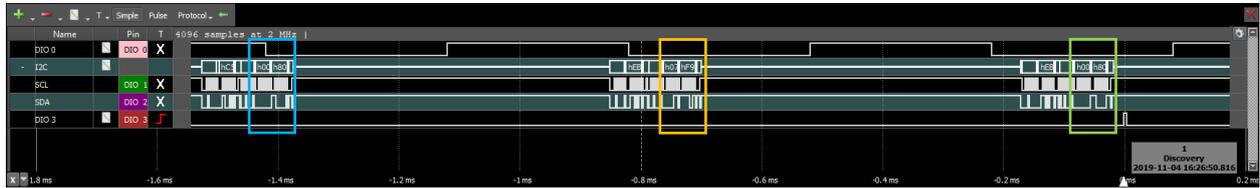
Figure 12. Counter Behavior

For the following condition, the Counter Data register contents are unexpectedly loaded into the counter’s DFF chain. This behavior occurs when there is a falling edge on the counter block’s clock input during the data return

portion of the I<sup>2</sup>C read of the Counter Data registers. Figure 12 shows this falling edge boxed in light blue followed by two I<sup>2</sup>C reads of the Current Count Value registers.

As you can see by the MCU data log below, the Current Count Value gradually increases from 0xF904 to 0xF907 but is unexpectedly reset to 0x8000. Please note that the colored HEX values in the MCU Log correspond to the boxed I<sup>2</sup>C read commands shown in the waveform above. As previously described, this reset occurs because there is a falling edge on the counter’s clock input while the GreenPAK device is responding to the I<sup>2</sup>C read request to 0xC5 and 0xC6 (note that 0xC5/0xC6 are the Counter Data registers and 0xEB/0xEC are the Current Count Value registers for CNT0).

The reason that the counter is not set to 0x8000 on the I<sup>2</sup>C read immediately following the Counter Data query is because the counter requires two rising edges on its clock input to load the data from the Counter Data registers into the DFF chain. Note that all rising edges during T<sub>stop</sub> will be gated internally by the “Stop and Restart” feature.

For systems that require I<sup>2</sup>C write access to the Counter Data registers while the counter is clocking, enable the “Stop and Restart Bit” (Case 2).

I<sup>2</sup>C Read of Counter Data: avoid reading Counter Data via I<sup>2</sup>C while the counter is being clocked.

Within the MCU, we recommend saving the Counter Data register configuration as a software variable so that the Counter Data register does not need to be read during counter operation.

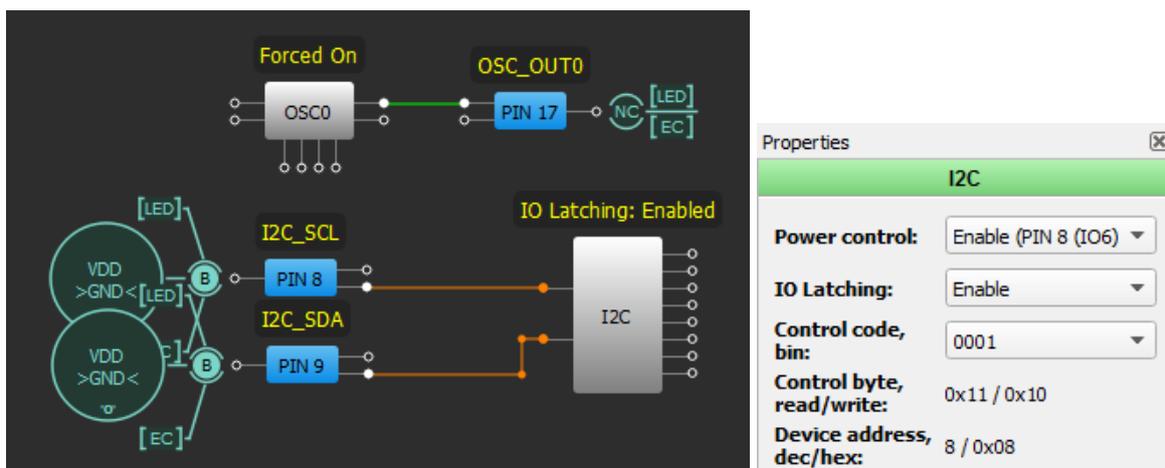
Figure 13

The GreenPAK device does not check for a matching I<sup>2</sup>C Slave address condition before triggering ‘IO Latching’. A Start bit on the I<sup>2</sup>C bus will trigger IO Latching. A Start bit is when I2C\_SDA goes low first followed by I2C\_SCL going low after.

In the example in [Figure 13](#), we will be monitoring the OSC output, which is measured by a scope on Channel 3 via PIN17 (“OSC\_OUT0”). The I<sup>2</sup>C bus will be forced low to create a START bit.

Disable IO Latching in programmed OTP. This register is I<sup>2</sup>C-write locked during normal operation and therefore should be disabled in configuration file.

Do not share I<sup>2</sup>C bus with other devices and make sure the I<sup>2</sup>C bus is not powered down while the GreenPAK is still powered through V<sub>DD</sub>.

If the above cannot be satisfied, then consider using the SLG4658x devices, where this errata has been fixed.

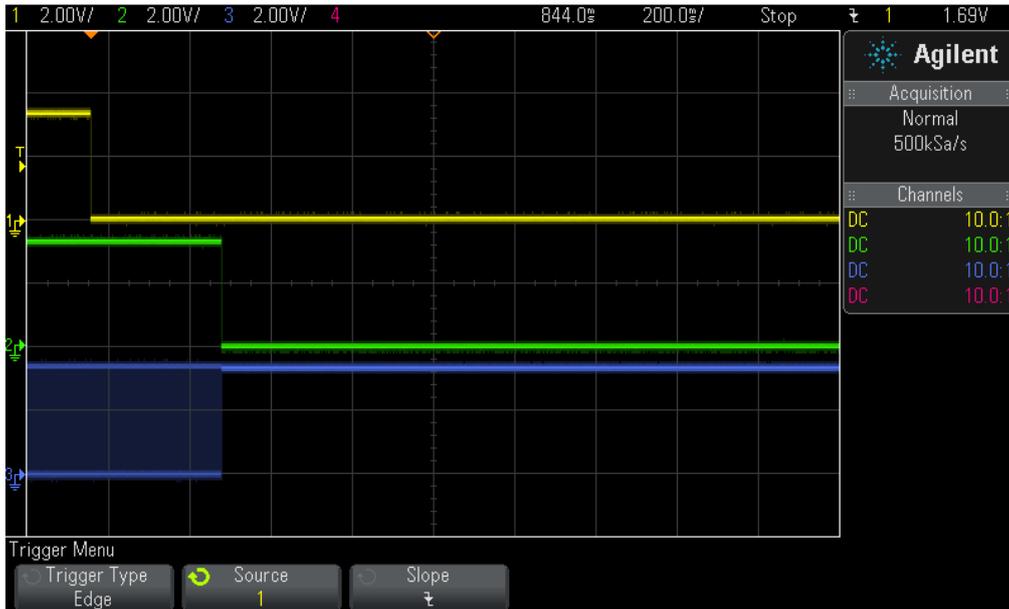
Figure 14

By toggling I2C\_SDA low and then I2C\_SCL low, the GreenPAK registers this as a start bit and latches all General Purpose Outputs such as PIN#17 (“OSC\_OUT0”). In Figure 14, notice that PIN#17 (OSC\_OUT0) stops toggling.

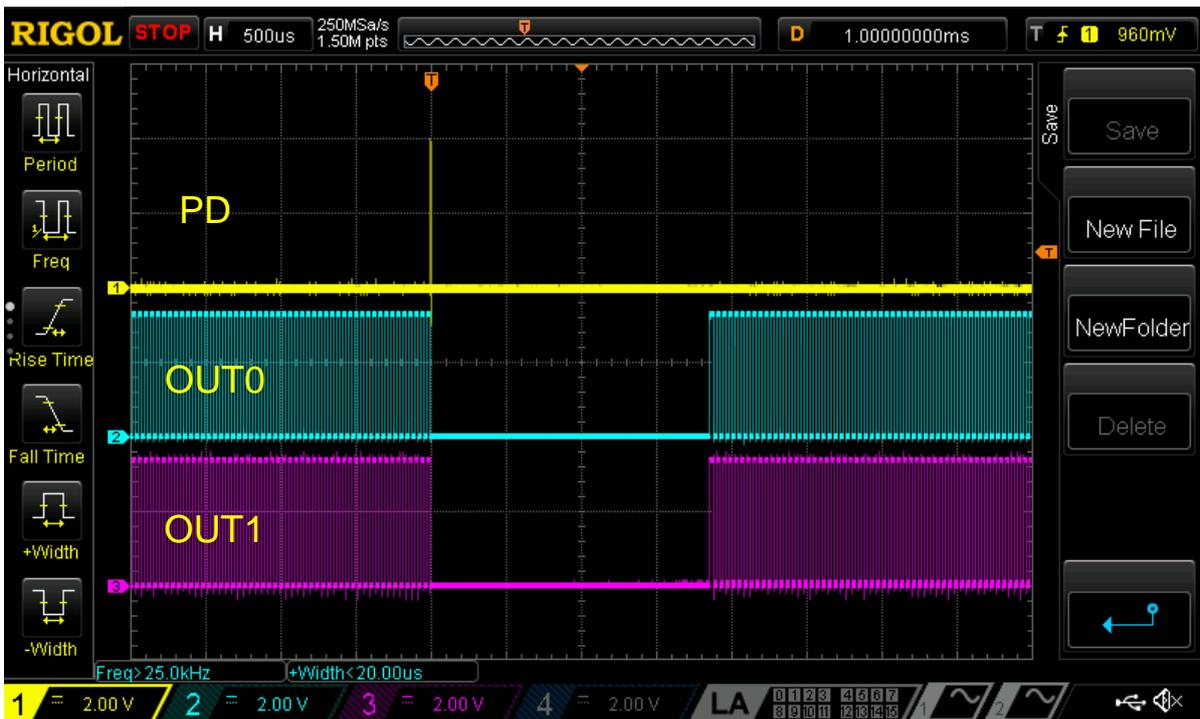
Figure 16. 25 kHz OSC Long Start-Up

If a pulse with a duration of less than ~40 ns is applied to the PWR DOWN input of the oscillator, the oscillator outputs remain stuck for milliseconds, as shown in Figure 16 and Figure 17. The issue is observed for all available oscillators.
