## PRODUCT/PROCESS CHANGE NOTICE (PCN)

| PCN #: <b>N1703-01</b> | Date: May 2, 2017 | MEANS OF DISTINGUISHING CHANGED DEVICES: |
| Product Affected: 8V97053NLGI | | <input checked="" type="checkbox"/> Product Mark      Prefix character on date code line as shown on Attachment 1 |

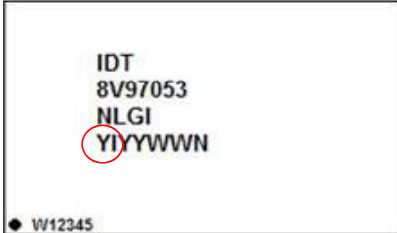
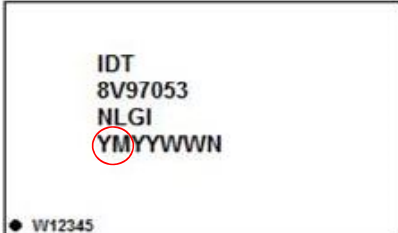
#### Example of Prefix character change in datecode line

| From: YI | To: YM |
