1 Purpose of Document

This document summarizes the changes between the previous ASI4U silicon revision C and the current silicon revision E. These include requested UART design changes. The purpose of the redesign was to correct reported timing errors by the UART in the following modes: Master, Monitor, and Repeater. A problem with slave communication in special network constellations was also fixed.

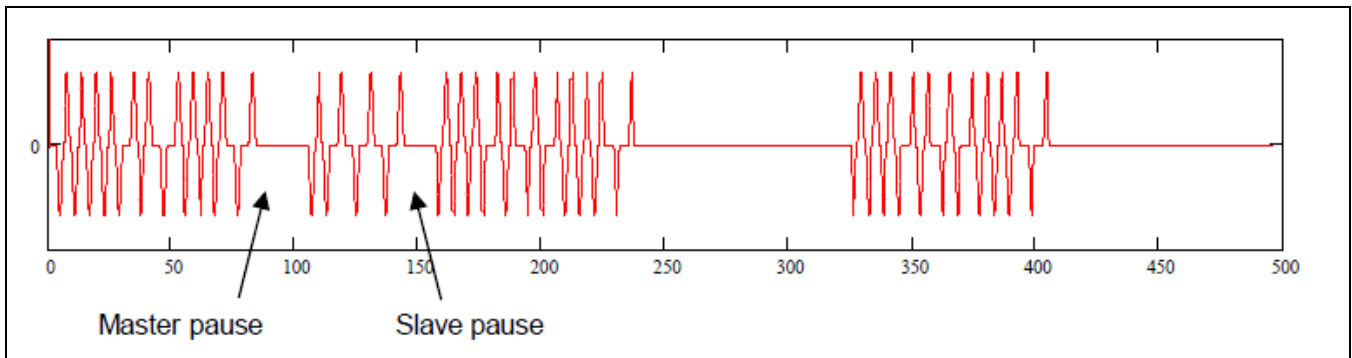
Figure 3.1 Test for ASI4U Revision C Error in Master Pause Detection

If the previous ASI4U revision C is operated in Slave Mode, the UART Master Pause detection does not always function correctly when the UART must listen to slave responses from a different slave. Depending on the actual AS-I line pulse timing, a slave response from a different slave is sometimes not recognized correctly, which results in a UART communication error. This prevents the Slave from understanding the next Master telegram correctly. If the Master telegram addresses the Slave itself, the error leads to a missing slave response and the Slave replies on a second repetition of the Master Call to its own address in asynchronous mode.

This behavior was mostly observed in mixed networks that used modules with the ASI4U, SAP5, and SAP4.1.

Figure 3.1 shows a telegram test case to reproduce the error. The AS-I signals shown in Figure 3.1 were generated by a signal generator that allowed sweeping the Master Pause and Slave Pause duration over the allowed specification limit. The first Master Call contains a different slave address than the tested slave. The second and third master calls address the tested slave. The tested slave replied with the erroneous behavior for certain Master pause and Slave pause scenarios only. The majority of the test cases were passed without error.

A new principle of AS-i telegram pause detection was implemented in ASI4U silicon revision E that is more precise and able to cover all valid timing scenarios for Master and Slave pauses. The new principle is now independent of the internal timing constraints of the UART state machine.
