RENESAS TECHNICAL UPDATE

Product Category	MPU/MCU	Document No.	TN-RA*-A0162A/E	Rev.	1.00
Title	Note for USBHS suspend/resume interrupt	Information Category	Technical Notification		
Applicable Product	RA8P1 Group RA8M2 Group RA8D2 Group	Lot No.	Reference Document	Hardware User Manual for each product (Refer table at the end of this document)	
		All

This document describes the note for USBHS Deep Software Standby USB Suspend/Resume Interrupt. The page and section numbers are based on the RA8P1 Group. For other products, see the table on the last page.

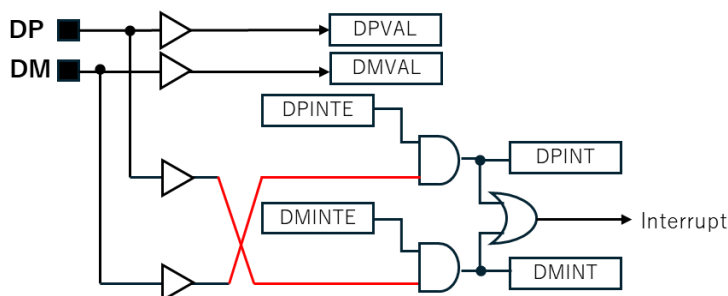
Fig.2 Incorrect connection

Deep software standby mode 1 is returned by a USB suspend/resume interrupt caused by a level change on the DP/DM pins, but a problem has been discovered in the circuit that generates the interrupt signal, where the DP and DM pin signals are connected in reverse.

In this case, if deep software standby mode 1 is set to be returned by a bus reset or a level change on the DP pin only upon disconnect detection, the device will not return deep software standby mode 1.

Change the DP/DM interrupt enable bit and DP/DM interrupt indication bit as follows:

38.2.51 DPUSR2R: Exchanges bits 9 and 8, and bits 1 and 0, of the Deep Software Standby USB Suspend/Resume Interrupt Register.
