SLG46625-A Errata Note

This document contains the known errata for SLG46625-A and the recommended workarounds.

Package(s)	20-pin TQFN: 3.5 mm x 3.5 mm x 0.75 mm, 0.5 mm pitch
-------------------	--

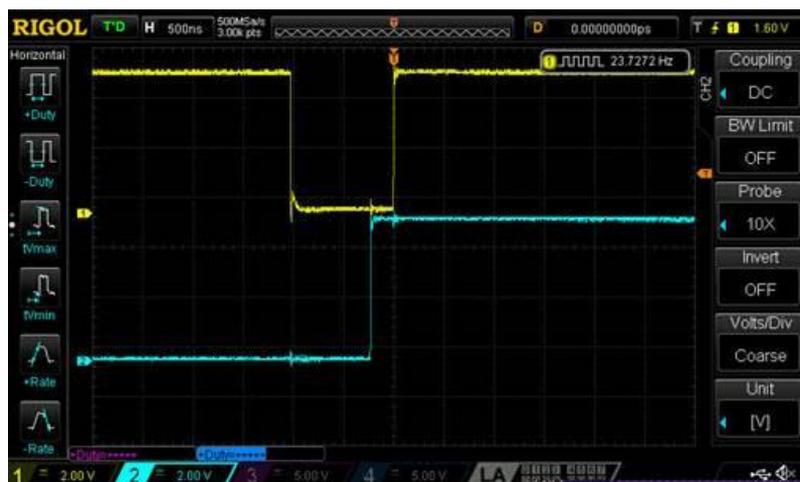
Figure 1. ACMP Output Glitch

The output of the ACMP incorrectly goes low even when IN+ is greater than IN- if the RING OSC is active when the WS signal rises.

Channel 1 – ACMP out

Channel 2 – WS_OUT

Avoid using the RING OSC with the WS Controller or add a filtering block on the ACMP output to filter out the glitch.

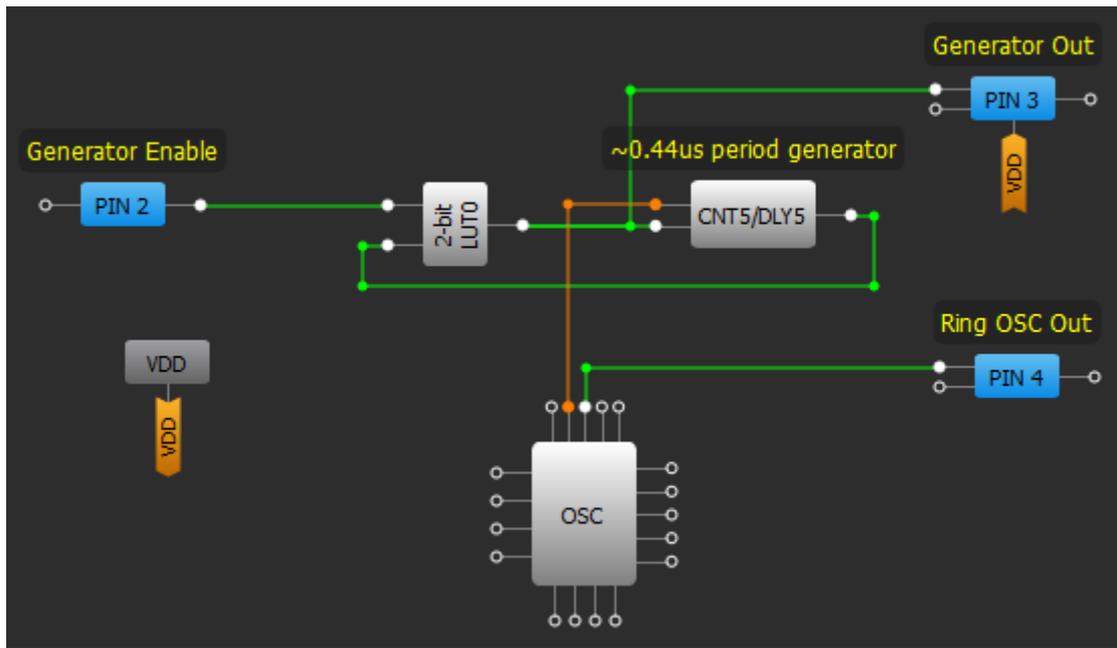
Figure 2. Ring OSC Test Design

The Ring OSC has a longer settling time when configured as Auto Power On in the designs that have very short Ring OSC disable time. An example of this issue is shown in the following configuration:

Set Ring OSC power mode to “Force Power On” or Set Turn on by register option in BG (Band Gap) block as “Enable”.

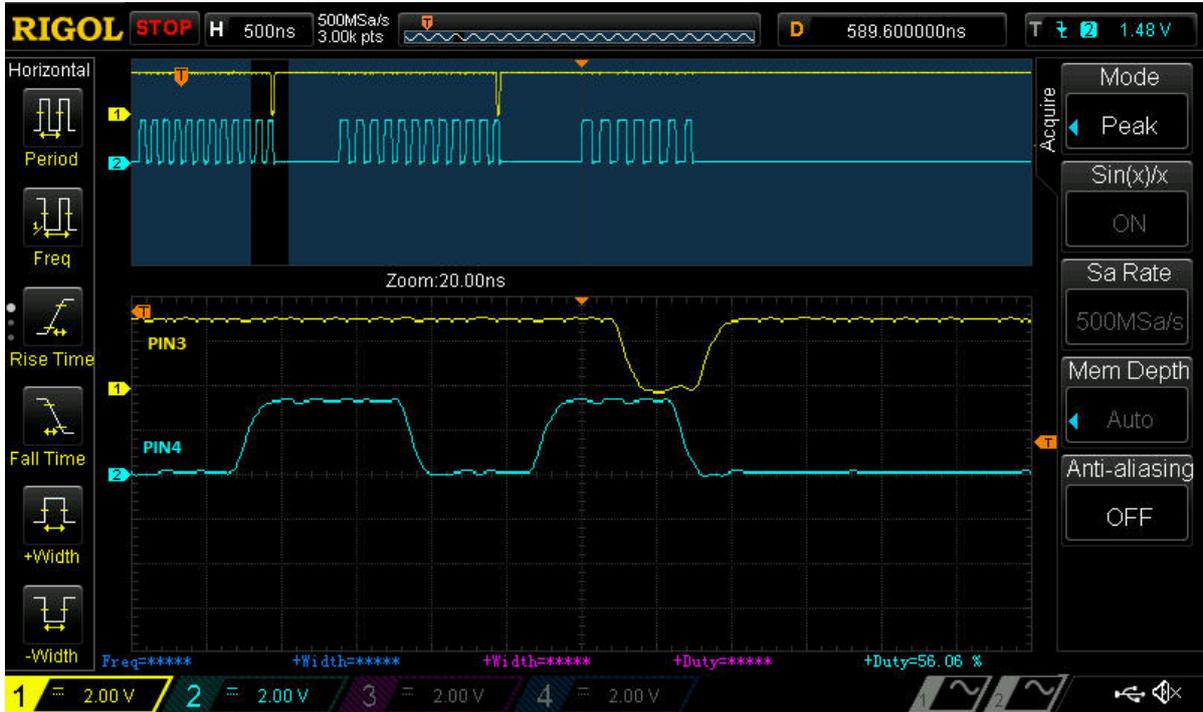
Figure 4. Ring OSC Output

The configuration shown above generates a periodical signal with a frequency defined by the Delay cell and started by a high signal on PIN2. The issue becomes apparent in a longer settling time when the scheme generates short pulses (Delay is configured as a rising edge delay only). See the waveform in [Figure 4](#).

Channel 1 – 2-bit LUT0 output

Channel 2 – Ring OSC output

Such behavior will lead to substantial error in period calculations if the delay time is relatively small.

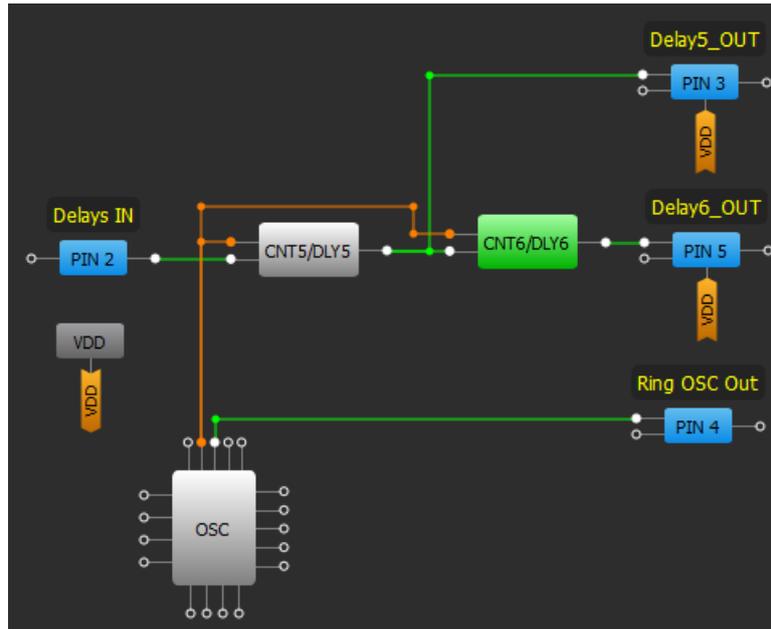
Figure 5. Ring OSC with DLY5, DLY6 Test Design

In [Figure 5](#), Delay5 and Delay6 are configured in the same way. However, Delay5 time is 11.4 us instead of expected 0.4 us (Delay5 time).

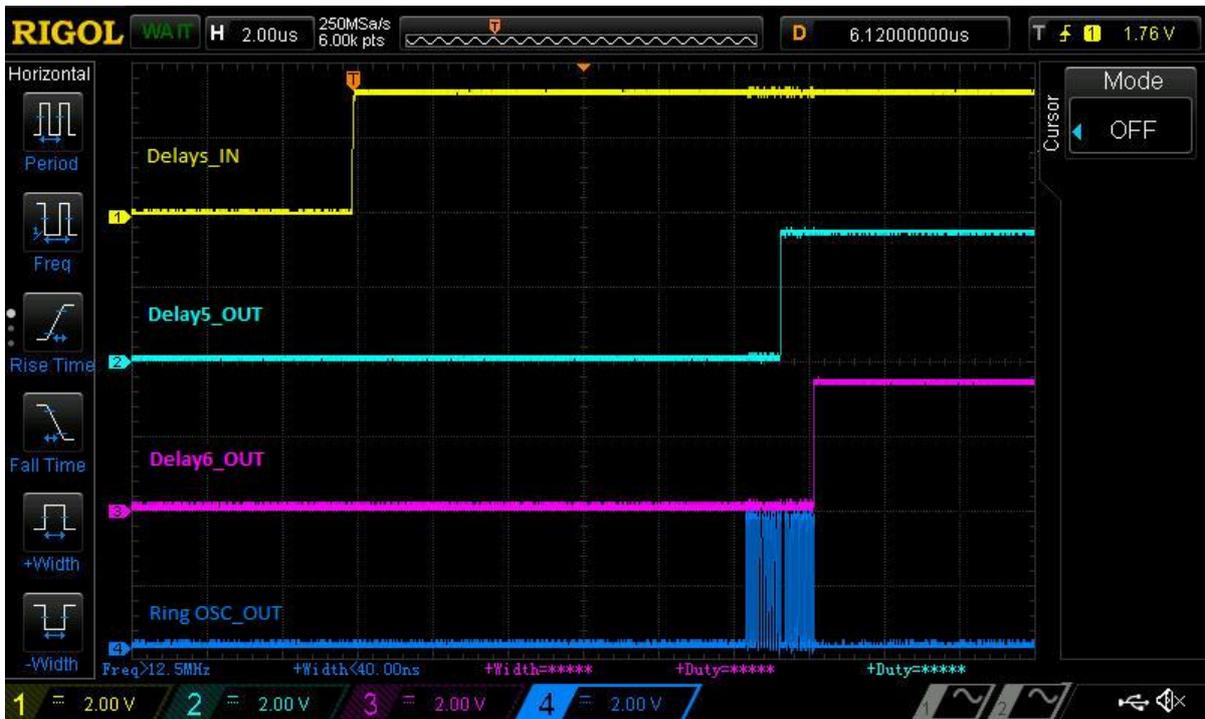
Figure 6. Ring OSC, DLY5 and DLY6 Waveform

A similar situation can occur while using two connected delays (all edge detect types except for a pair “Rising edge DLY – Falling edge DLY”).

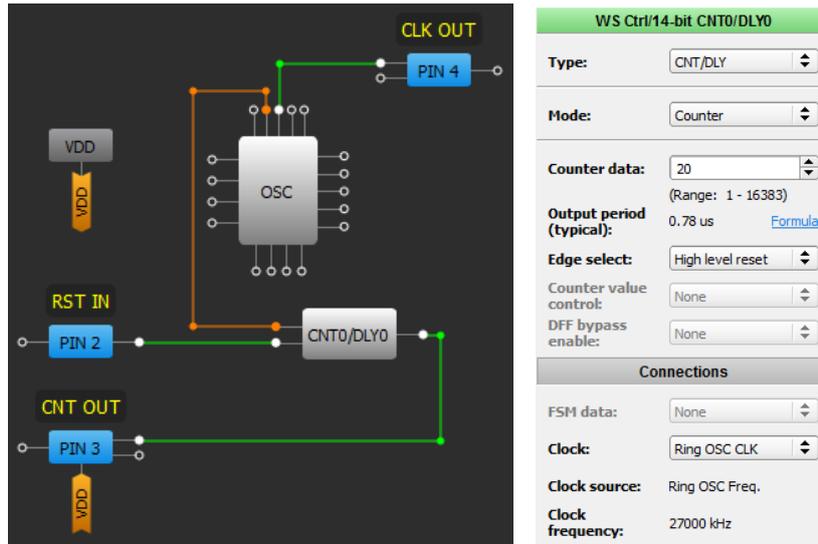
Figure 7. CNT Test Design

If the Counter Reset occurs at a time very close to a rising edge of the clock signal during clock signal generation (for example OSC operation), there is a possibility that the Counter Data of the Counter is reset incorrectly and the counter end signal (HIGH pulse) may appear faster than expected. This phenomena appears more frequently the higher the clock frequency is.

Synchronize RESET input of the Counter with its CLK using 2 DFF cells as shown in Figure 9.

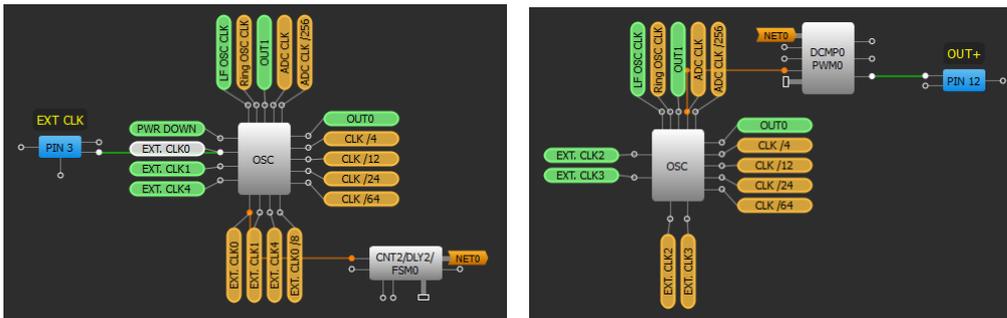
Figure 10. DCMP Test Design

For example, DCMP IN+ sources from FSM0 and IN- from Register0. DCMP is clocked from the Ring OSC.

Synchronize the data source clock with the DCMP clock source using 2 DFF cells as shown in [Figure 12](#).

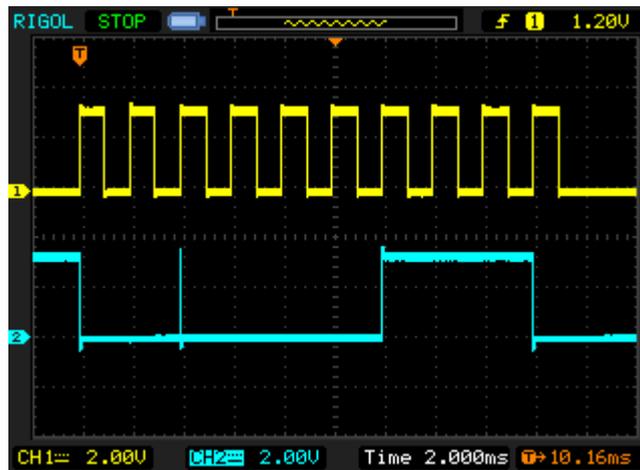
Figure 11. DCMP Glitch

DCMP's OUT+ output may have a glitch when the input data is changed. This issue appears more frequently the higher DCMP clock is.

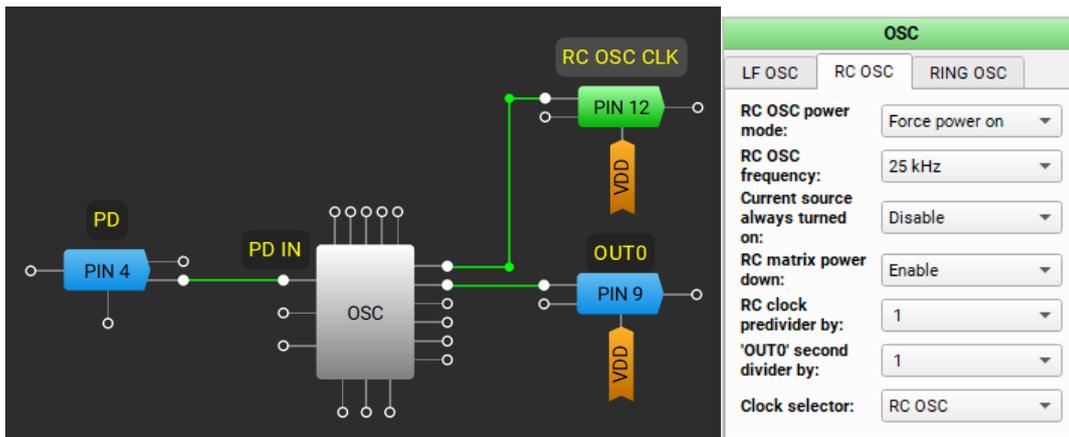
Figure 13. Test Design

When a short pulse of less than ~40 ns is applied to the PWR DOWN input.

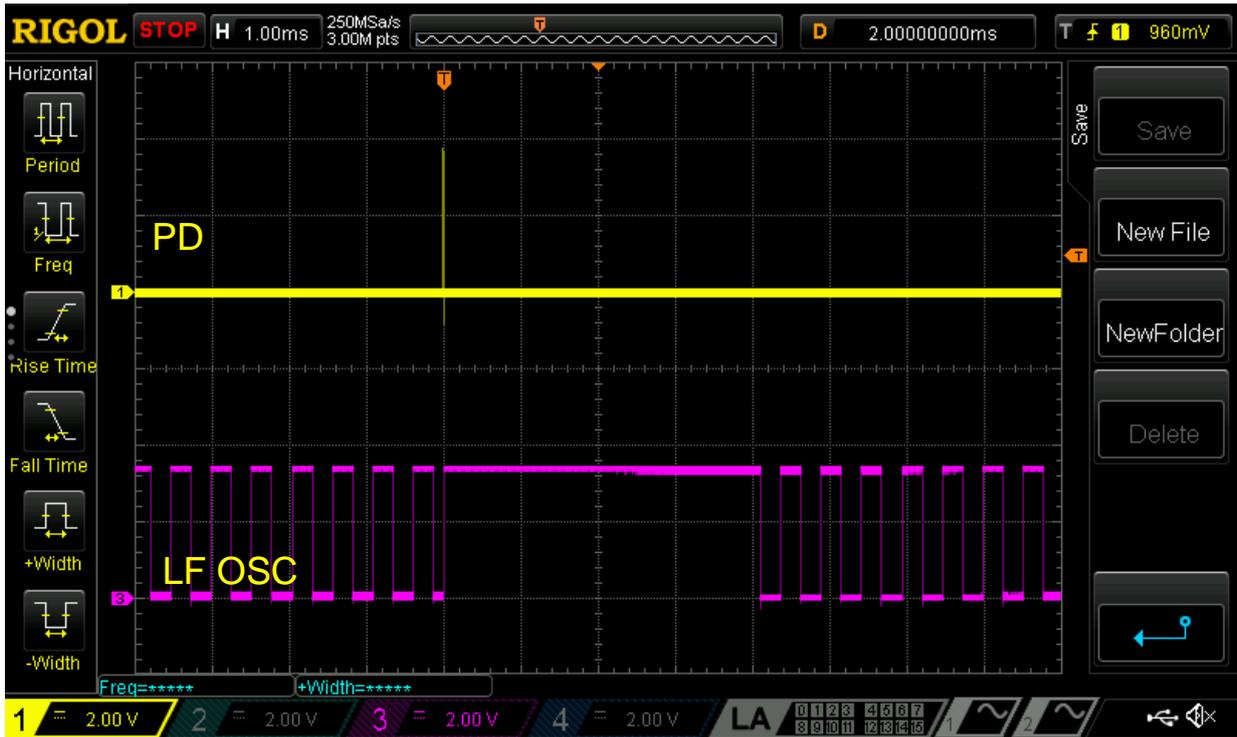
Figure 14. 1.9 kHz OSC Long Start-Up

If a pulse with a duration of less than ~40 ns is applied to the PWR DOWN input of the oscillator, the oscillator outputs remain stuck for milliseconds, as shown in Figure 14, Figure 15 and Figure 16. The issue is observed for all available oscillators.
