Customer Notification

V850E/PH03

32-Bit Single-Chip Microcontrollers

Operating Precautions

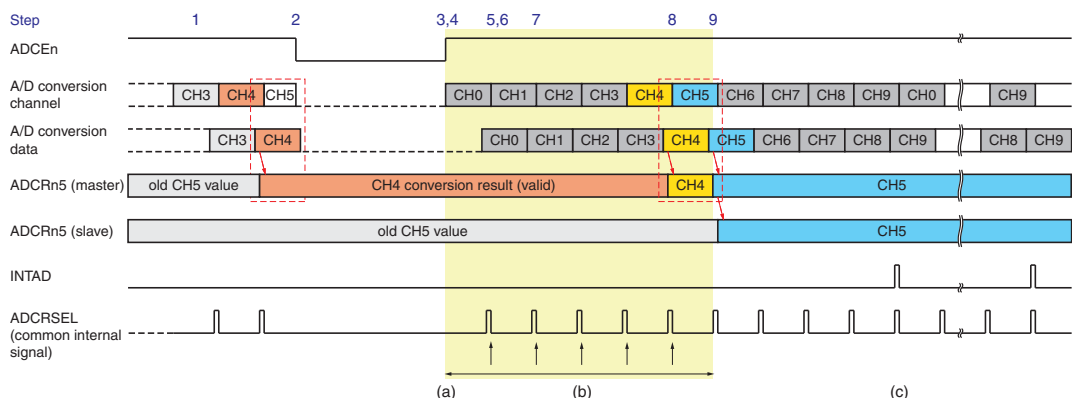
No. 14 ADC: When reading the ADCRnm registers asynchronously the conversion result from previous channel might be provided. (Specification change notice)

When the concerned conversion result register (ADCRnm) is read during the conversion time, the conversion result of the previous channel may be read, if at that time the internal ADCRSEL signal is active (for an ADC clock period of 62.5 ns).

When an ADCRnm register is read between steps 3 to 9, the result of the previous channel might be read until the conversion of the concerned channel has been finished the first time, e. g. ADCRn0 can be read properly from step 6 on.

- (a) Restart of A/D converter.
- (b) For instance when ADCRn₅ register is read after restart of the A/D converter during period (b) at the timing of an active ADCRSEL signal (1 x ADCLK = 62.5 ns), the conversion result may be read from ADCRn₅ master register, which holds the result of the previous channel 4 at that time, rather than from the ADCRn₅ slave register.
- (c) After first INTADn occurrence, proper read of all ADCRn_m registers is ensured.

When the ADC is stopped asynchronously during scan mode operation apply one of the following three procedures when reading the conversion results after reconfiguration and restart of the ADC.

- Use DMA transfer to obtain AD conversion results (ADDMA_n register).
- Read ADCRn_m registers in a corresponding INTADn service routine.
- Synchronize the first read of ADCRn_m registers with the first occurrence of the INTADn interrupt after restart of the ADC (without applying an interrupt service routine)
 - Clear ADICn.IF flag during reconfiguration and check ADICn.IF flag before reading the ADCRn_m registers.
 - In case of external or timer trigger ensure that the period b/w two consecutive trigger events is greater than the scan period of all selected channels. (refer to precaution 15.8 (2) in UM)
