[Notes]

CS+ Code Generator for RL78 (CS+ for CC)

e² studio Code Generator Plug-in

1. Peripheral I/O redirection register 0 (PIOR0)

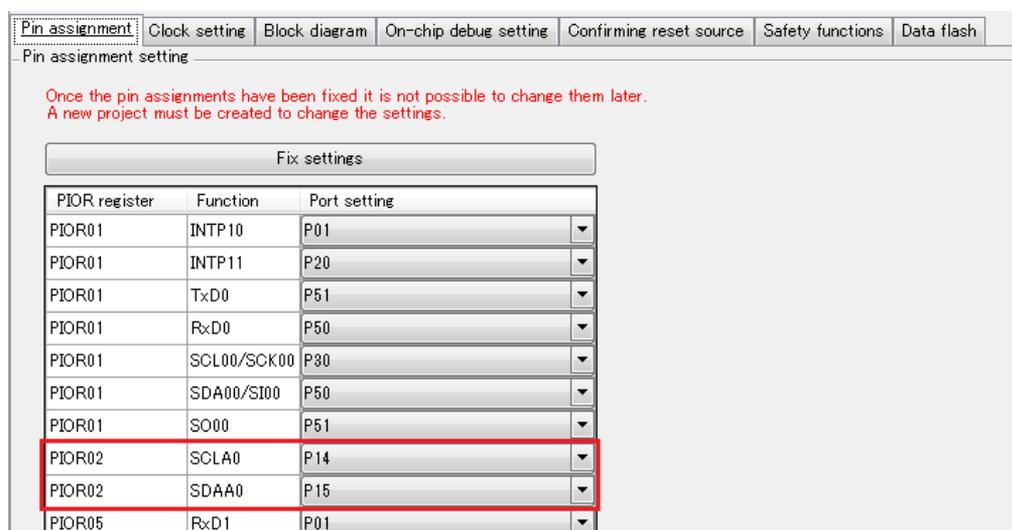
Regarding the common and clock generation circuit pin assignments, code generated by the tools listed above will have an error when the pin assignment setting of bit PIOR02 in the PIOR register should assign the SCLA0 and SDAA0 functions to pins P14 and P15. Thus, the serial interface IICA cannot be used.

Correct the setting of peripheral I/O redirection register 0 (PIOR0) in the following function: “void R_Systeminit(void)” in the source file “r_cg_systeminit.c”.

This modification is required every time code is generated.

An example of the correction so that only PIOR02 is changed (only PIOR02 is set to 1) is shown below. The red text is the modification.
