R20TS0747EC0100

# CS+ Code Generator for RH850, AP4 Coding Assistance Tool for RH850

1. Notes on using CSH Master receive and Master transmit/receive operation mode

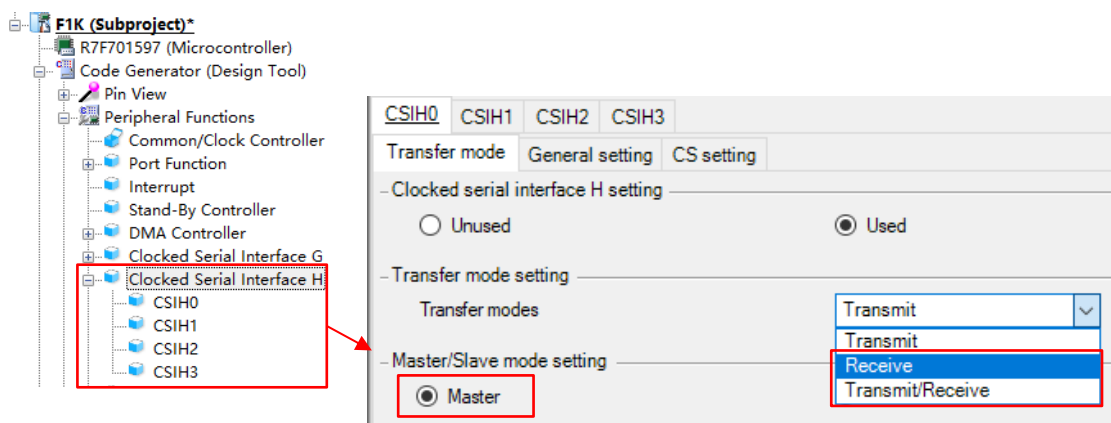
Figure 1-1 Setting of CSH operation mode

When using CSH as Master “Receive” and Master “Transmit/Receive” mode (refer to figure 1-1), master can only receive the first data correctly. From the second data, master fails to receive.

- RH850/F1K:  
CSIH0, CSH1, CSH2, CSH3

User can manually modify the register setting code in the following source file

- Source file: “r\_cg\_csih\_user.c”.
- Function: “void r\_<csihn>\_interrupt\_receive (void)”

The following is an example of the required modification when *<csihn>* is CSIH0 in the RH850/F1K group. The code in red color is wrong code before modification, while the code in blue color is correct code after modification.

```
void r_Config_CSIH0_interrupt_receive(void)
{
    uint8_t err_type;
    uint16_t temp;
    .....
    else
    {
        temp = g_csih0_rx_total_num;
        if (temp > g_csih0_rx_num)
        {
            *gp_csih0_rx_address = CSIH0.RX0W;
            gp_csih0_rx_address++;
            g_csih0_rx_num++;
            CSIH0.TX0W |= 0U;          --> change "=" to "|="
        }
        .....
    }
}
```
