Product part number: SLG46400

Active SLG46400 Errata List

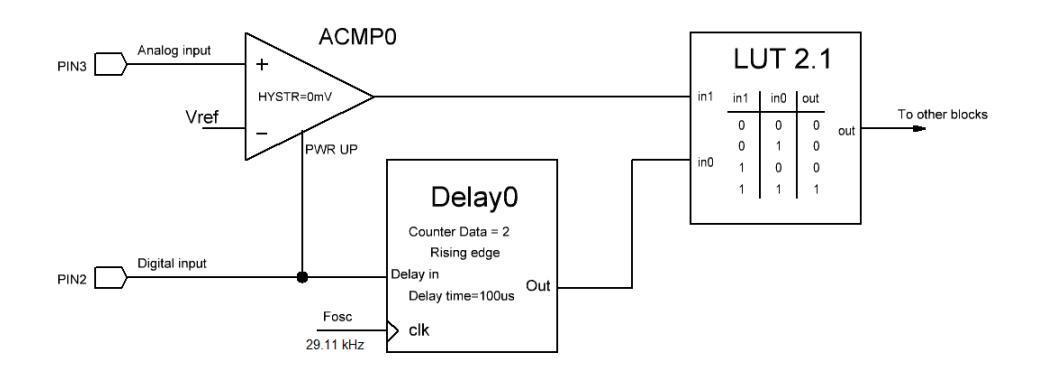
ISSUE 5: ACMP dynamic on/off glitches

ACMP will have glitches on its output after being turned on during 100us maximum.

Use 100us Deglitch Delay on the ACMP output (typically 100us both edges delay) or make a system
of 100us rising edge Delay block and LUT to reject the ACMP output for 100us after its power up (See
example below)

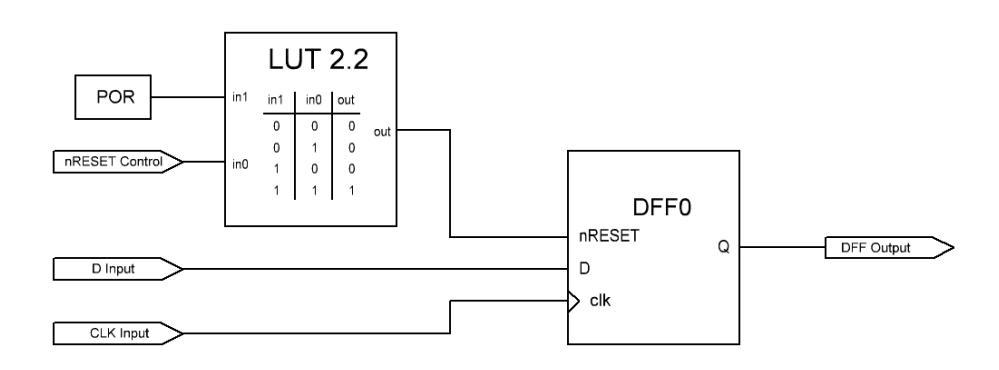
ISSUE 14: DFF incorrect startup

DFFs with nREST/nSET can start (initialize) with different output states.

• Set DFF initial state before POR signal appears. Use similar connections as shown below

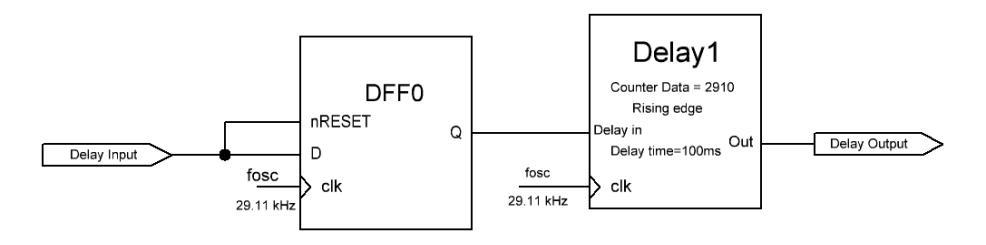
ISSUE 16: Incorrect Delay time

If the input edge of the Delay (or reset of Counter) is very close (<1ns) to the rising edge of the sourced clocking signal (RC OSC is Forced Power On or operating because another blocks request) the Counter/Delay cell might have incorrect Counter Data loaded.

• Use synchronization block on the Counter/Delay input, similar to that shown below. In case of Rising Edge Delay:

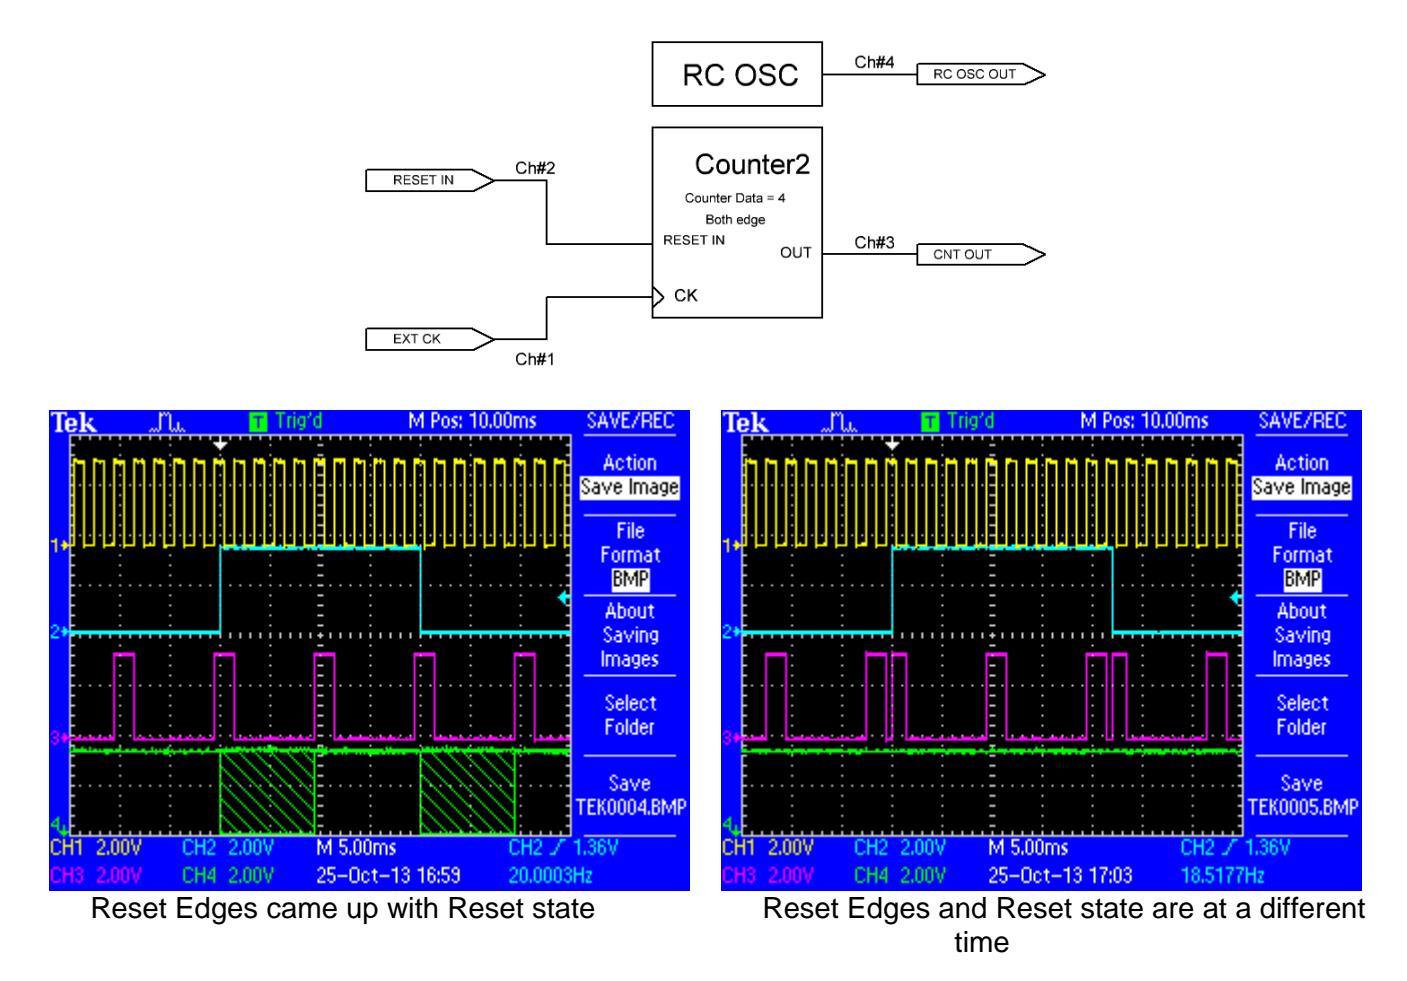
ISSUE 18: Counter with external clock starts internal RC OSC operation when reset

CNT2 and CNT3 (FSM0 and FSM1) have a possibility to be sourced from external RC OSC signal and have RESET signal at the same time. While block is in a reset state (when finished counting cycle and output is logic HIGH) and the defined RESET edge appears the internal RC OSC will start its operation until counter enters the next reset state.

Currently there is no universal workaround. If the RSC should be powered down all the time its Shared Power Down can be set to be controlled from matrix and SHARED PD input connected to HIGH level source.
