PG-FP4

Operating Precautions

Operating Precautions for PG-FP4

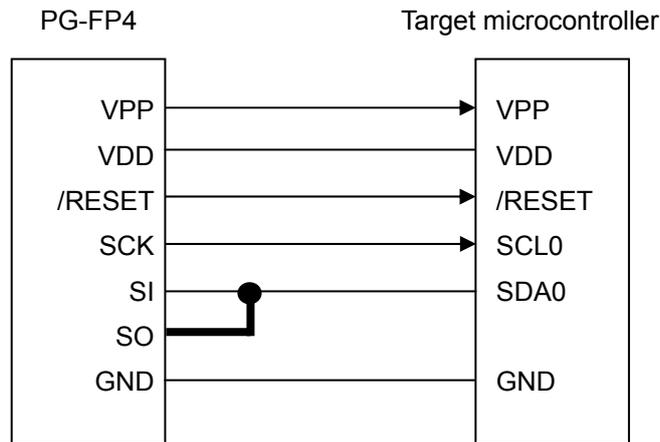
When using IIC communication mode with PG-FP4 control code B, short the SI and SO pins in the PG-FP4.

The IIC communication mode adapter board is included in products with control code C (firmware: V1.17, GUI: V2.00) and later. Use the IIC communication mode adapter board for IIC communication.
