e² studio Smart Configurator Plug-in,

R20TS0696ES0100 Rev.1.00 May. 16, 2021

Smart Configurator for RX

RENESAS TOOL NEWS

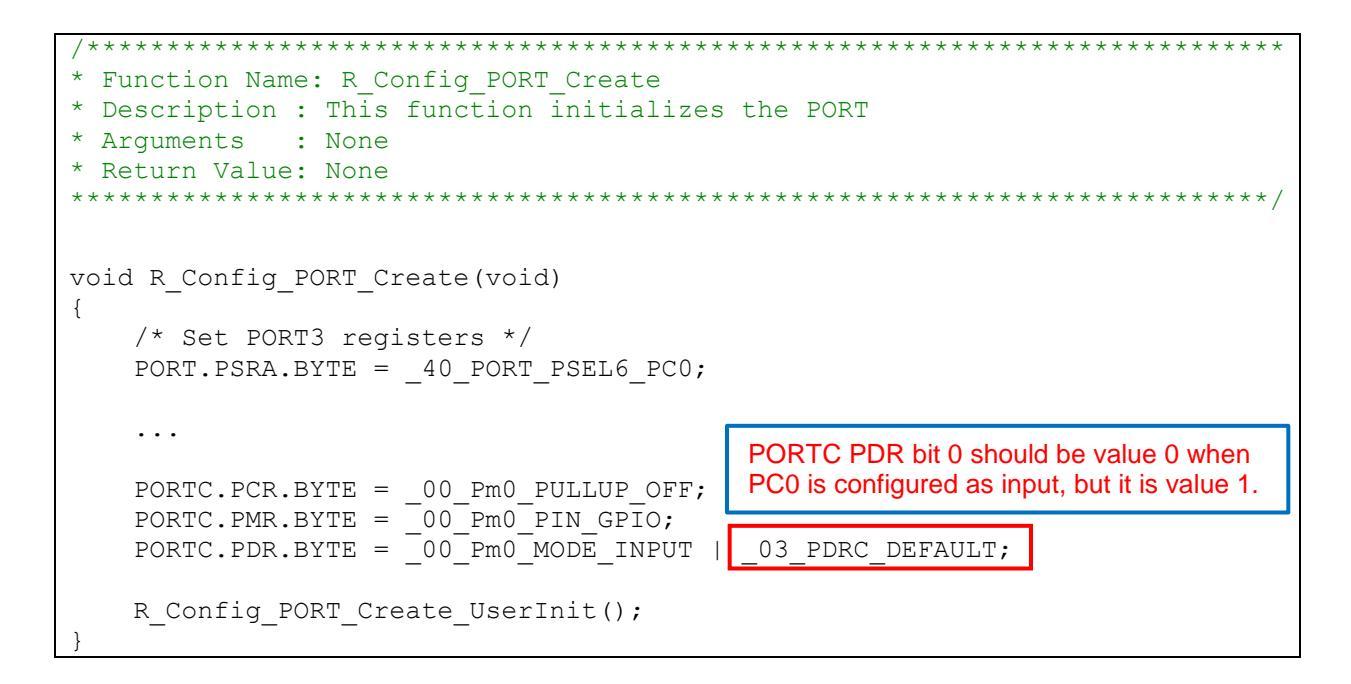
When using PORT component and configuring PORTC multiplexed pins as input, the generated code for PDR register is wrong, its bit 0 should be set to value 0 instead of value 1.

Figure 1.1 Configure PC0 as input for PORT component (RX130 64 pin)

Manually update corresponding bit value from 1 to 0 for this PDR register generated code, e.g. for the PC0, macro name should be updated from "_03_PDRC_DEFAULT" to "_02_PDRC_DEFAULT" and its value should also be updated from "0x03U" to "0x02U" in the "r_cg_port.h" generated file.
