[Notes]

R20TS1168ES0100

e² studio Smart Configurator Plug-in, Smart Configurator for RX

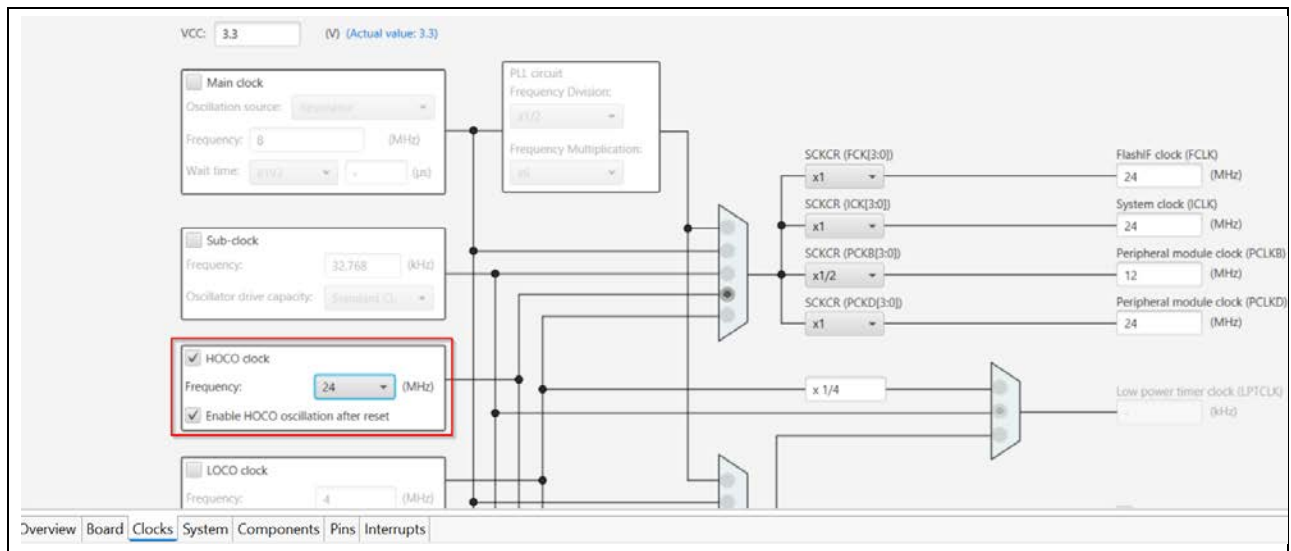
- Create an RX140 or RX260 or RX261 project
- Go to Clocks tab
- Select "HOCO clock"
- Change Frequency value
- Select "Enable HOCO oscillation after reset"
- Save and close project
- Reopen Smart Configurator project

Figure 4. Change HOCO frequency and select "Enable HOCO oscillation after reset" and

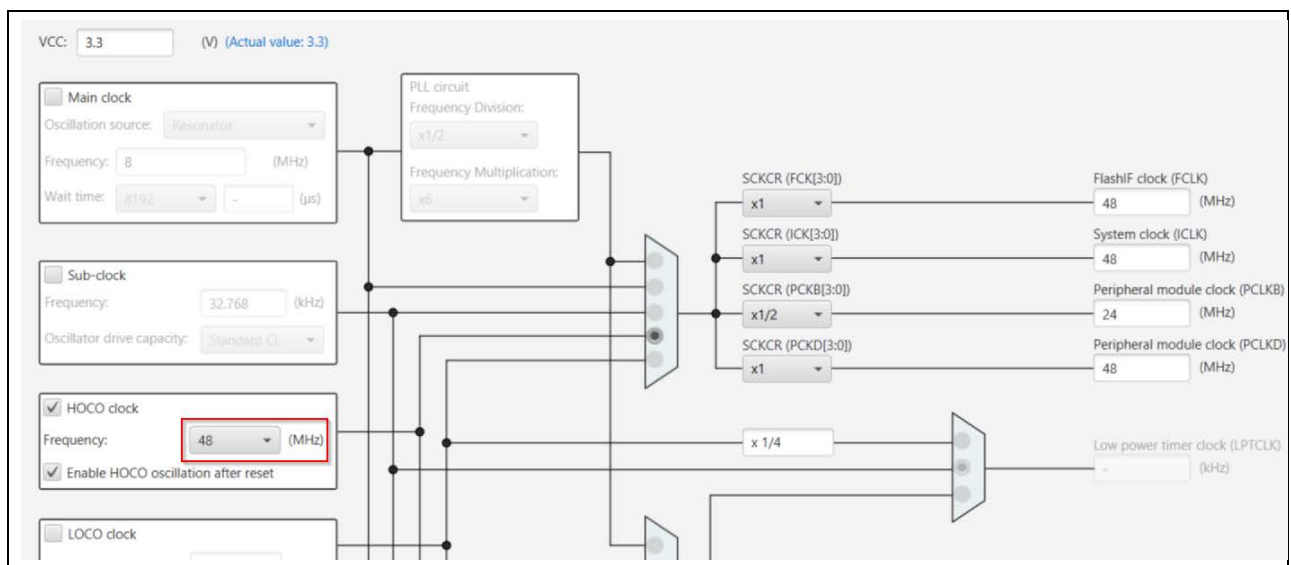
HOCO frequency is changed when reopening the Smart Configurator project under the conditions specified in section 2.4.

Figure 5. HOCO frequency is changed when reopening the project

When reopening the Smart Configurator project under the conditions specified in section 2.4, set HOCO frequency again if it has changed.

This problem will be fixed in the following product versions, scheduled for release in Oct. 2025.
