SLG4653x Errata

CE-GP-002

This document contains the known errata for SLG46533, SLG46534, SLG46535, SLG46536, SLG46537, SLG46538 and the recommended workarounds.

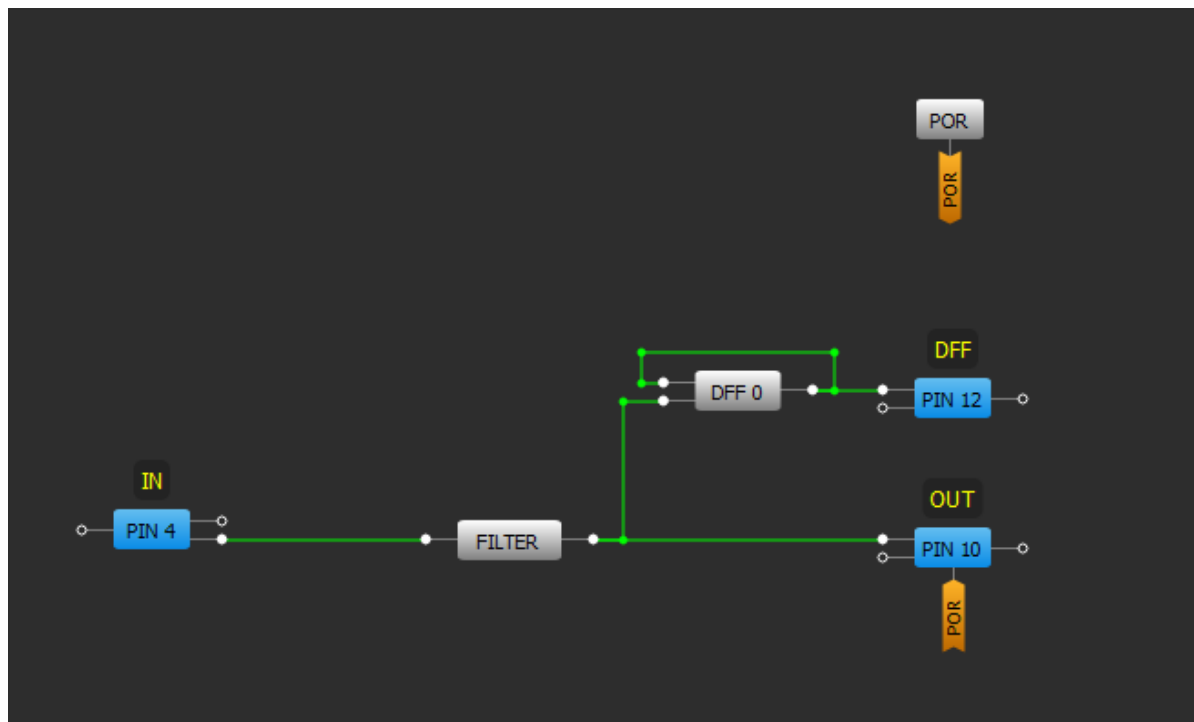
Figure 4

If clock type high frequency input comes in, the FILTER cell may not filter out it. There are several factors like input frequency, duty cycle, and LOW duration in such signal that may lead to its passing through FILTER block.

Channel 1 (yellow/top line) – PIN#4 (IN).

Channel 2 (light blue/2nd line) – PIN#10 (OUT).

Channel 3 (magenta /3rd line) – PIN#12 (DFF).

Currently there is no workaround for this issue. Filter block is good at filtering short spontaneous glitches. It is intended to be used in series connection before the delay cell to avoid its latching.

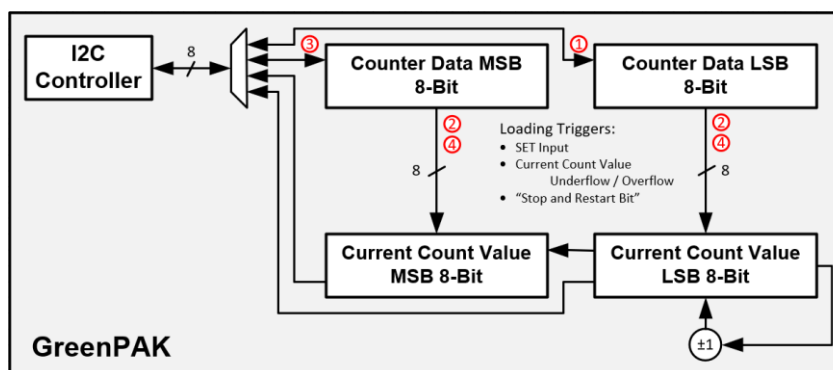
Figure 11: 16-Bit I2C Counter Block Diagram

As previously mentioned, the 16-bit value is loaded from the I2C buffers to the Counter Data registers in 8-bit chunks. Right at time “1”, the LSB byte (0x01) is loaded into the Counter Data registers. This makes the Counter Data value temporarily equal to 0x0001. At time “2” between the internal I2C load signals, the counter receives a rising edge on its clock input. This causes the Current Count Value to underflow and to be loaded with the Counter Data value which is 0x0001. At time “3”, the MSB byte (0x01) is loaded into the Counter Data registers setting the Counter Data value to 0x0101. At time “4”, the Current Count Value underflows again and is set to the Counter Data value of 0x0101.

This behavior results in two output pulses on OUT when only one pulse is expected. Observing this behavior depends upon the asynchronous timing between the counter's clock and the I2C write command to the Counter Data registers. For some applications, the extra pulse on OUT can be ignored and the counter will self-correct after underflowing, overflowing, or being SET/RESET through the GreenPAK connection matrix.

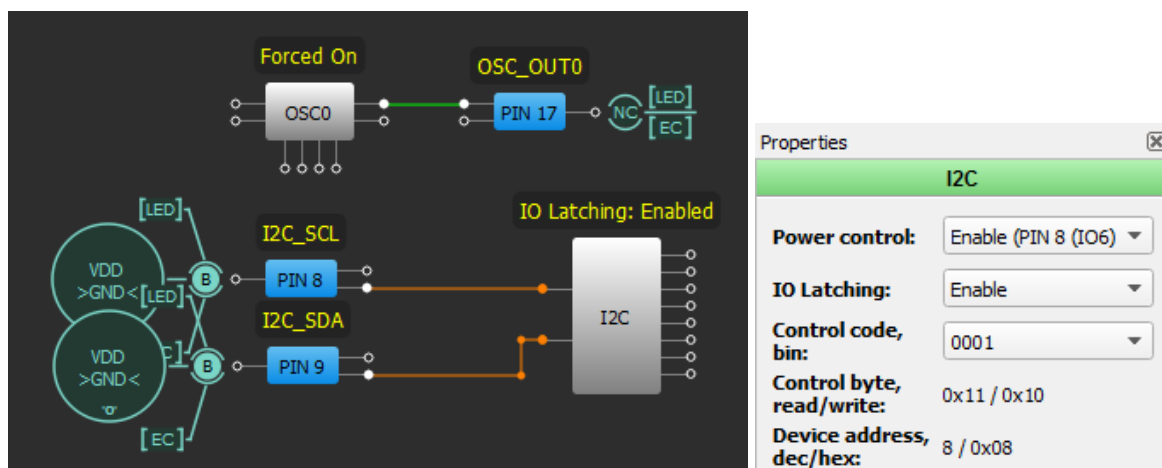
Figure 13

The GreenPAK device does not check for a matching I2C Target address condition before triggering 'IO Latching'. A Start bit on the I2C bus will trigger IO Latching. A Start bit is when I2C\_SDA goes low first followed by I2C\_SCL going low after.

In the example below, we will be monitoring the OSC output, which is measured by a scope on Channel 3 via PIN17 ("OSC\_OUT0"). The I2C bus will be forced low to create a START bit.

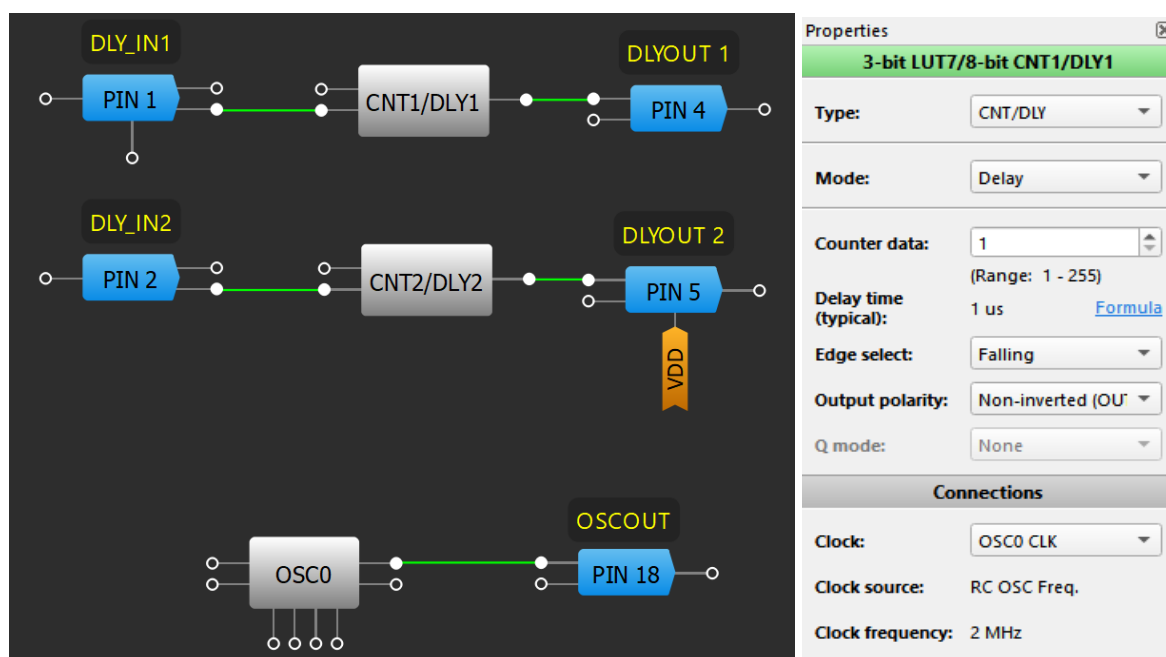
Figure 16: Test Circuit

For this chip, the Auto Power On circuitry of the 25 kHz/2 MHz generators contains a circuit errata, which can potentially fail to power on the OSC for a specific pattern and timing of the OR of all related DLY trigger signals. The pattern is shown in [Figure 15](#) (boxed in red) and consists of a relatively longer pulse (~145 ns) followed by a shorter (~5 ns) glitch of opposite polarity.

The error is difficult to capture as the timing must be exact within ns, and short (ns) pulses are difficult to generate glitch precise enough to induce the problem. GPIO naturally filter out ns pulses, so for purposes of errata capture, two simultaneous falling-edge DLY circuits (as shown in [Figure 16](#)) were used. By lining up two delays precisely at a particular timing relationship, we can use the internal Auto Power On (OR logic) to generate the glitch pattern necessary to cause the error.

1. Use signal conditioning circuits to prevent glitch on DLY inputs < 200 ns. Examples:
  - a. ACMP with Hysteresis
  - b. External RC in front of Digital Input with Schmitt Trigger
  - c. Filter cell.
2. Set OSC power mode to Force Power On mode instead of Auto Power On.
3. Use different oscillator, such as 25 MHz Ring OSC, which does not have Auto Power On issue.

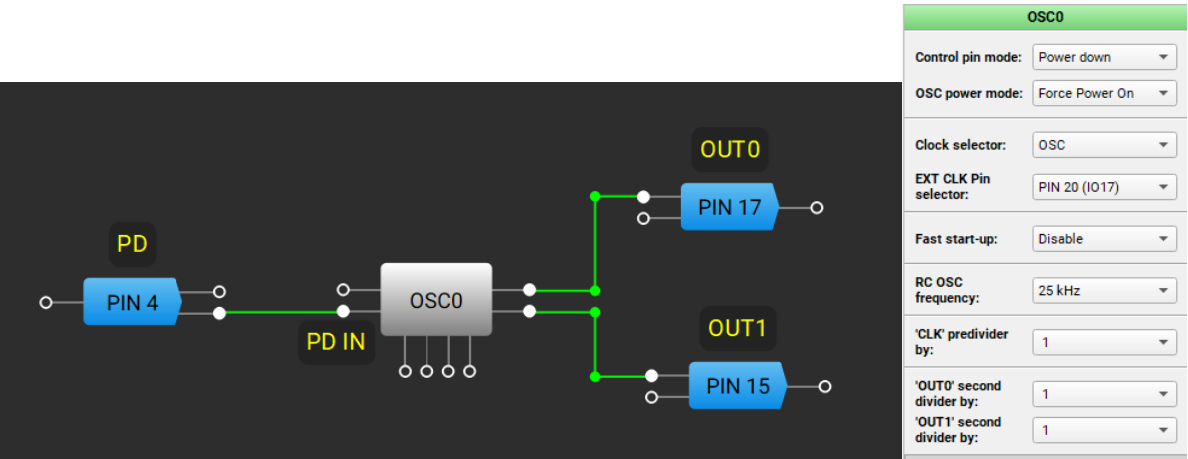
Figure 19. Test Design

When a short pulse of less than ~40 ns is applied to the PWR DOWN input.

Use the “Force power on” OSC power control option to make the OSC operate at all times. However, this will cause increased constant current consumption.

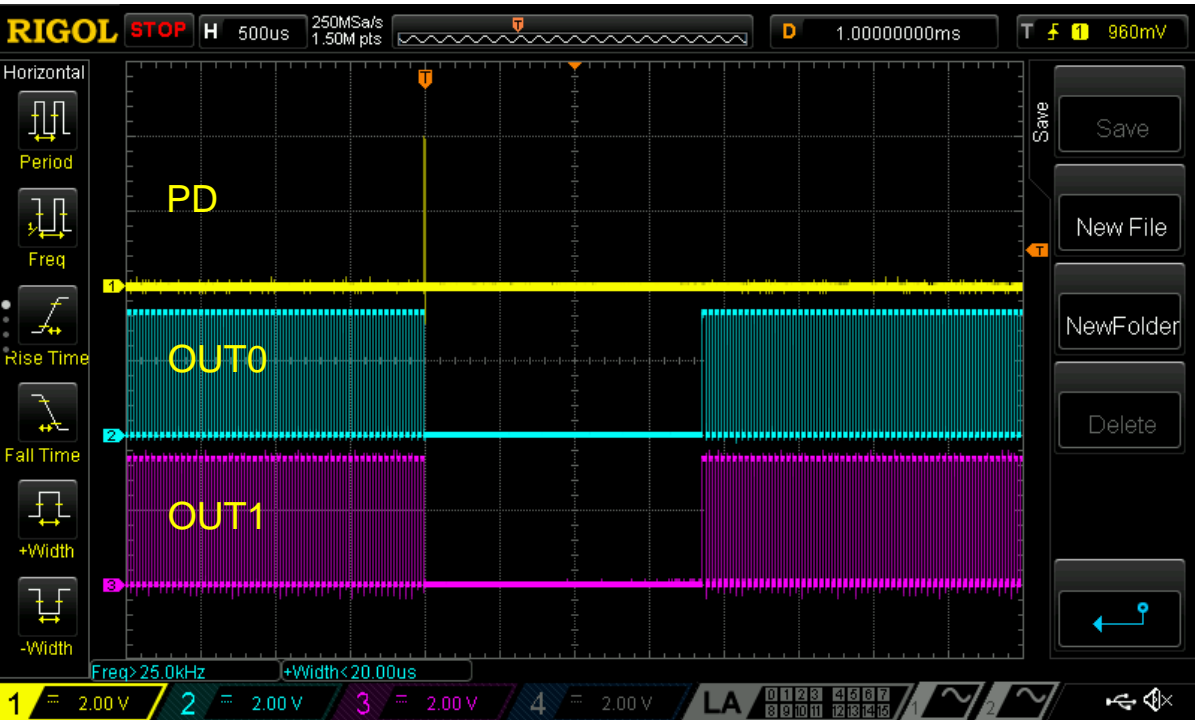
If a pulse with a duration of less than ~40 ns is applied to the PWR DOWN input of the oscillator, the oscillator outputs remain stuck for milliseconds, as shown in figures below. The issue is observed for all available oscillators.
