SLG4653x Errata

CE-GP-002

This document contains the known errata for SLG46533, SLG46534, SLG46535, SLG46536, SLG46537, SLG46538 and the recommended workarounds.

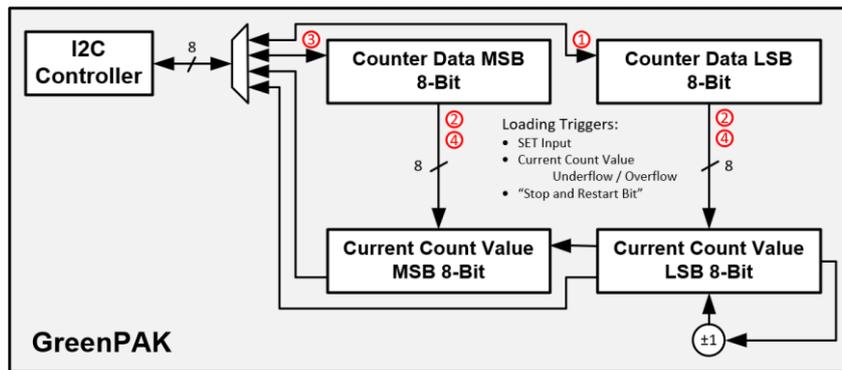
Figure 11: 16-Bit I2C Counter Block Diagram

As previously mentioned, the 16-bit value is loaded from the I2C buffers to the Counter Data registers in 8-bit chunks. Right at time “1”, the LSB byte (0x01) is loaded into the Counter Data registers. This makes the Counter Data value temporarily equal to 0x0001. At time “2” between the internal I2C load signals, the counter receives a rising edge on its clock input. This causes the Current Count Value to underflow and to be loaded with the Counter Data value which is 0x0001. At time “3”, the MSB byte (0x01) is loaded into the Counter Data registers setting the Counter Data value to 0x0101. At time “4”, the Current Count Value underflows again and is set to the Counter Data value of 0x0101.

This behavior results in two output pulses on OUT when only one pulse is expected. Observing this behavior depends upon the asynchronous timing between the counter’s clock and the I2C write command to the Counter Data registers. For some applications, the extra pulse on OUT can be ignored and the counter will self-correct after underflowing, overflowing, or being SET/RESET through the GreenPAK connection matrix.
