SLG46108-EV Errata Note

This document contains the known errata for SLG46108-EV and the recommended workarounds.

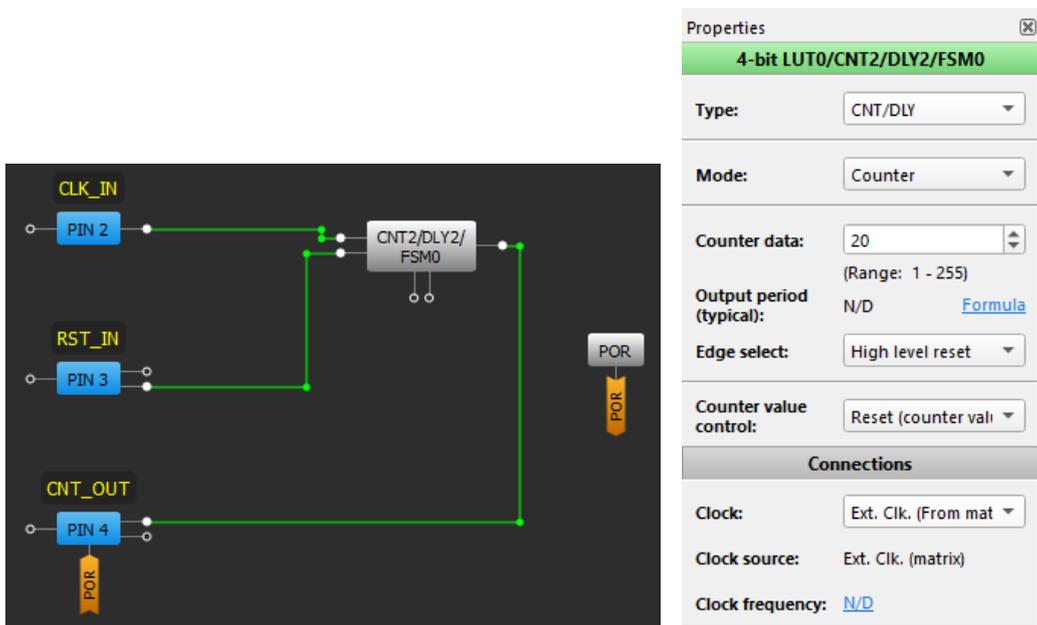
Figure 1. Testing Design and Settings

If the Counter Reset is asserted at the same time as a rising clock edge, it is possible that the Counter Data will be reset incorrectly and the counter output may appear faster than expected, it doesn't depend on the edge select option. This phenomenon appears more often as the clock frequency increases.

Synchronize the RESET input of the Counter with its CLK using 2 DFF cells as shown in [Figure 3](#).

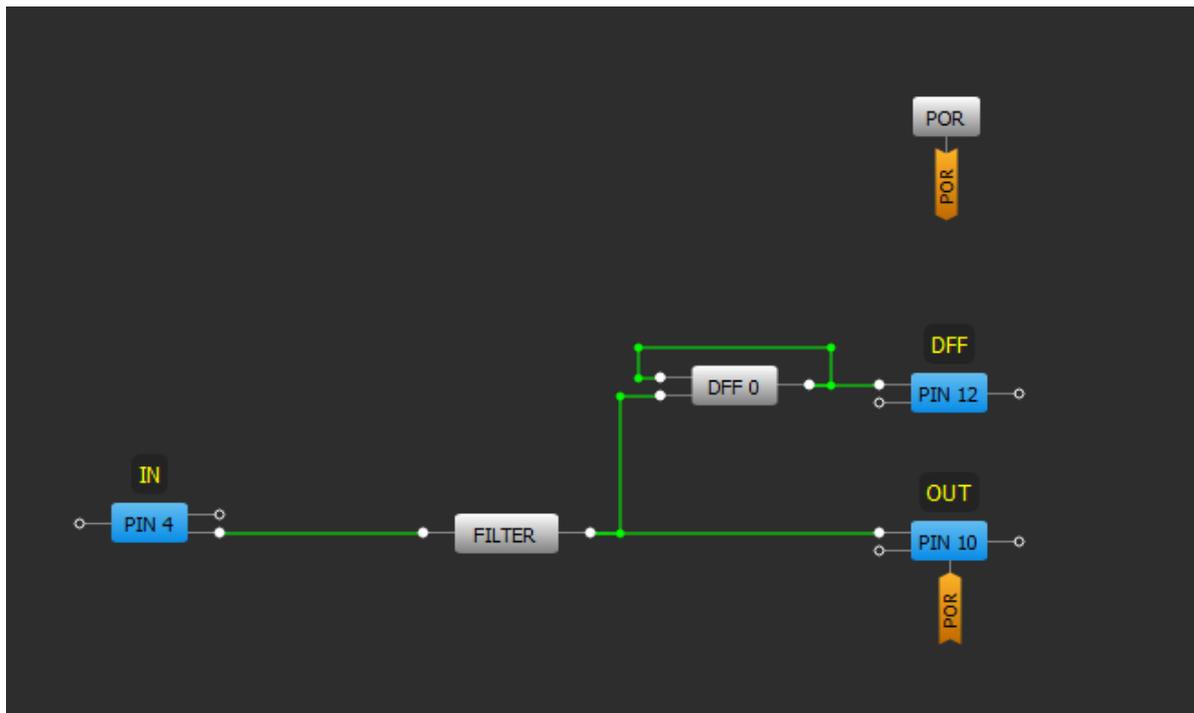
Figure 6. Testing Design

If high-frequency clock input comes in, the FILTER cell may not filter out it. There are several factors like input frequency, duty cycle, and LOW duration in such signal that may lead to its passing through the FILTER block.

Currently, there is no workaround for this issue. Filter block is good at filtering short spontaneous glitches. It is intended to be used in a series connection before the delay cell to avoid its latching.

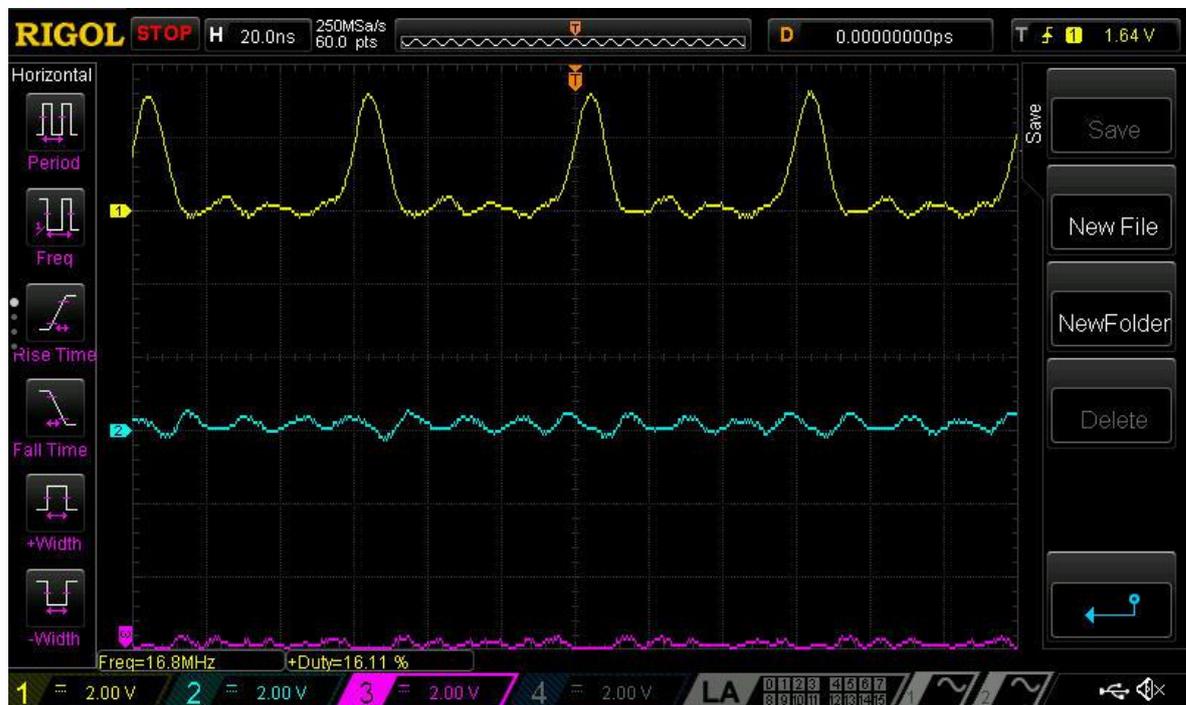
Figure 7. Output Waveforms at Period = 60 ns, Pulse Width = 10 ns, DC = 16.7 % (Correct Functionality)

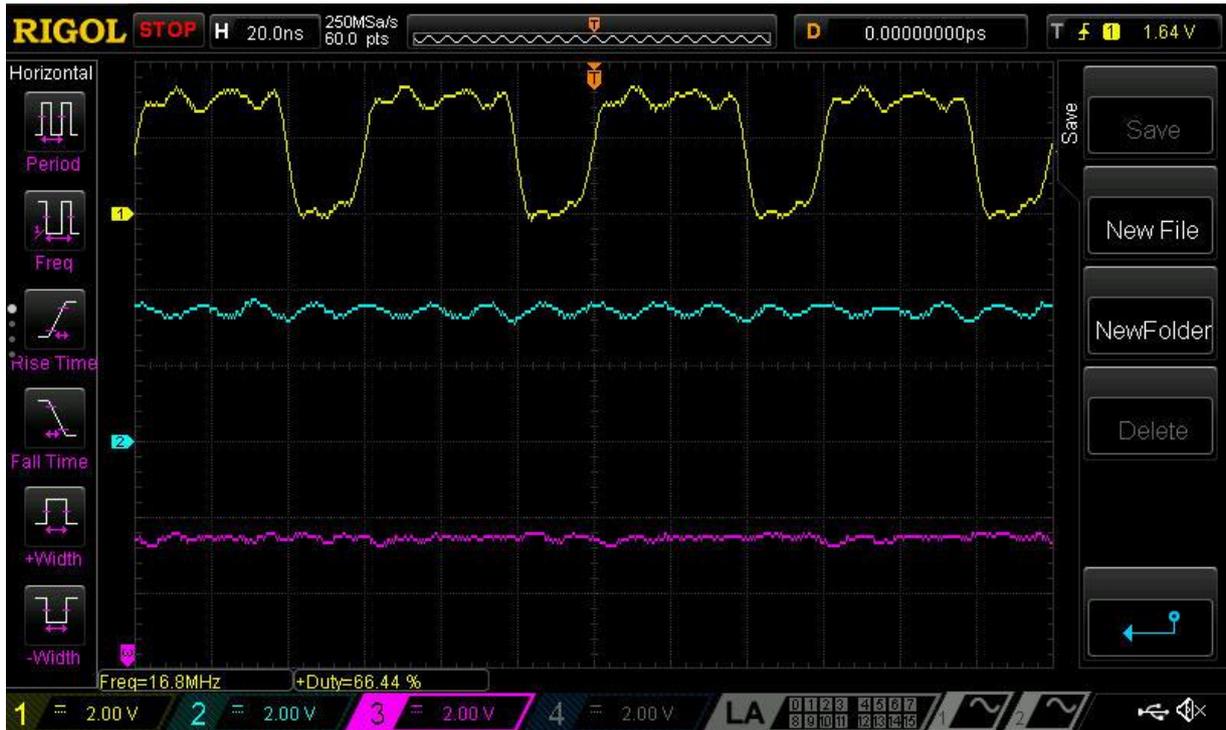
Figure 10. Output Waveforms at Period = 60 ns, Pulse Width = 40 ns, DC = 66.67% (Correct Functionality)

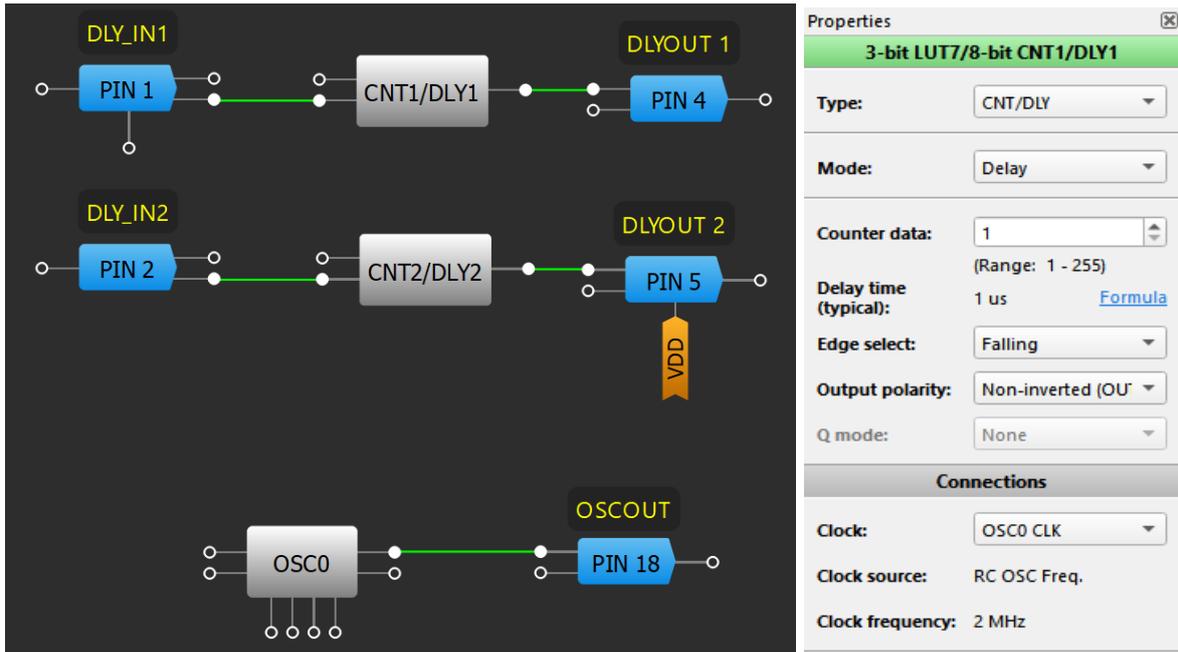
Figure 12. Test Circuit

For this chip, the Auto Power On circuitry of the 25 kHz/2 MHz generators contains a circuit errata, which can potentially fail to power on the OSC for a specific pattern and timing of the OR of all related DLY trigger signals. The pattern is shown in Figure 11 (boxed in red) and consists of a relatively longer pulse (~145 ns) followed by a shorter (~5 ns) glitch of opposite polarity.

The error is difficult to capture as the timing must be exact within ns, and short (ns) pulses are difficult to generate glitches precise enough to induce the problem. GPIO naturally filters out ns pulses, so for purposes of errata capture, two simultaneous falling-edge DLY circuits (as shown in Figure 12) were used. By lining up two delays precisely at a particular timing relationship, we can use the internal Auto Power On (OR logic) to generate the glitch pattern necessary to cause the error.

- Use signal conditioning circuits to prevent glitches on DLY inputs < 200 ns. Examples:
 - ACMP with Hysteresis
 - External RC in front of Digital Input with Schmitt Trigger
 - Filter cell.
- Set OSC power mode to Force Power On mode instead of Auto Power On.
- Use a different oscillator, such as 25 MHz Ring OSC, which does not have Auto Power On issue.

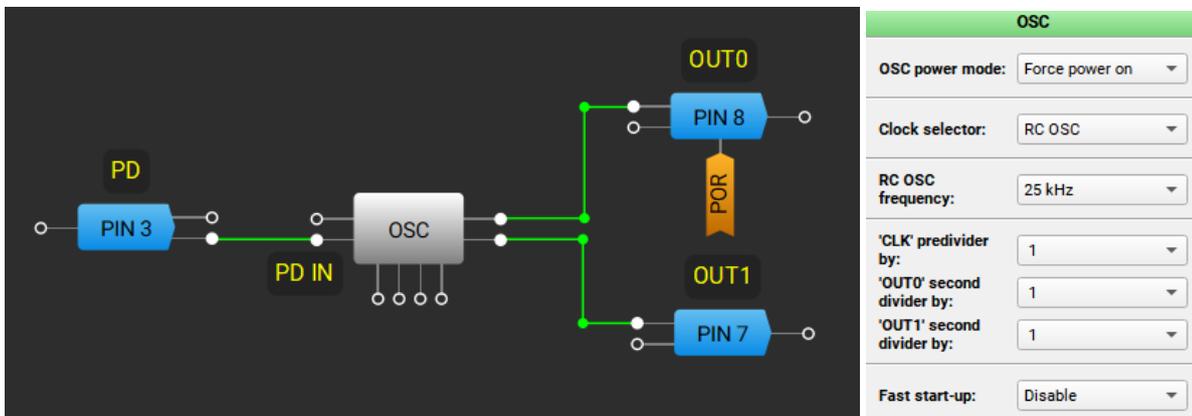
Figure 15. Test Design

When a short pulse of less than ~40 ns is applied to the PWR DOWN input.

If a pulse with a duration of less than ~40 ns is applied to the PWR DOWN input of the oscillator, the oscillator outputs remain stuck for milliseconds, as shown in Figure 16 and Figure 17. This issue is observed for both 25 kHz and 2 MHz oscillators.
