Errata

SLG46121

CE-GP-019

This document contains the known errata for SLG46121 and the recommended workarounds.

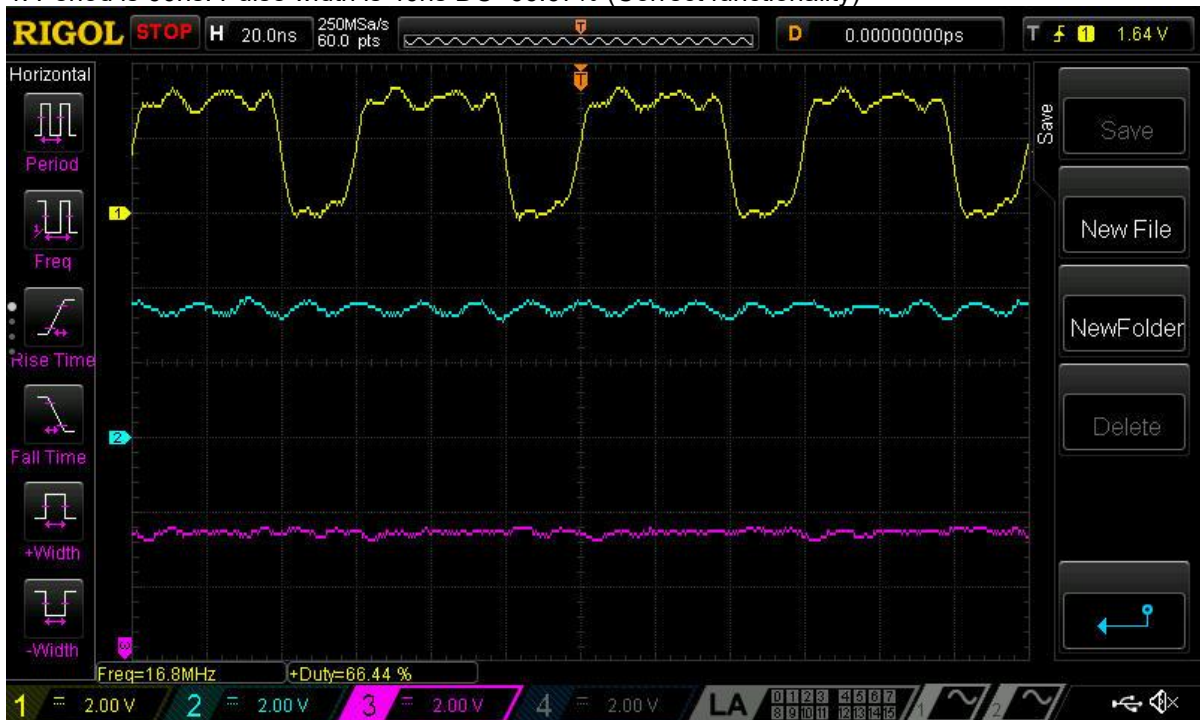
4. Period is 60ns. Pulse width is 40ns DC=66.67% (Correct functionality)

3.5.4 Workaround

Currently there is no workaround for this issue. Filter block is good at filtering short spontaneous glitches. It is intended to be used in series connection before the delay cell to avoid its latching (see issue #5).
