# Errata

## SLG46517

### CE-GP-001

*This document contains the known errata for SLG46517 and the recommended workarounds.*

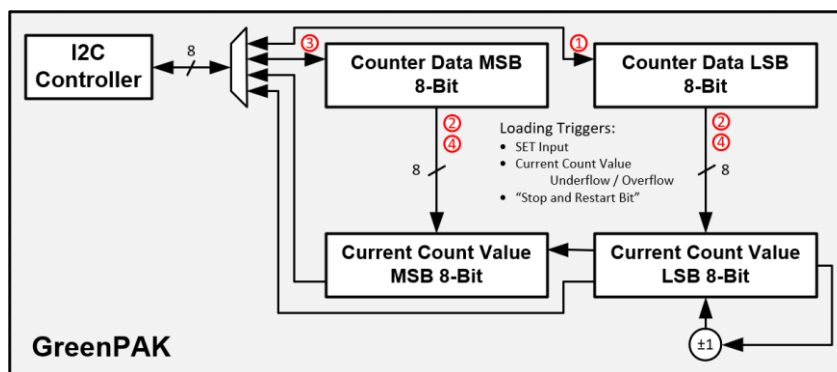
**Figure 11: 16-Bit I2C Counter Block Diagram**

As previously mentioned, the 16-bit value is loaded from the I2C buffers to the Counter Data registers in 8-bit chunks. Right at time “1”, the LSB byte (0x01) is loaded into the Counter Data registers. This makes the Counter Data value temporarily equal to 0x0001. At time “2” between the internal I2C load signals, the counter receives a rising edge on its clock input. This causes the Current Count Value to underflow and to be loaded with the Counter Data value which is 0x0001. At time “3”, the MSB byte (0x01) is loaded into the Counter Data registers setting the Counter Data value to 0x0101. At time “4”, the Current Count Value underflows again and is set to the Counter Data value of 0x0101.

This behavior results in two output pulses on OUT when only one pulse is expected. Observing this behavior depends upon the asynchronous timing between the counter's clock and the I2C write command to the Counter Data registers. For some applications, the extra pulse on OUT can be ignored and the counter will self-correct after underflowing, overflowing, or being SET/RESET through the GreenPAK connection matrix.

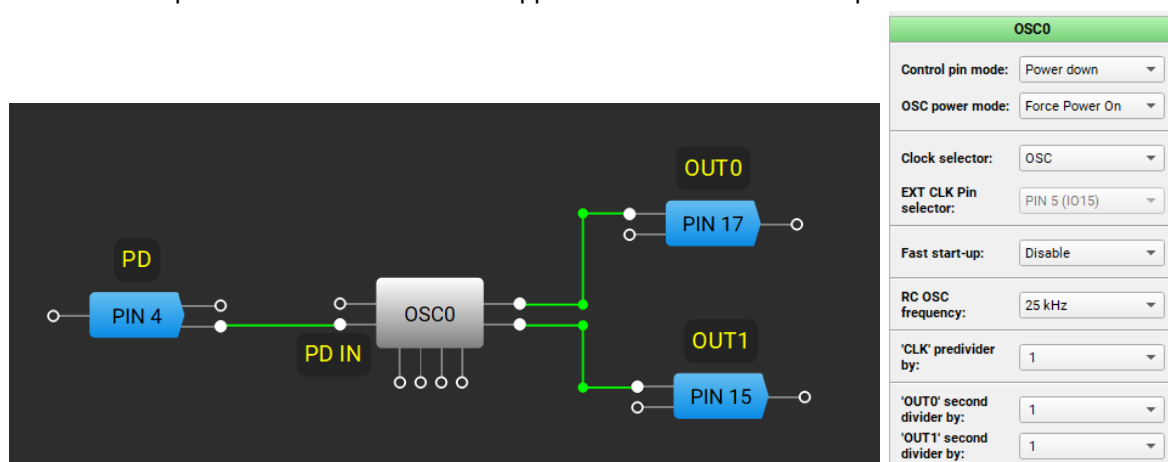
Figure 13. Test Design

When a short pulse of less than ~40 ns is applied to the PWR DOWN input.

If a pulse with a duration of less than ~40 ns is applied to the PWR DOWN input of the oscillator, the oscillator outputs remain stuck for milliseconds, as shown in figures below. The issue is observed for all available oscillators.
