SLG46538-A Errata Note

This document contains the known errata for SLG46538-A and the recommended workarounds.

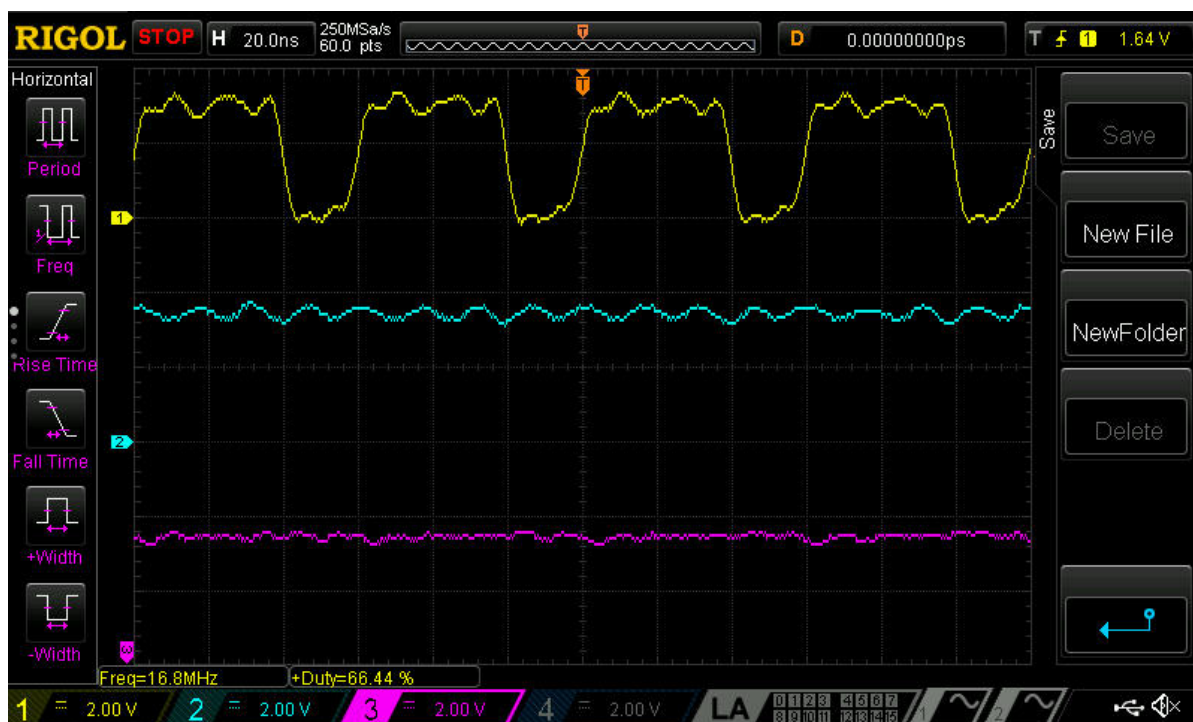
Figure 8

4. Period is 60 ns. Pulse width is 40 ns, DC = 66.67 % (correct functionality).

3.2.4. Workaround

Currently there is no workaround for this issue. Filter block is good at filtering short spontaneous glitches. It is intended to be used in series connection before the delay cell to avoid its latching.
