SLG46538-A Errata Note

This document contains the known errata for SLG46538-A and the recommended workarounds.

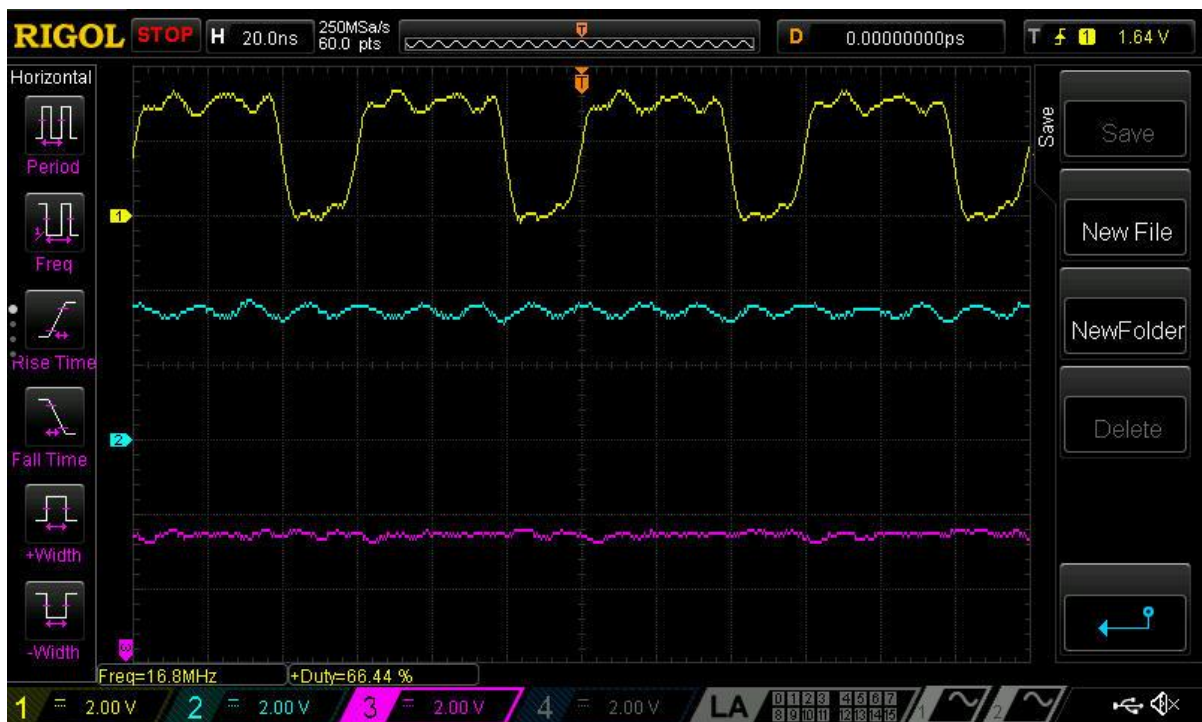
Figure 8

Currently there is no workaround for this issue. Filter block is good at filtering short spontaneous glitches. It is intended to be used in series connection before the delay cell to avoid its latching.

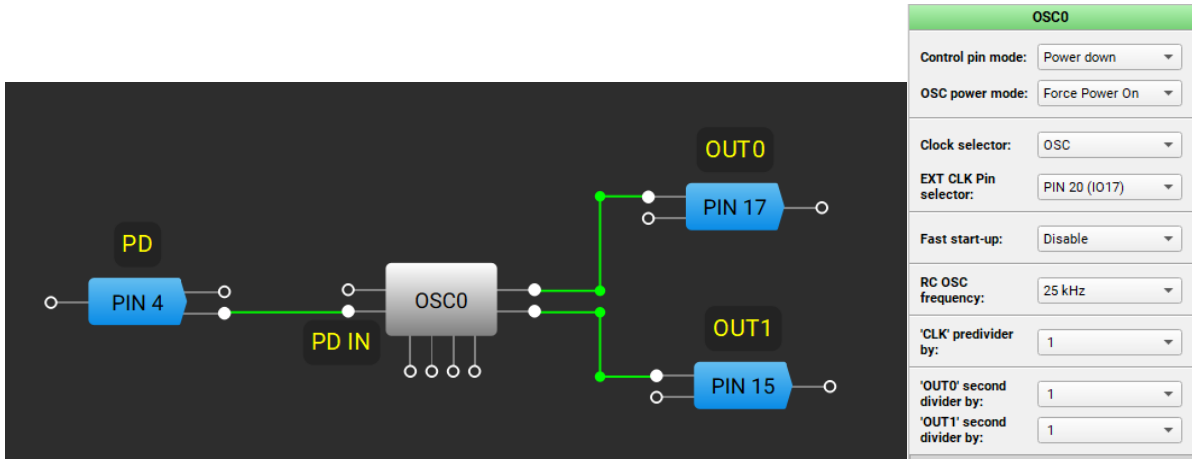
Figure 15. Test Design

When a short pulse of less than ~40 ns is applied to the PWR DOWN input.

If a pulse with a duration of less than ~40 ns is applied to the PWR DOWN input of the oscillator, the oscillator outputs remain stuck for milliseconds, as shown in Figure 16 and Figure 17. The issue is observed for all available oscillators.
