SLG4653x-E Errata Note

This document contains the known errata for SLG46533-E, SLG46534-E, SLG46535-E, SLG46536-E, SLG46537-E, SLG46538-E and the recommended workarounds.

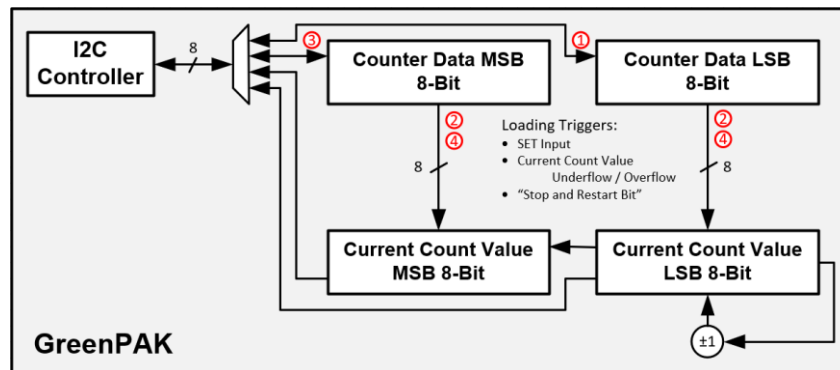
Figure 11. 16-Bit I²C Counter Block Diagram

This behavior results in two output pulses on OUT when only one pulse is expected. Observing this behavior depends upon the asynchronous timing between the counter's clock and an I²C write command to the Counter Data registers. For some applications, the extra pulse on OUT can be ignored and the counter will self-correct after underflowing, overflowing, or being SET/RESET through the GreenPAK connection matrix.

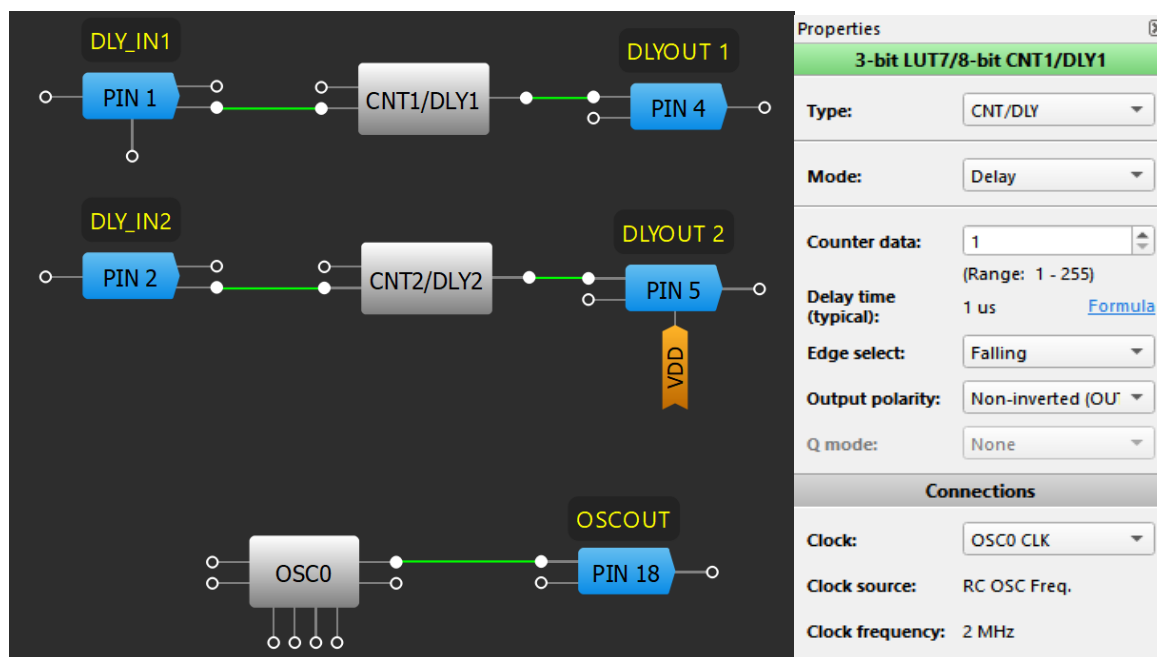
Figure 16. Test Circuit

The error is difficult to capture as the timing must be exact within ns, and short (ns) pulses are difficult to generate glitch precise enough to induce the problem. GPIO naturally filter out ns pulses, so for purposes of errata capture, two simultaneous falling-edge DLY circuits (as shown in Figure 16) were used. By lining up two delays precisely at a particular timing relationship, it can be used the internal Auto Power On (OR logic) to generate the glitch pattern necessary to cause the error.

1. Use signal conditioning circuits to prevent glitch on DLY inputs < 200 ns. Examples:
  - a. ACMP with Hysteresis

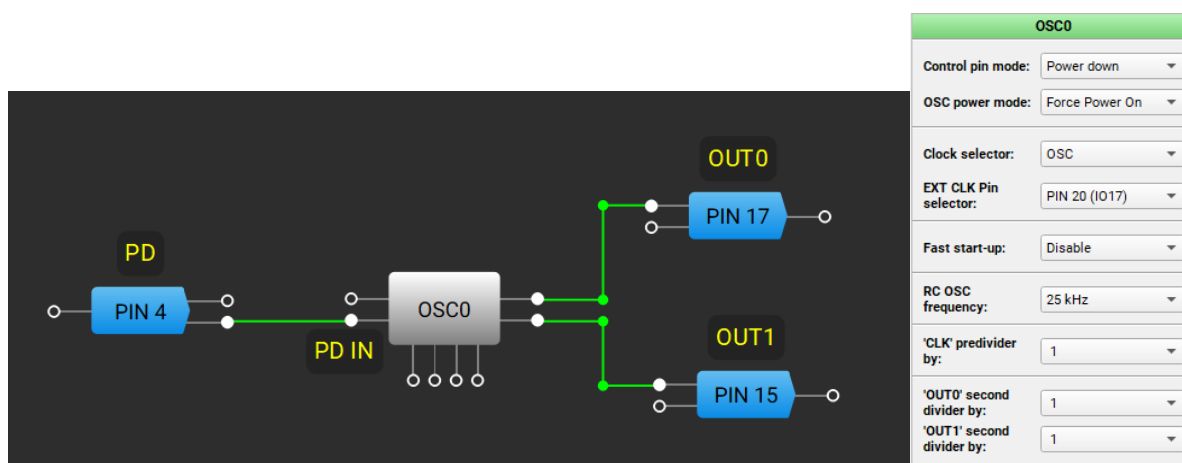
Figure 19. Test Design

If a pulse with a duration of less than ~40 ns is applied to the PWR DOWN input of the oscillator, the oscillator outputs remain stuck for milliseconds, as shown in [Figure 20](#) and [Figure 21](#). The issue is observed for all available oscillators.
