SLG4653x Errata

CE-GP-002

This document contains the known errata for SLG46533, SLG46534, SLG46535, SLG46536, SLG46537, SLG46538 and the recommended workarounds.

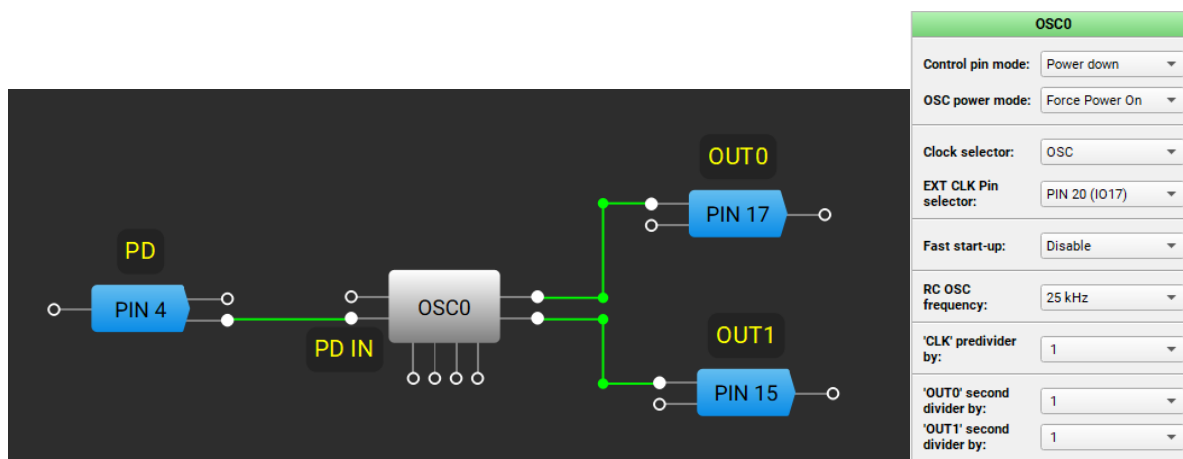
Figure 19. Test Design

When a short pulse of less than ~40 ns is applied to the PWR DOWN input.

If a pulse with a duration of less than ~40 ns is applied to the PWR DOWN input of the oscillator, the oscillator outputs remain stuck for milliseconds, as shown in figures below. The issue is observed for all available oscillators.
