# Errata

## SLG46580 Errata

### CE-GP-002

*This document contains the known errata for SLG46580 and the recommended workarounds.*

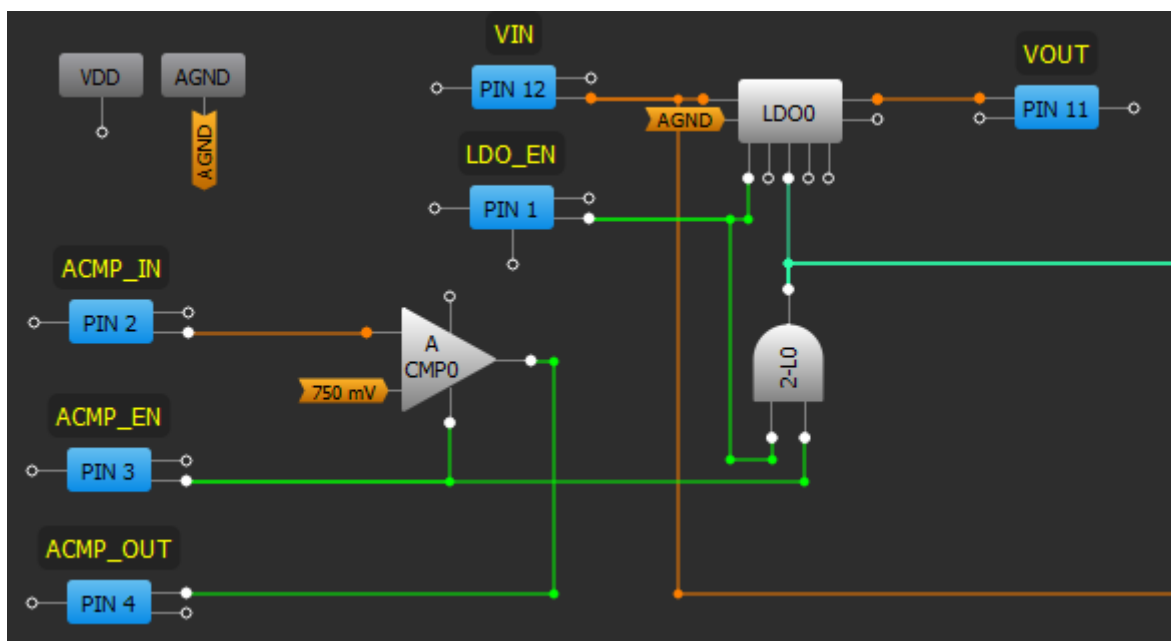
If an LDO's Low Power Mode is selected (for example tied to  $V_{DD}$ ) a glitch may appear on the ACMP's output after the first LDO is enabled. When the first LDO is turned on, the Low Power Mode switch causes a drop in the internal bandgap voltage that is used to derive the ACMP reference voltages.

- Use both edge delay on the output to filter out the glitch.
- Use some logic to avoid turning on Low Power Mode before enabling LDO and powering up the ACMP. Example is shown below.
