SLG46585 Errata

CE-GP-002

This document contains the known errata for SLG46585 and the recommended workarounds.

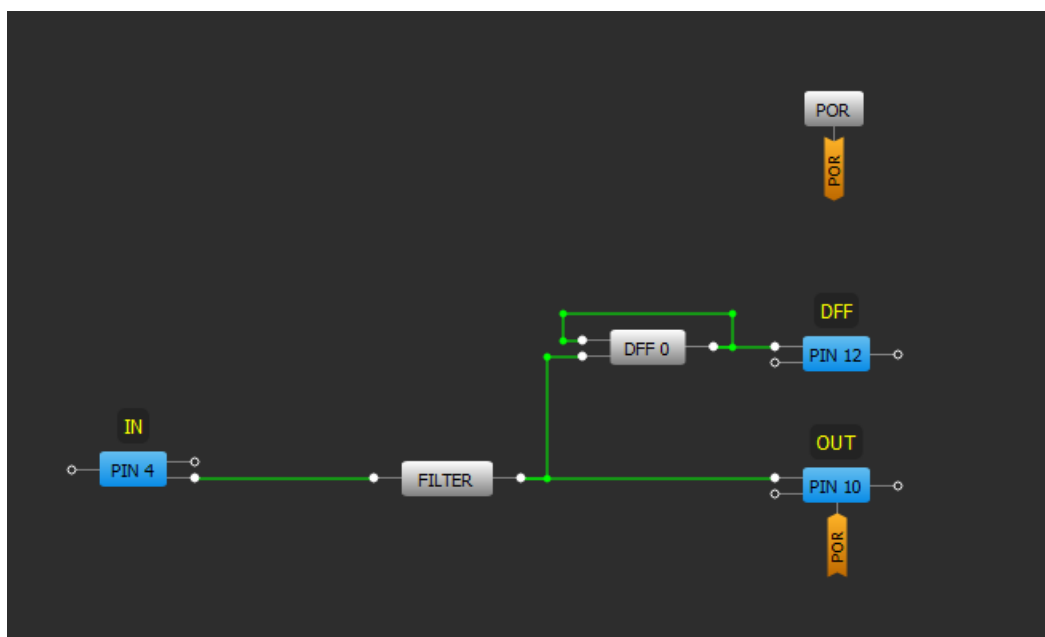
If the FILTER cell's input signal contains multiple consecutive pulses within short time intervals, the FILTER cell may not filter the input pulses as expected. The errant behavior applies only to repeated input pulses and depends on both their frequency and duty cycle.

Channel 1 (yellow/top line) – PIN#4 (IN).

Channel 2 (light blue/2nd line) – PIN#10 (OUT).

Channel 3 (magenta /3rd line) – PIN#12 (DFF).

1. Period is 60 ns. Pulse width is 10 ns, DC = 16.7 % (correct functionality).

Currently, there is no workaround for this issue. The FILTER block correctly filters isolated glitches, but it shouldn't be used to filter repetitive, high frequency input signals.

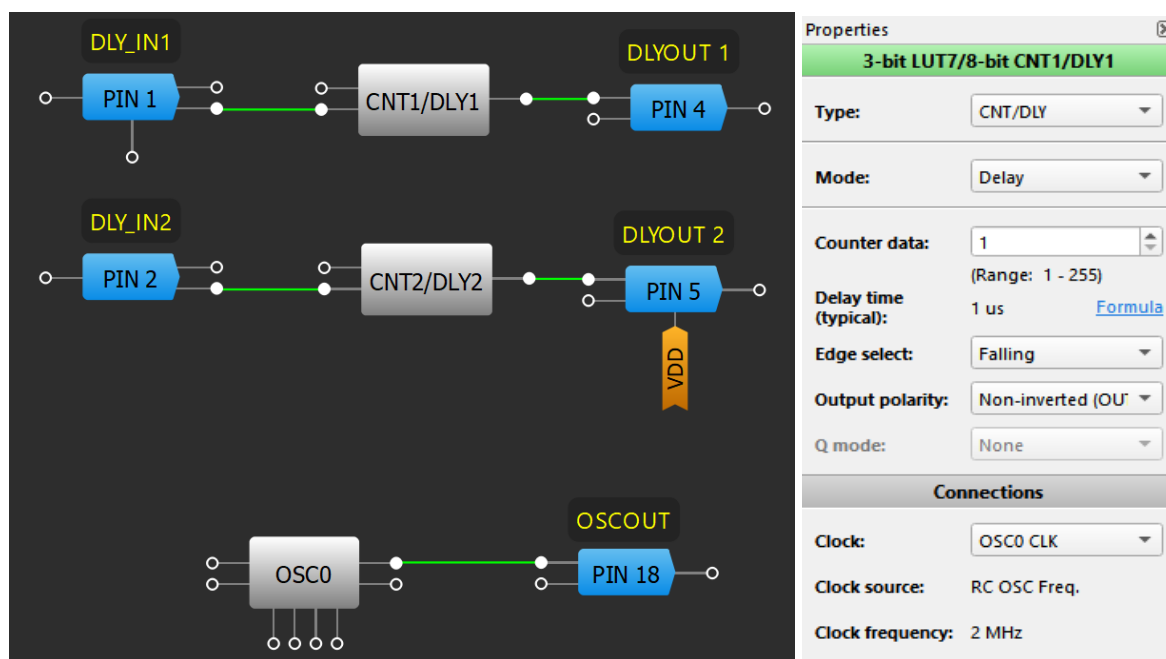
Figure 2: Test Circuit

The error is difficult to capture as the timing must be exact within ns, and short (ns) pulses are difficult to generate glitch precise enough to induce the problem. GPIO naturally filter out ns pulses, so for purposes of errata capture, two simultaneous falling-edge DLY circuits (as shown in Figure 2) were used. By lining up two delays precisely at a particular timing relationship, we can use the internal Auto Power On (OR logic) to generate the glitch pattern necessary to cause the error.

1. Use signal conditioning circuits to prevent glitch on DLY inputs < 200 ns. Examples:

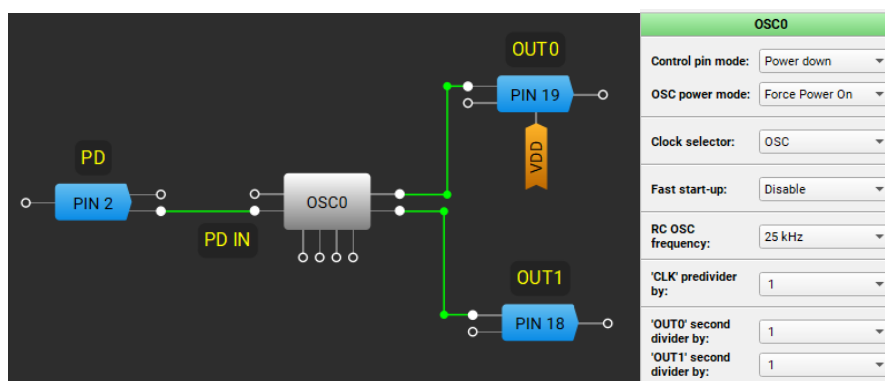
Short pulse of less than ~40ns is applied to PWR DOWN OSC.

If a pulse with a duration of less than ~40 ns is applied to the PWR DOWN input of an oscillator, the oscillator outputs remain stuck for milliseconds. The issue is observed for all available oscillators.

Use the “Force power on” OSC power control option to make the OSC operate at all times. However, this will cause increased constant current consumption.
