## SLG47525/28 Errata Note

This document contains the known errata for SLG47525/28 and the recommended workarounds.

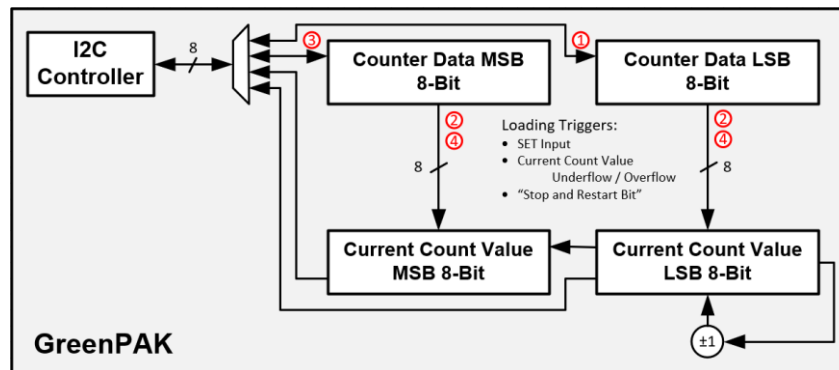
Figure 11. 16-Bit I<sup>2</sup>C Counter Block Diagram

As previously mentioned, the 16-bit value is loaded from the I<sup>2</sup>C buffers to the Counter Data registers in 8-bit chunks. Right at time “1”, the LSB byte (0x01) is loaded into the Counter Data registers. This makes the Counter Data value temporarily equal to 0x0001. At time “2” between the internal I<sup>2</sup>C load signals, the counter receives a rising edge on its clock input. This causes the Current Count Value to underflow and to be loaded with the Counter Data value which is 0x0001. At time “3”, the MSB byte (0x01) is loaded into the Counter Data registers setting the Counter Data value to 0x0101. At time “4”, the Current Count Value underflows again and is set to the Counter Data value of 0x0101.

This behavior results in two output pulses on OUT when only one pulse is expected. Observing this behavior depends upon the asynchronous timing between the counter's clock and an I<sup>2</sup>C write command to the Counter Data registers. For some applications, the extra pulse on OUT can be ignored and the counter will self-correct after underflowing, overflowing, or being SET/RESET through the GreenPAK connection matrix.

Disable the counter's clock during the I<sup>2</sup>C write.

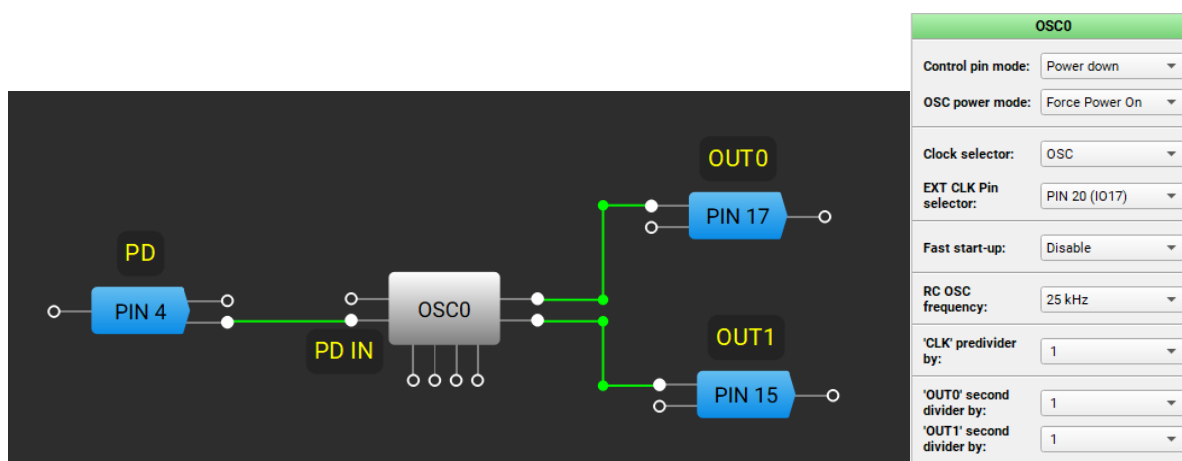
Figure 15. Test Design

When a short pulse of less than ~40 ns is applied to the PWR DOWN input.

If a pulse with a duration of less than ~40 ns is applied to the PWR DOWN input of the oscillator, the oscillator outputs remain stuck for milliseconds, as shown in [Figure 16](#) and [Figure 17](#). The issue is observed for all available oscillators.
