## SLG47525/28 Errata Note

This document contains the known errata for SLG47525/28 and the recommended workarounds.

Package(s)	14-pin STQFN (SLG47525): 2.0 mm x 2.2 mm x 0.55 mm, 0.4 mm pitch
	20-pin STQFN (SLG47528): 2.0 mm x 3.0 mm x 0.55 mm, 0.4 mm pitch

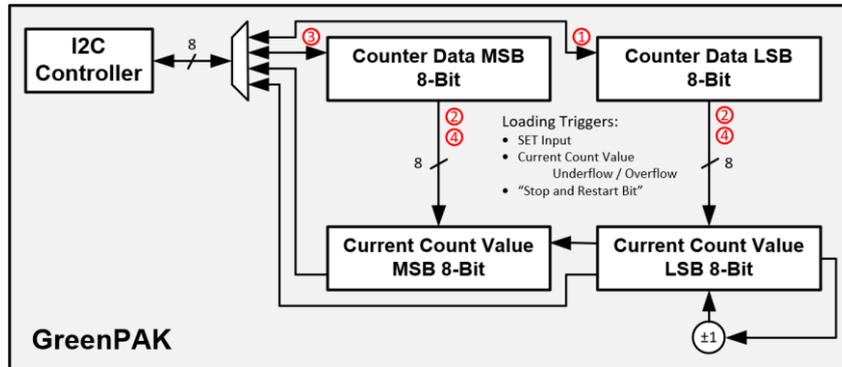
Figure 11. 16-Bit I<sup>2</sup>C Counter Block Diagram

As previously mentioned, the 16-bit value is loaded from the I<sup>2</sup>C buffers to the Counter Data registers in 8-bit chunks. Right at time “1”, the LSB byte (0x01) is loaded into the Counter Data registers. This makes the Counter Data value temporarily equal to 0x0001. At time “2” between the internal I<sup>2</sup>C load signals, the counter receives a rising edge on its clock input. This causes the Current Count Value to underflow and to be loaded with the Counter Data value which is 0x0001. At time “3”, the MSB byte (0x01) is loaded into the Counter Data registers setting the Counter Data value to 0x0101. At time “4”, the Current Count Value underflows again and is set to the Counter Data value of 0x0101.

This behavior results in two output pulses on OUT when only one pulse is expected. Observing this behavior depends upon the asynchronous timing between the counter’s clock and an I<sup>2</sup>C write command to the Counter Data registers. For some applications, the extra pulse on OUT can be ignored and the counter will self-correct after underflowing, overflowing, or being SET/RESET through the GreenPAK connection matrix.

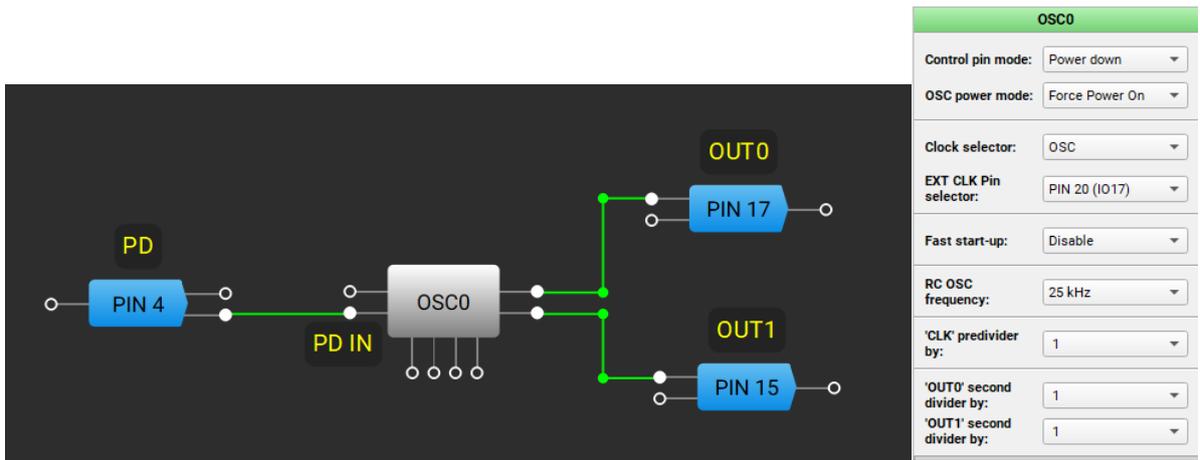
Figure 15. Test Design

When a short pulse of less than ~40 ns is applied to the PWR DOWN input.

If a pulse with a duration of less than ~40 ns is applied to the PWR DOWN input of the oscillator, the oscillator outputs remain stuck for milliseconds, as shown in Figure 16 and Figure 17. The issue is observed for all available oscillators.
