Renesas RA Family

Standard Boot Firmware for the RA family MCUs Based on Arm® Cortex®-M33

This document describes the Standard Boot Firmware Specifications for RA family MCUs flash memory based on Arm Cortex-M33 flash memory. Make sure you understand the target devices and FPSYS / FACL specifications before reading this document. We do not guarantee the operation of any usage not described in this document.

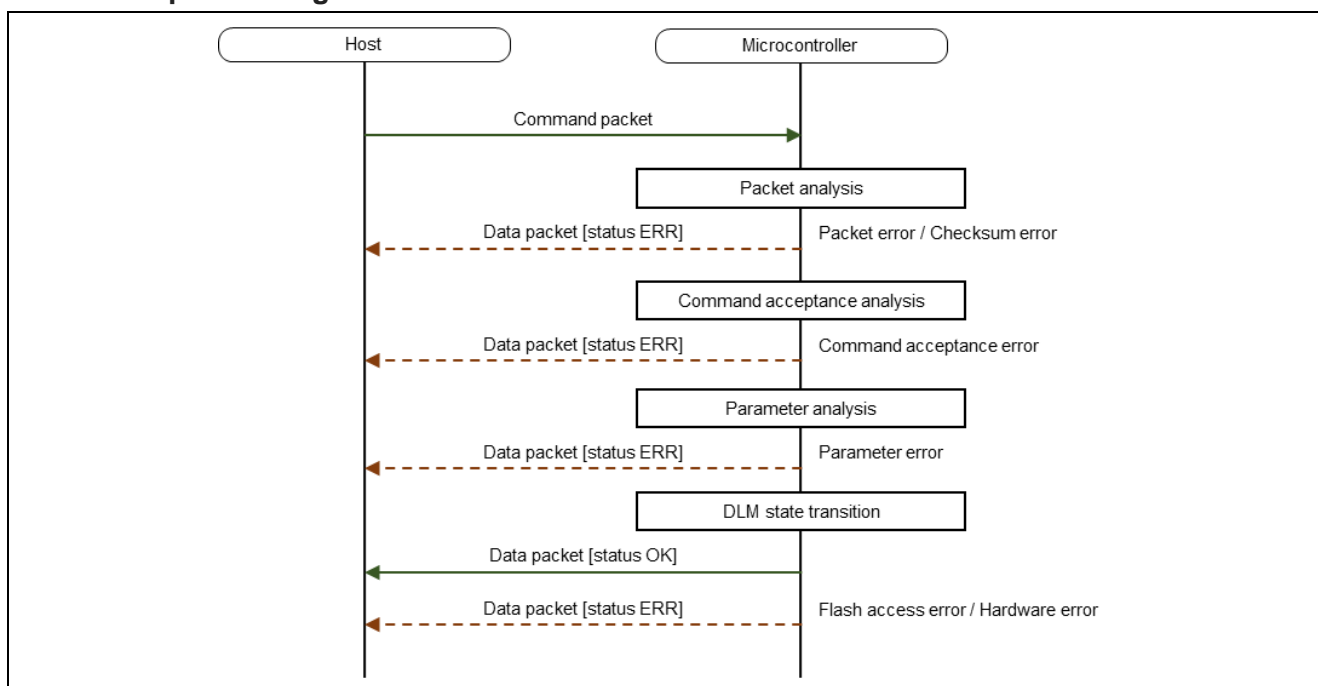
6.2.1 Sequence diagram

This command transitions the DLM state without authentication. The boot firmware is hung when the DLM state transitions to LCK_BOOT.
