On-chip Debuggers

E2 emulator and E2 emulator Lite (RA Connection)

1. Notes on using E2 emulator or E2 emulator Lite for RA Family

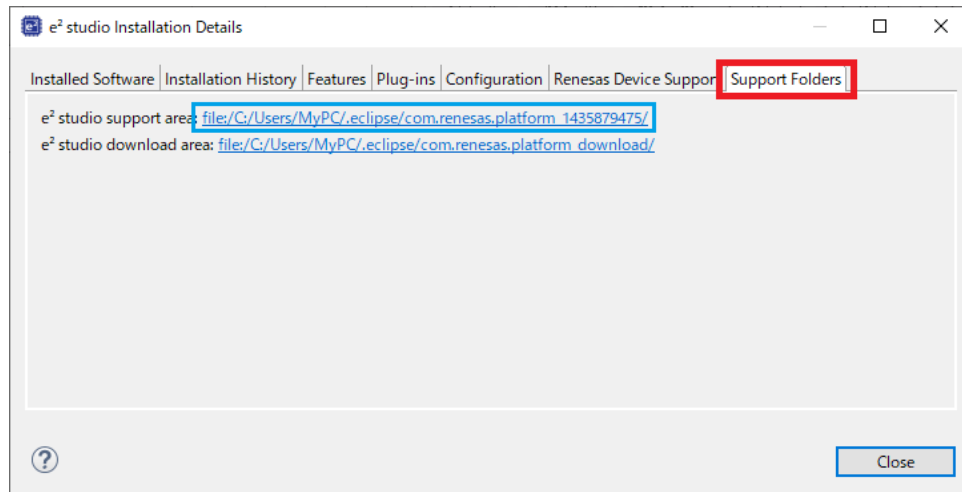
- ⑥ [e² studio Installation Details] opens. Click [Support Folders] (framed in red).
 - ⑦ In [Support Folders], click the link of [e² studio support area] (framed in blue)*.
- *The link in the image is an example. The link varies depending on the user environment.

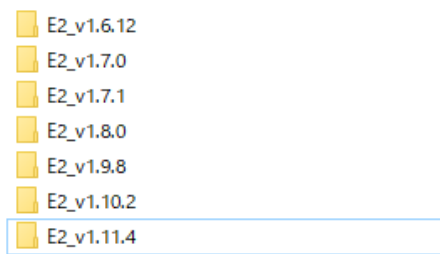
- ⑧ The e² studio support area opens in Explorer. Move to the following folder:
 DebugComp > RA~~4~~ARM > E2_vx.xx.x > MCUFiles > RA4M2*
 *xx in E2_vx.xx.xx varies depending on the user environment.
- ⑨ Overwrite the contents of the folder with those unzipped in step ①.
 If more than one E2_vx.xx.xx appears (as shown below), update all the folders.
